Contract No. CV/2016/10  
Site Formation and Associated Infrastructural Works for  
Development of Columbarium, Crematorium and  
Related Facilities at Sandy Ridge Cemetery

**Vegetation Survey Report and Transplantation Proposal**

Revision	1	
Date of issue	12 Sep 2018	
Prepared by	Desmond Tang Qualified Ecologist

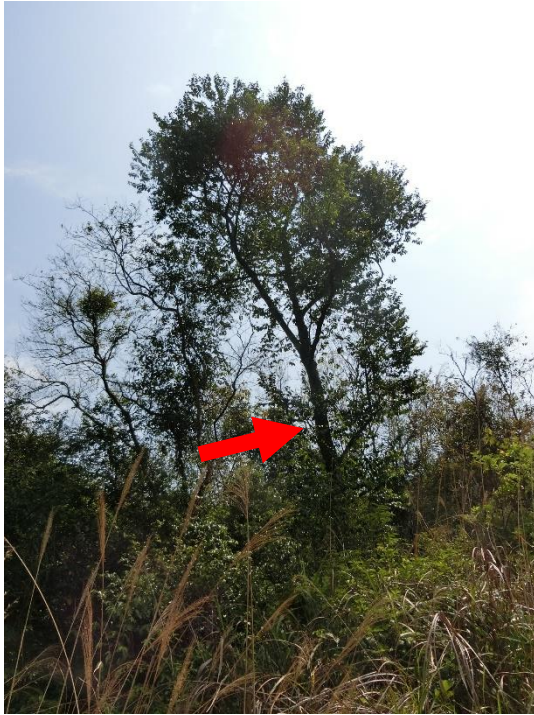
*Aquilaria sinensis* (1)

Species	DBH (mm)	Height (m)	Crown Spread (m)	Health	Structural Condition	Survival rate after transplanting (High/Medium/Low)
<i>Aquilaria sinensis</i>	295	11	5	Fair	Fair	Medium

- 4.1 The *Aquilaria sinensis* recorded within the surveyed area is a mature tree with 11 meters in height. It is located in woodland at the central part of project which a fill slope (FS1) will be constructed in this area as shown in Appendix E. Excavation and change in terrain will inevitably damage the tree especially its rooting system and reduce the survival rate during the construction period. Avoidance of disturbance to the *Aquilaria sinensis* would be technically infeasible. Therefore, transplantation to a receptor site in proximity area is recommended.

- 4.2 Since the *Aquilaria sinensis* recorded within the surveyed area has direct conflict with the construction work, and the formation of rootball of adequate shape and size for transplanting would be technical feasible, it is recommended to transplant the *Aquilaria sinensis* to a permanent receptor site beyond the work site boundary. The proposed receptor site for the transplanting trees is shown in Appendix F.
