**CEDD CONTRACT CV/2016/10
SITE FORMATION AND ASSOCIATED INFRASTRUCTURAL
WORKS FOR DEVELOPMENT OF COLUMBARIUM AT
SANDY RIDGE CEMETERY**

**MONTHLY ENVIRONMENTAL MONITORING AND AUDIT
REPORT (No.3) – OCTOBER 2018**

**PREPARED FOR
HSIN CHONG TSUN YIP JOINT VENTURE**

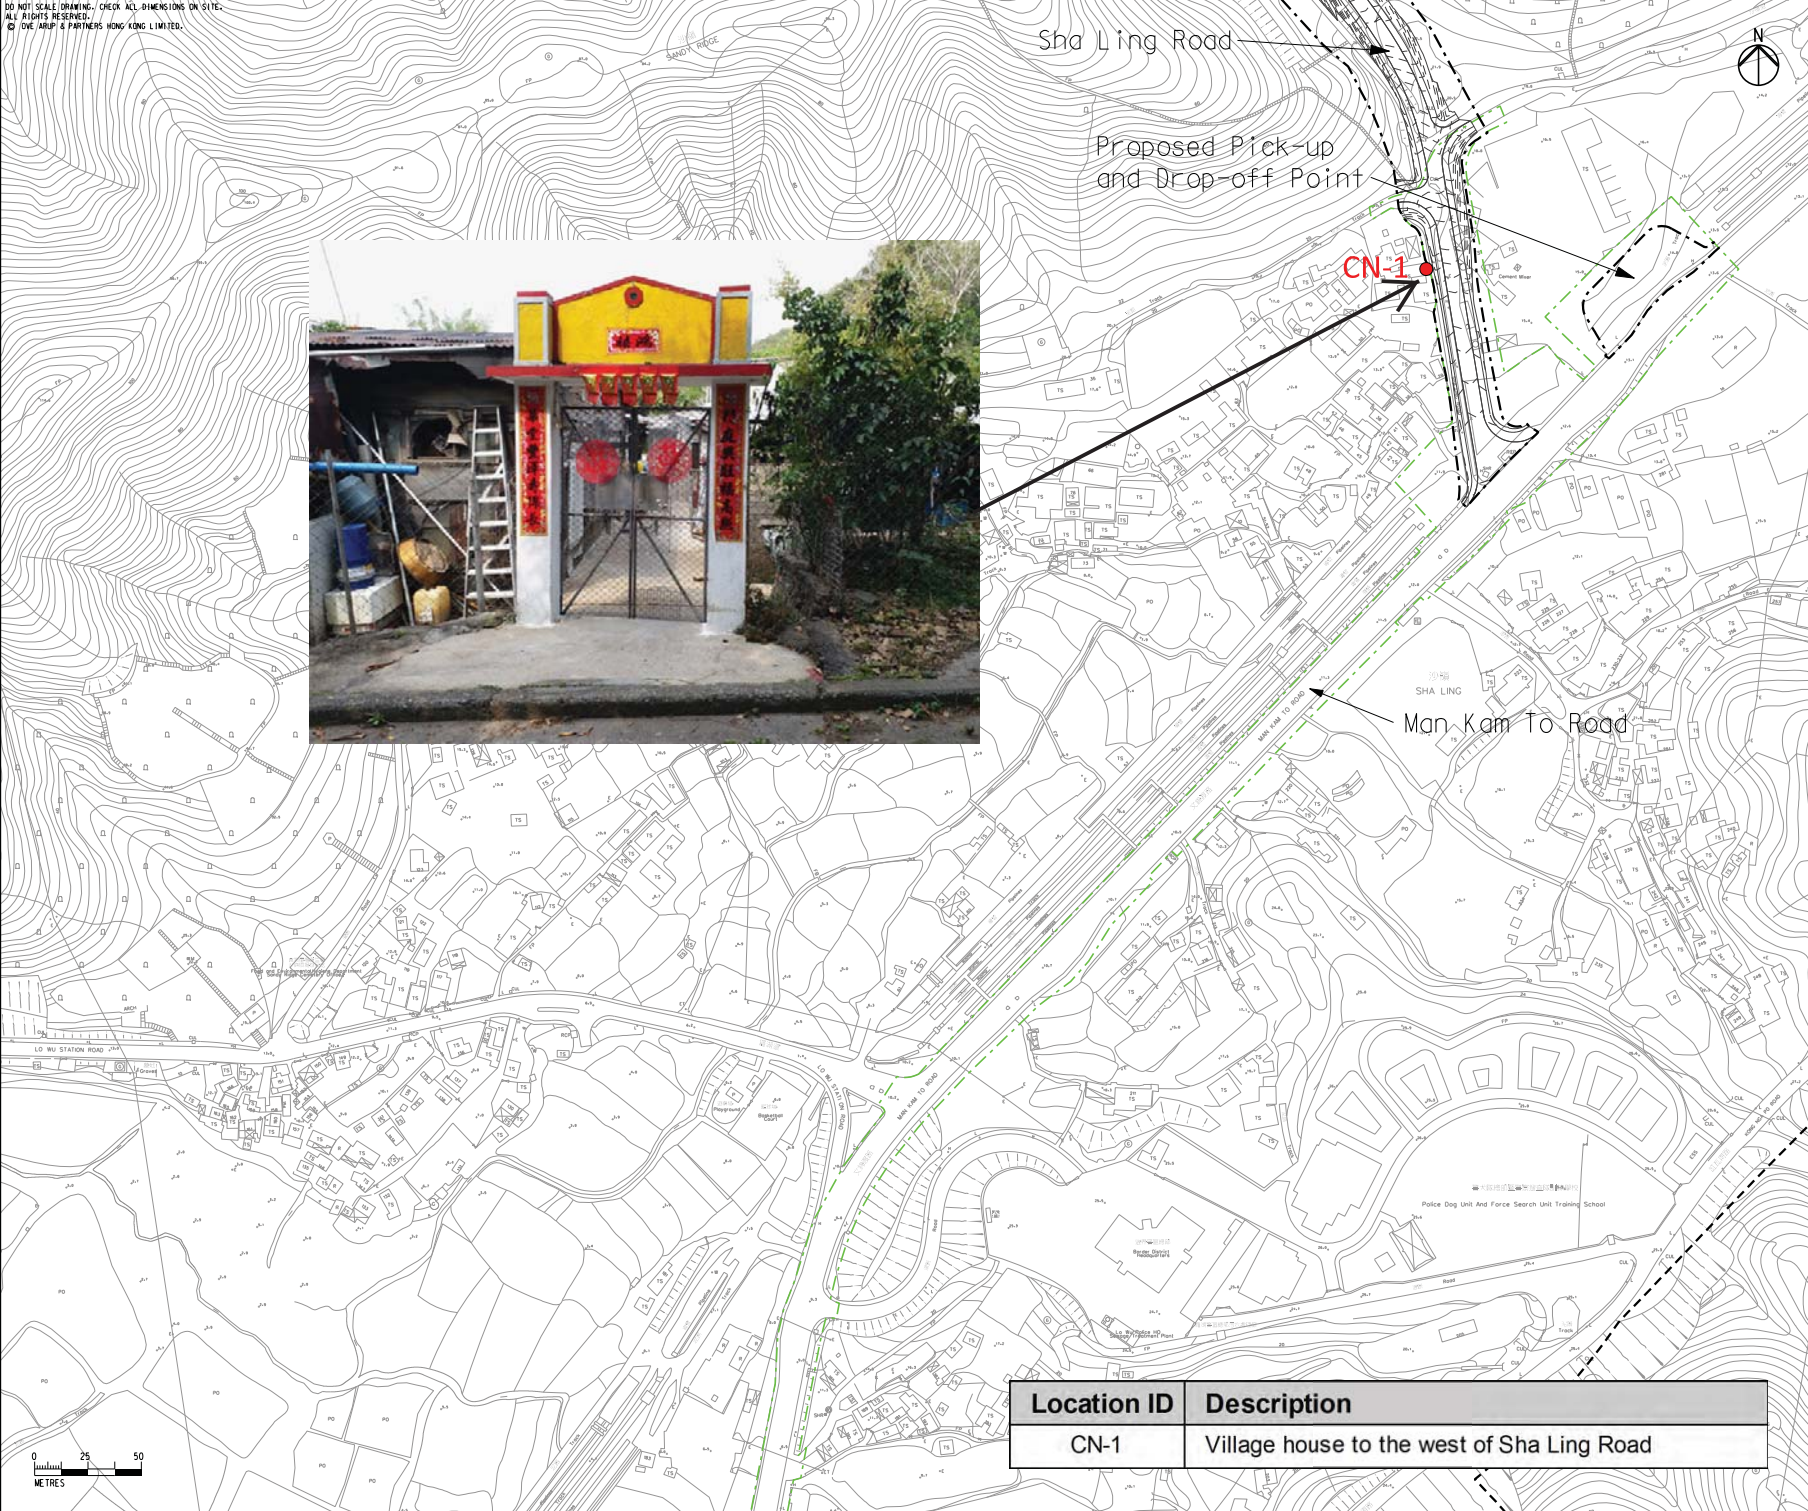
- Legend
- Project Boundary
 - Utilities Construction
 - 300m Assessment Area
 - Proposed Construction Noise Monitoring Locations

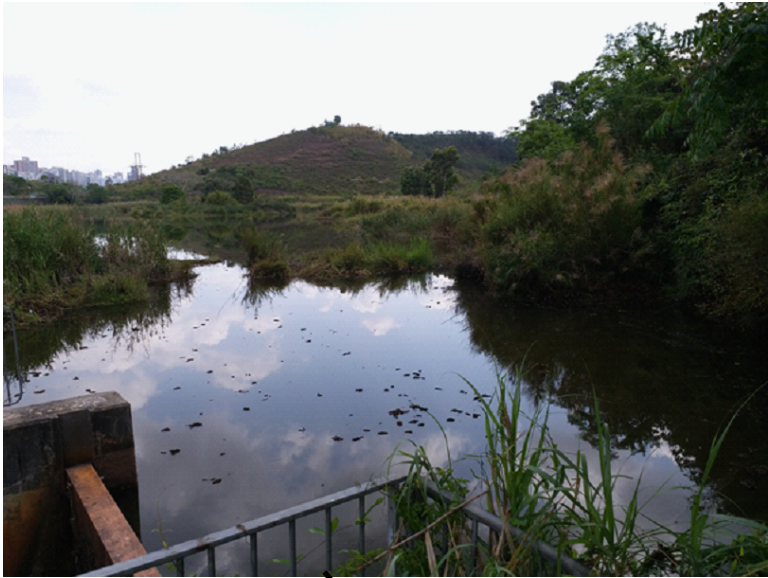
Printed by : 2/29/2016
Filename : G:\env\project\231448\13 Drawing Deliverables\Reports\018 EM&A Manual\20160226 Revised Final\1\Figure 7.1.1 - Water Quality Monitoring Locations.dgn

Proposed Water Quality Monitoring Station under Contract 1

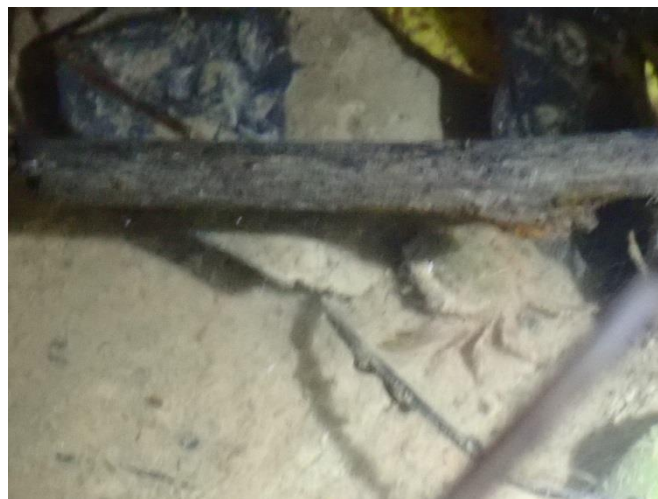
Figure 1

Somanniathelphusa zanklon (鎌 刀 束 腰 蟹)

7.3.7 2 crabs of conservation importance *Somanniathelphusa zanklon* (鎌刀束腰蟹) were found in marsh.

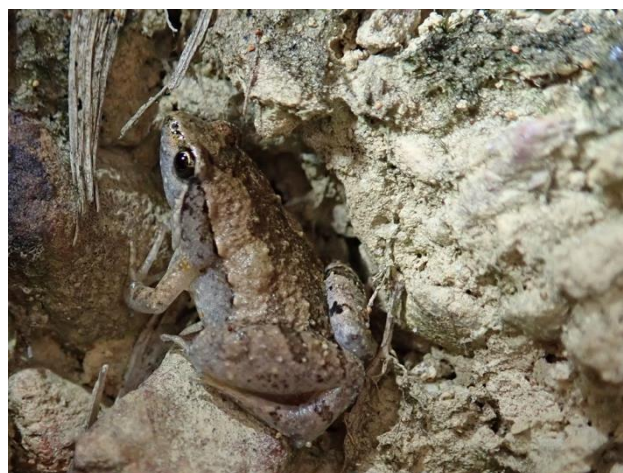
Figure 2

Microhyla fissipes Ornate Pigmy Frog 飾紋姬蛙

pulchra, Asiatic Painted Frog, 花狹口蛙) and *Microhyla fissipes*, Ornate Pigmy Frog, 飾紋姬蛙) found in the monitoring area.

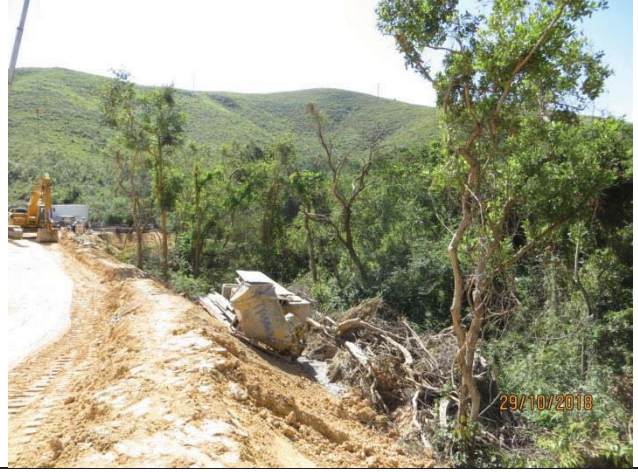
Fig A.	Fig B.

No hoarding or barrier was provided	No proper TPZ was provided for some of the retained trees

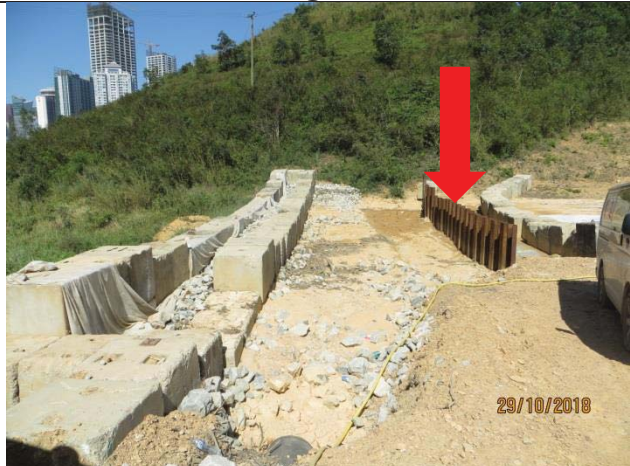
<p>Fig C.</p>

<p>Trench Steel Sheet Piles were inserted in the earth bund</p>	<p>Raised soil level to prevent muddy water enters the wet wood land</p>
<p>Fig E.</p>

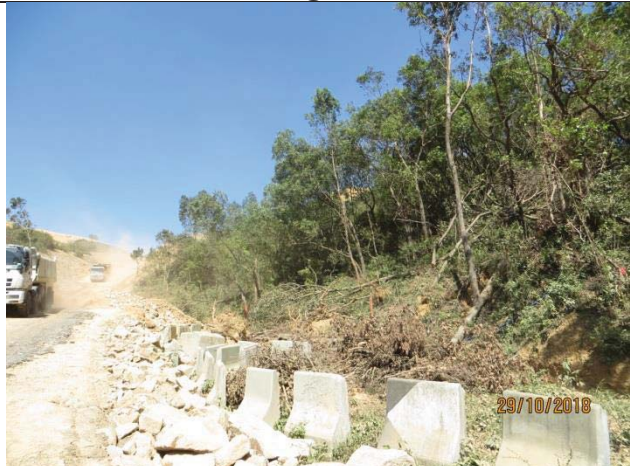
<p>Retain trees affected by typhoon Mangkhut</p>	<p>Construction material placing next to retained tree</p>
<p>Fig G.</p>

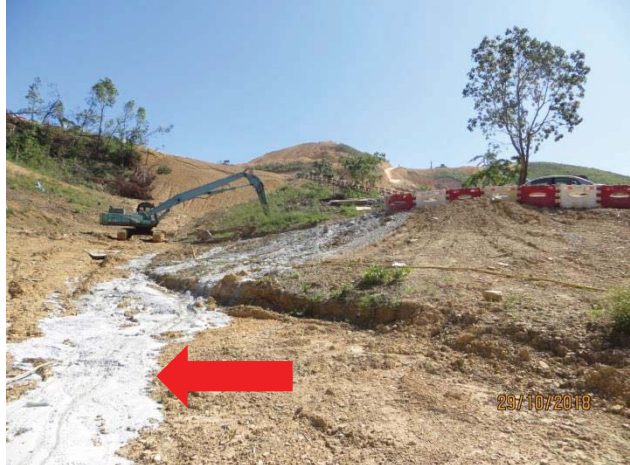
<p>Concrete leakage on the construction site</p>	<p>Raised soil level near root flare of tree</p>
