**CEDD CONTRACT CV/2016/10  
SITE FORMATION AND ASSOCIATED INFRASTRUCTURAL  
WORKS FOR DEVELOPMENT OF COLUMBARIUM AT  
SANDY RIDGE CEMETERY**

**MONTHLY ENVIRONMENTAL MONITORING AND AUDIT  
REPORT (NO.1) – AUGUST 2018**

**PREPARED FOR  
Hsin Chong Tsun Yip Joint Venture**

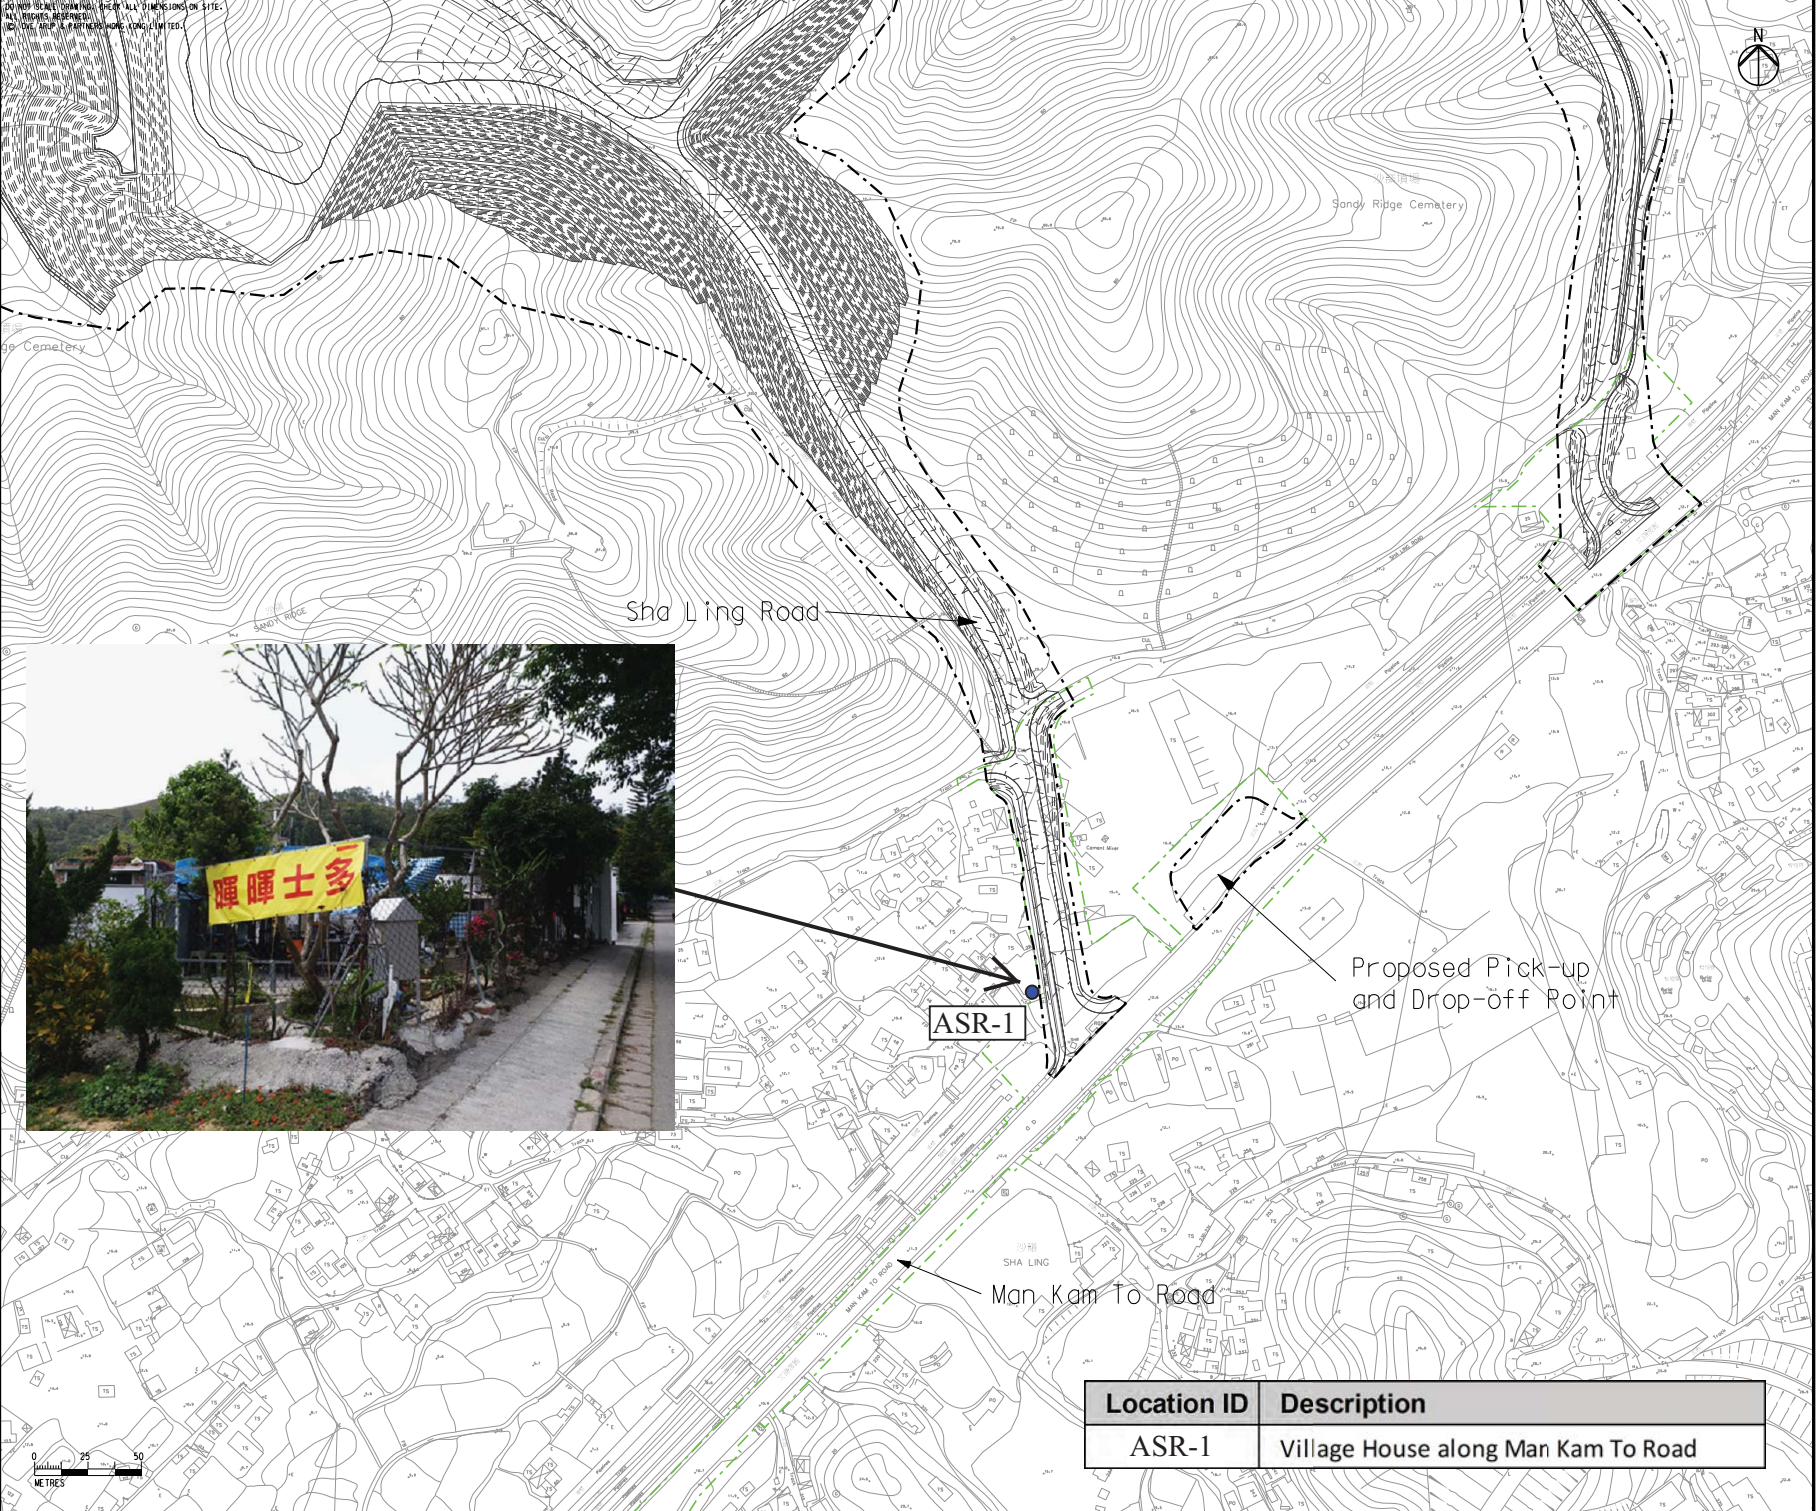
Printed by : 2/26/2016  
Filename : G:\env\project\231448\13\_Drawing Deliverables\Reports\018\_EIM&A Manual\20160226 Revised Final\Figure 5.12 - Locations of Construction Dust Monitoring (Sheet 2 of 4).dgn

3.3.3 There were three (3) air quality monitoring stations / air quality sensitive receivers (ASR) recommended in the Approved EM&A Manual Section 5.6.1.1. The designated air quality monitoring locations were listed in *Table 3-2* and illustrated in *Appendix D*.

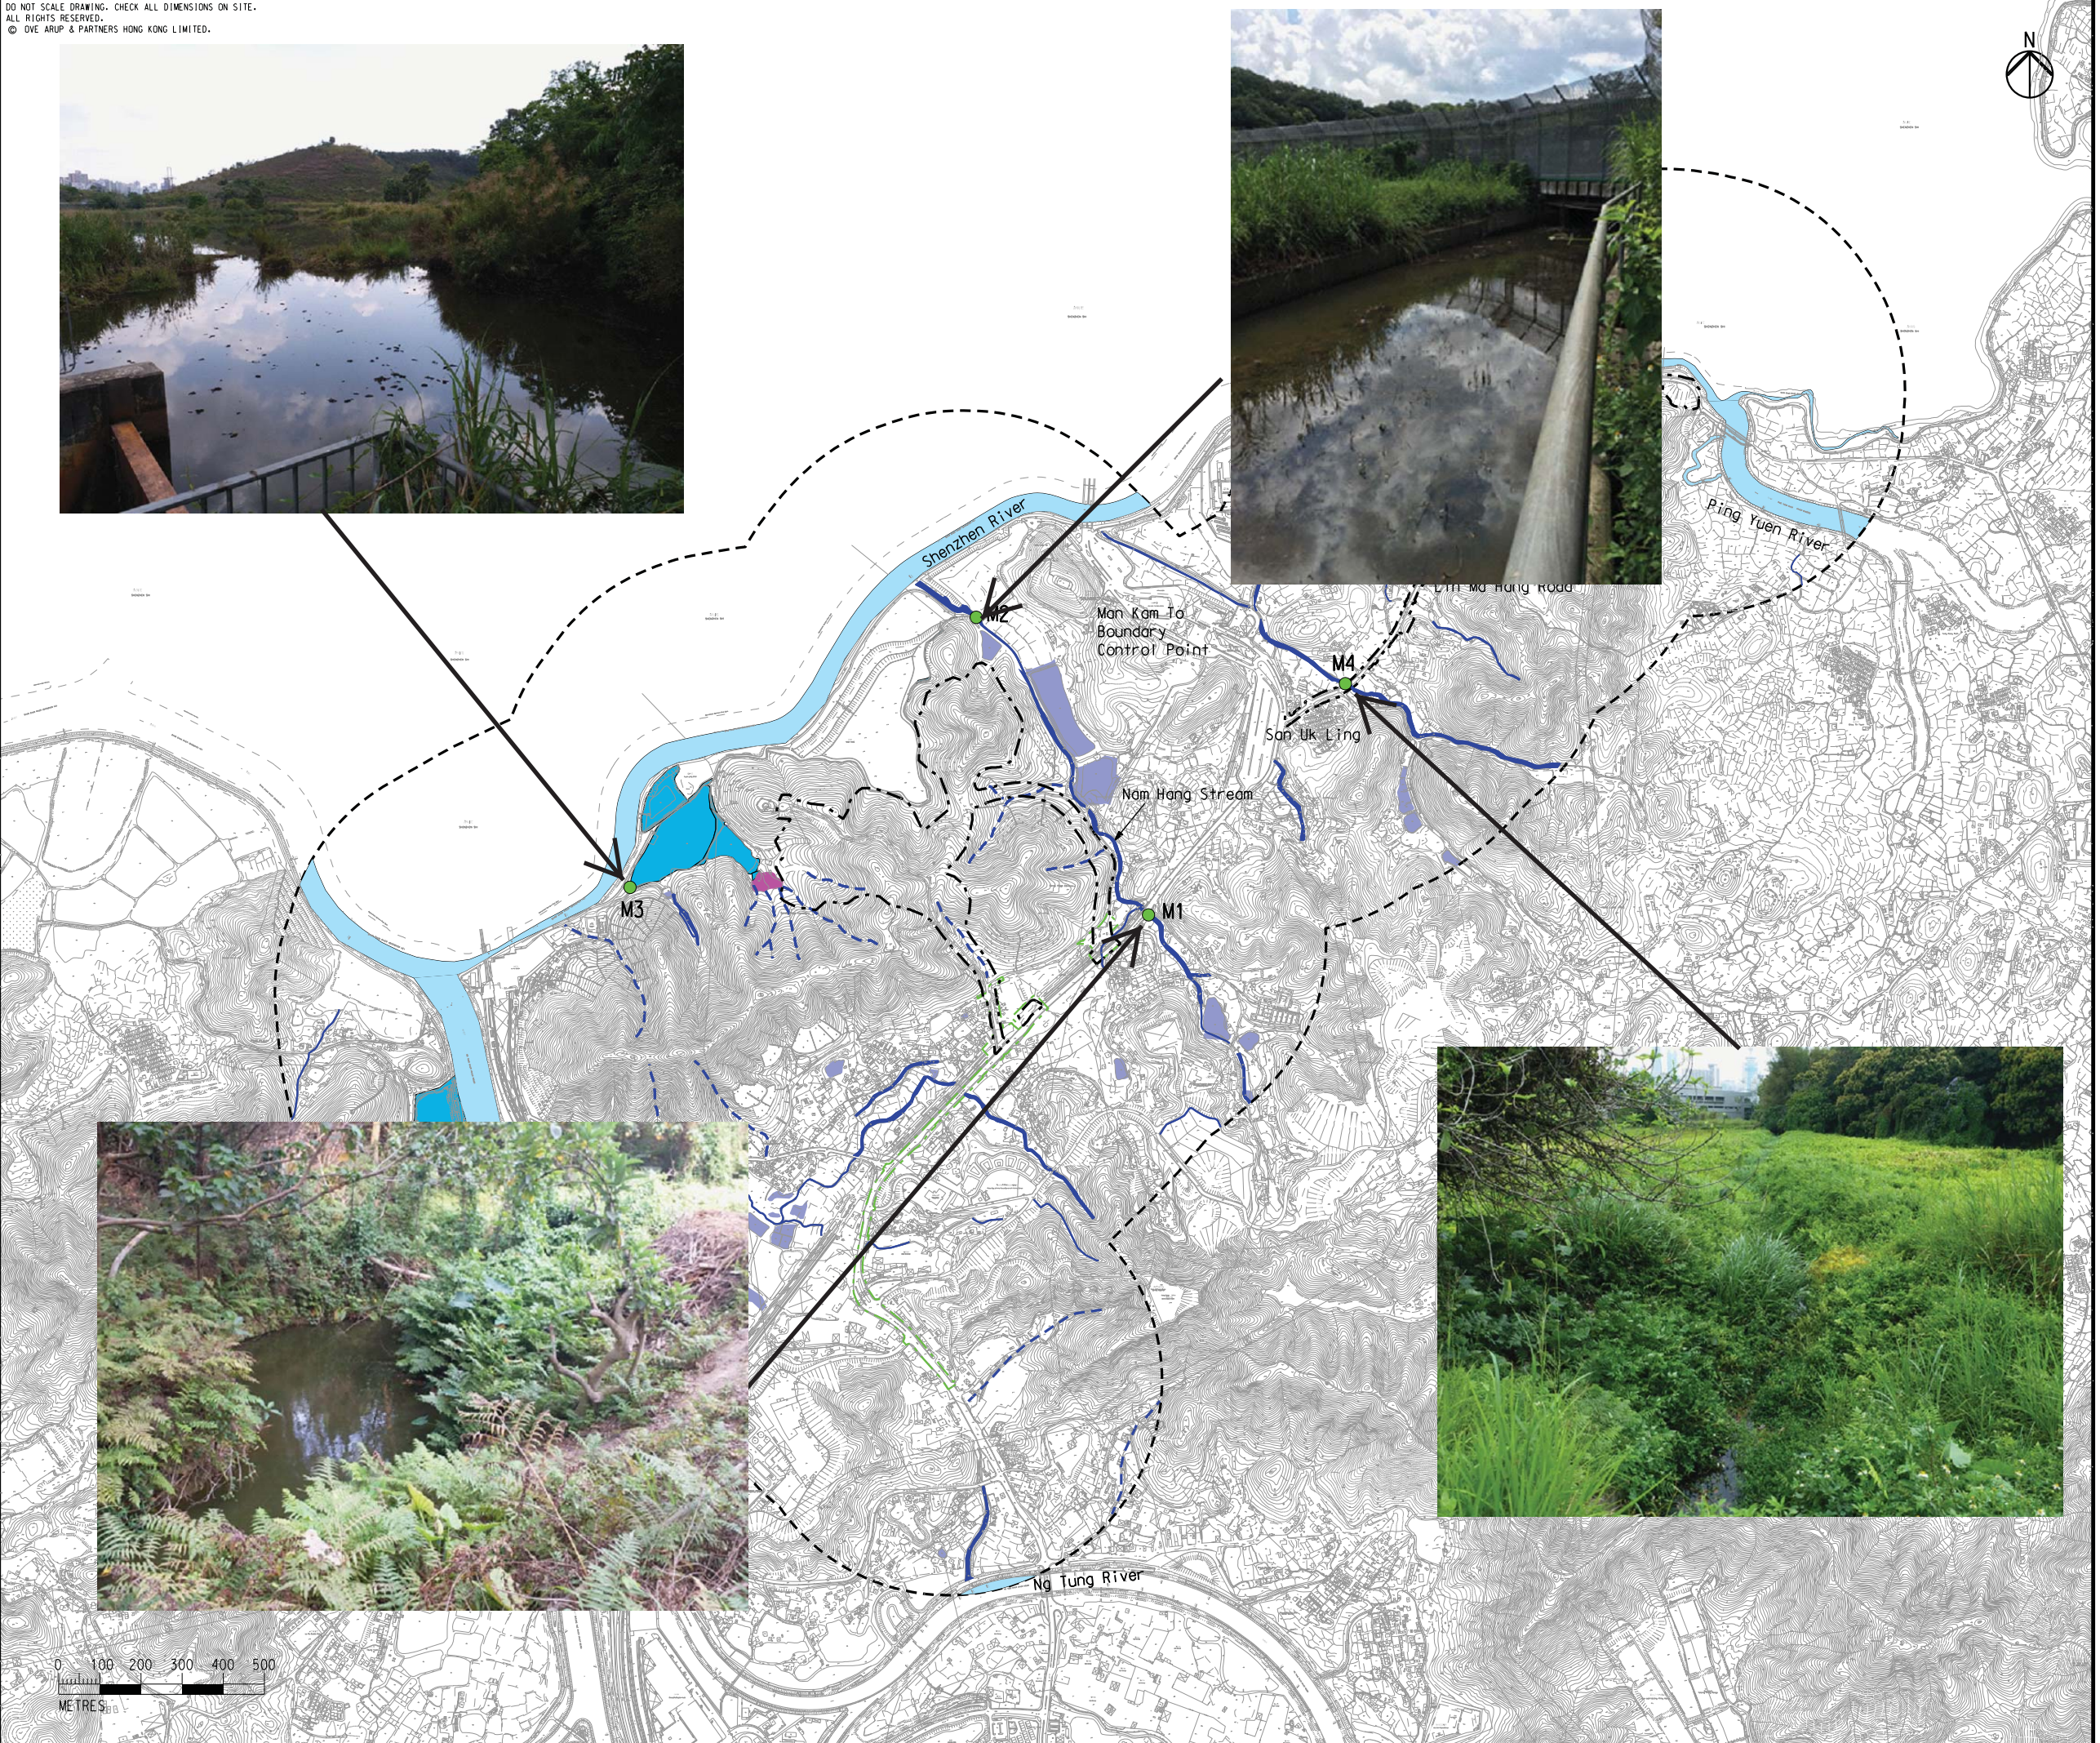
Printed by : 2/29/2016  
Filename : G:\env\project\231448\13 Drawing Deliverables\Reports\018 EM&A Manual\20160226 Revised Final\_v1\Figure 7.11 - Water Quality Monitoring Locations.dgn

3.3.10 There were four (4) water quality monitoring locations recommended in the Approved EM&A Manual Section 7.6.1.2. The locations and coordinates of water quality monitoring were listed in **Table 3-6** and illustrated in **Appendix D**.

- Legend
- Project Boundary
  - Utilities Construction
  - 500m Assessment Area
  - Channelized River
  - Pond
  - Watercourse
  - Conservation Area (CA)
  - Wet Woodland
  - Seasonal Watercourse
  - Water Quality Monitoring Stations in EM&A Manual

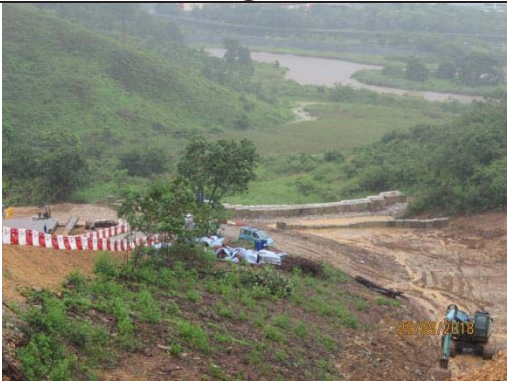
Fig A.	Fig B.

No hoarding and barrier was provided	No TPZ was provided
Fig C.	Fig D.

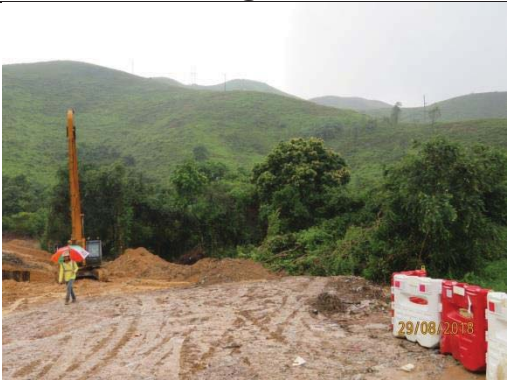
No TPZ was provided	Earth bund failed to filter the muddy water
