JOB No.: TCS00881/18 & TCS00944/18

**SITE FORMATION AND ASSOCIATED INFRASTRUCTURAL
WORKS FOR DEVELOPMENT OF COLUMBARIUM,
CREMATORIUM AND RELATED FACILITIES AT SANDY
RIDGE CEMETERY**

**MONTHLY ENVIRONMENTAL MONITORING AND AUDIT
REPORT (NO.35) – JULY 2021**

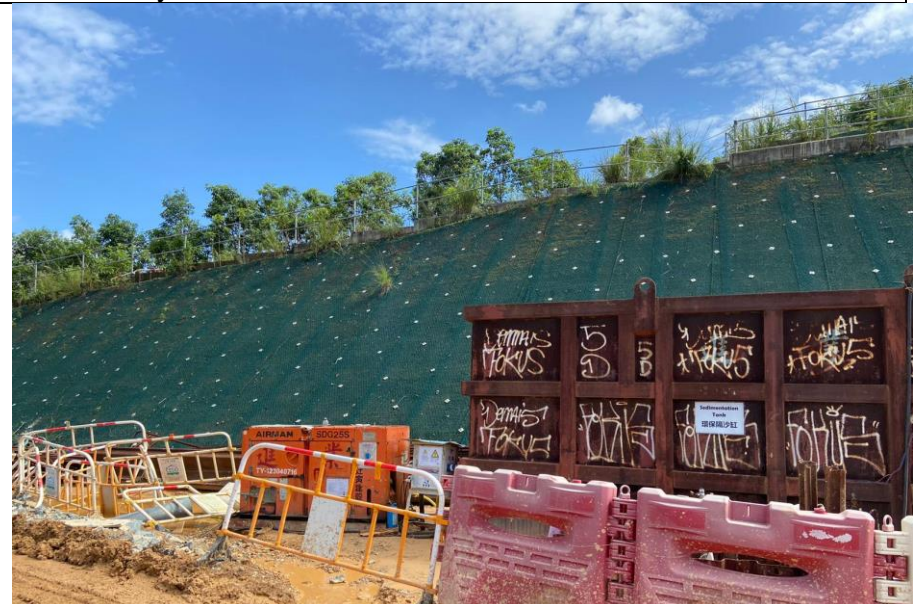
Hydro-seeding was applied on the slope to minimize muddy runoff.
