**JOB No.: TCS00881/18 & TCS00944/18**

**SITE FORMATION AND ASSOCIATED INFRASTRUCTURAL  
WORKS FOR DEVELOPMENT OF COLUMBARIUM,  
CREMATORIUM AND RELATED FACILITIES AT SANDY  
RIDGE CEMETERY**

**MONTHLY ENVIRONMENTAL MONITORING AND AUDIT  
REPORT (NO.37) – AUGUST 2021**

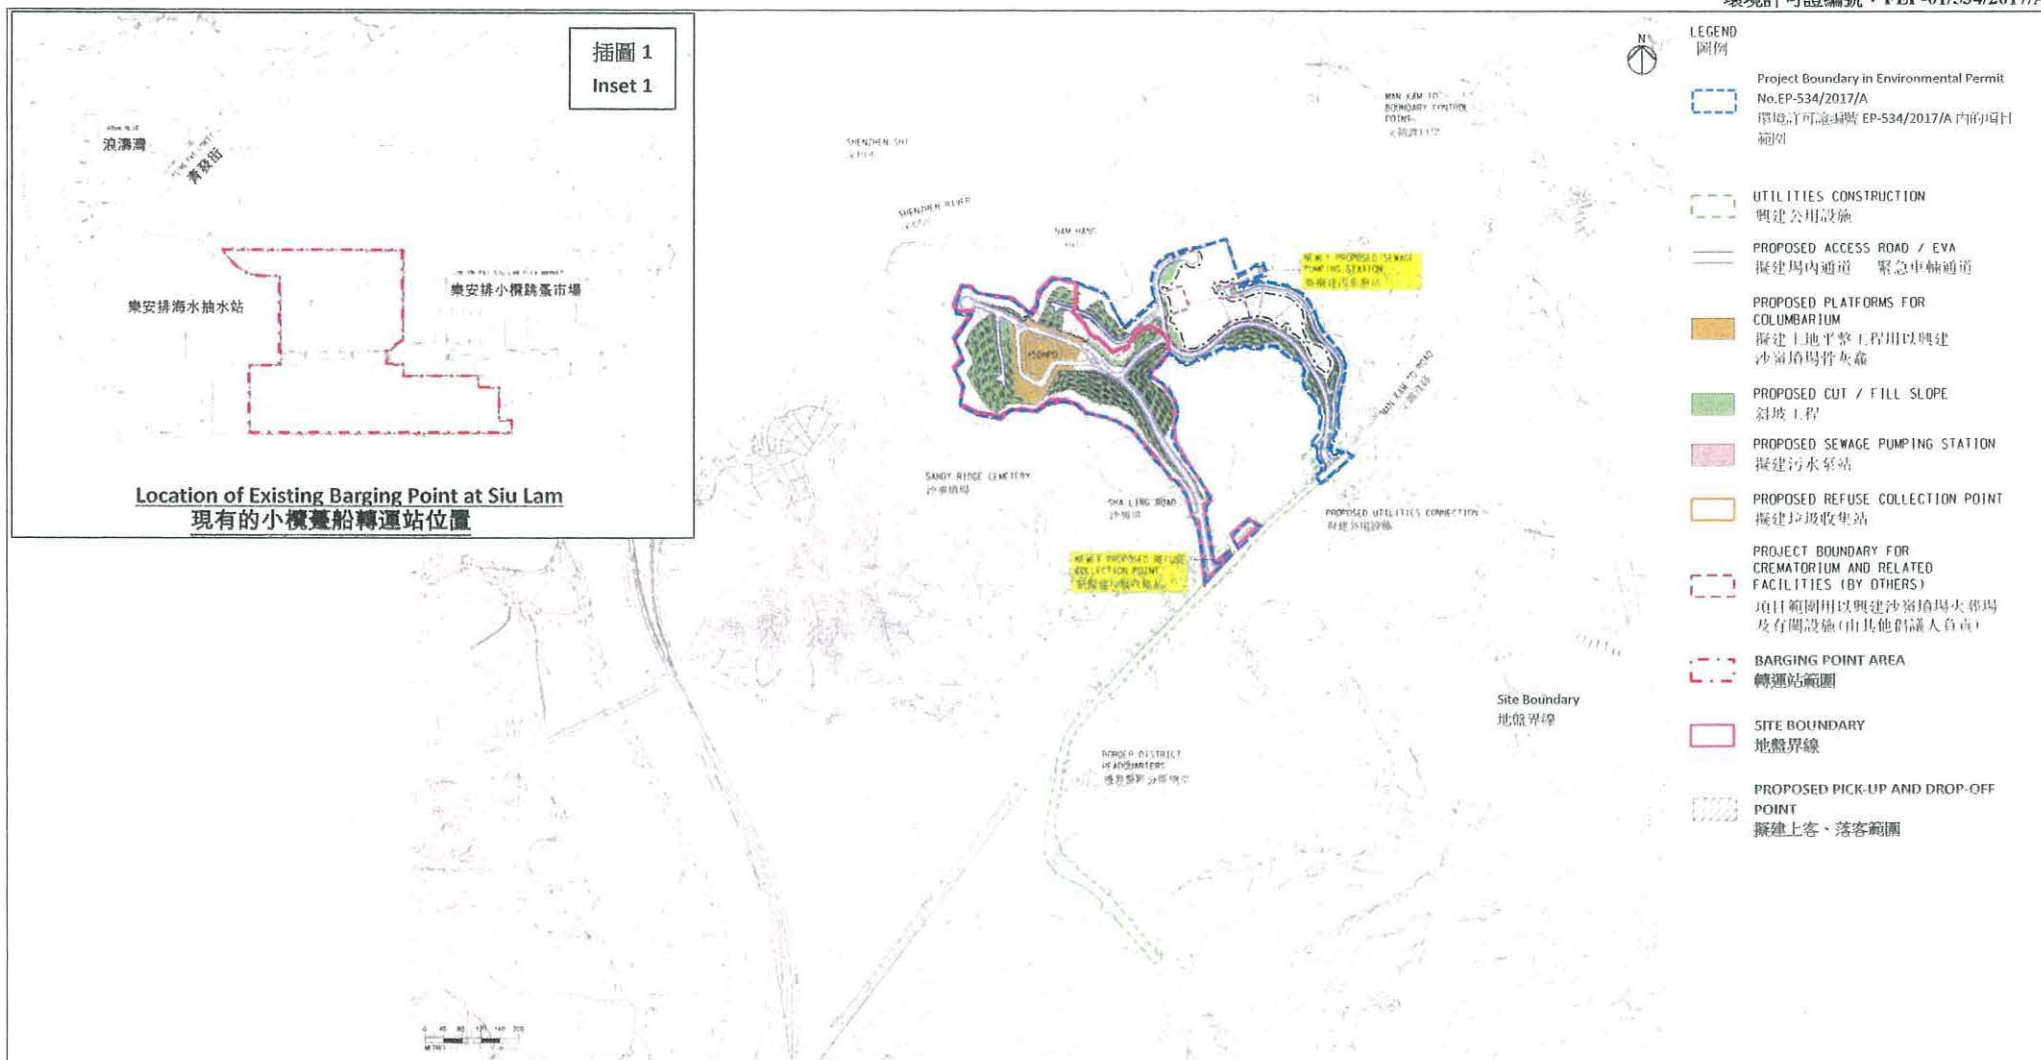
**Figure 1: Project Location Plan**

**Project Title: Site Formation and Associated Infrastructural Works for Development of Columbarium at Sandy Ridge Cemetery**  
**工程名稱: 沙嶺墳場興建骨灰龕的工地平整及相關基建工程**

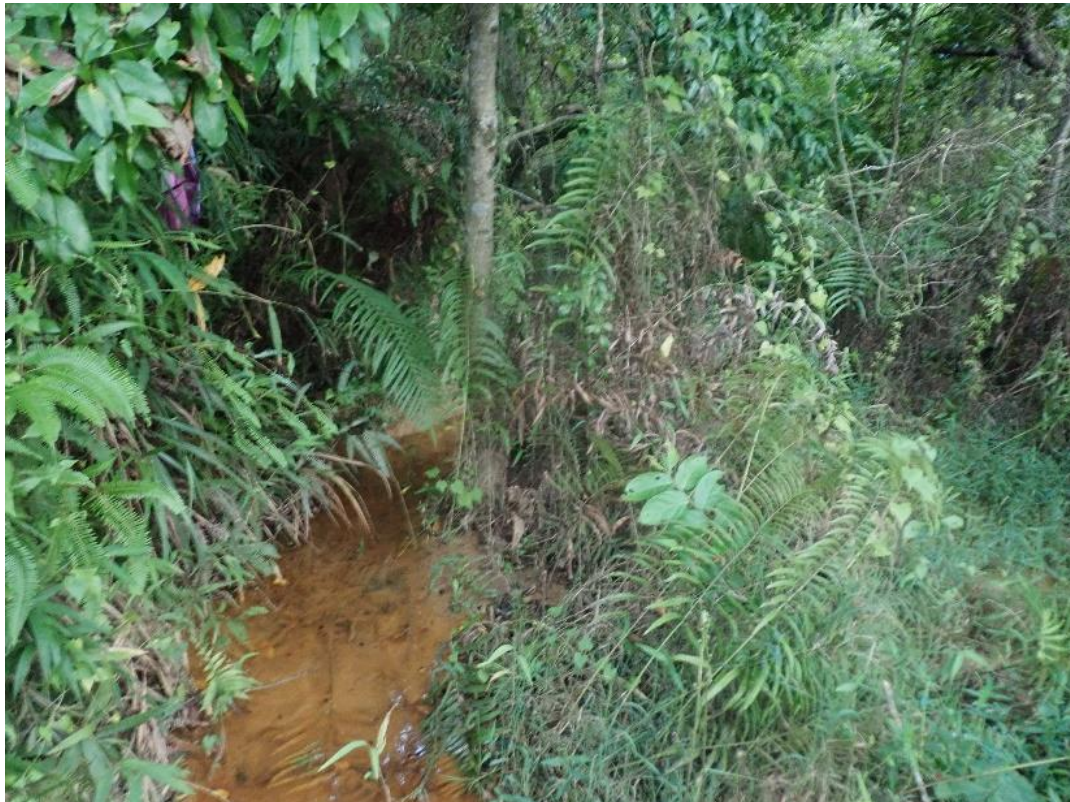
**Picture 2**

Wetland in monitoring area.

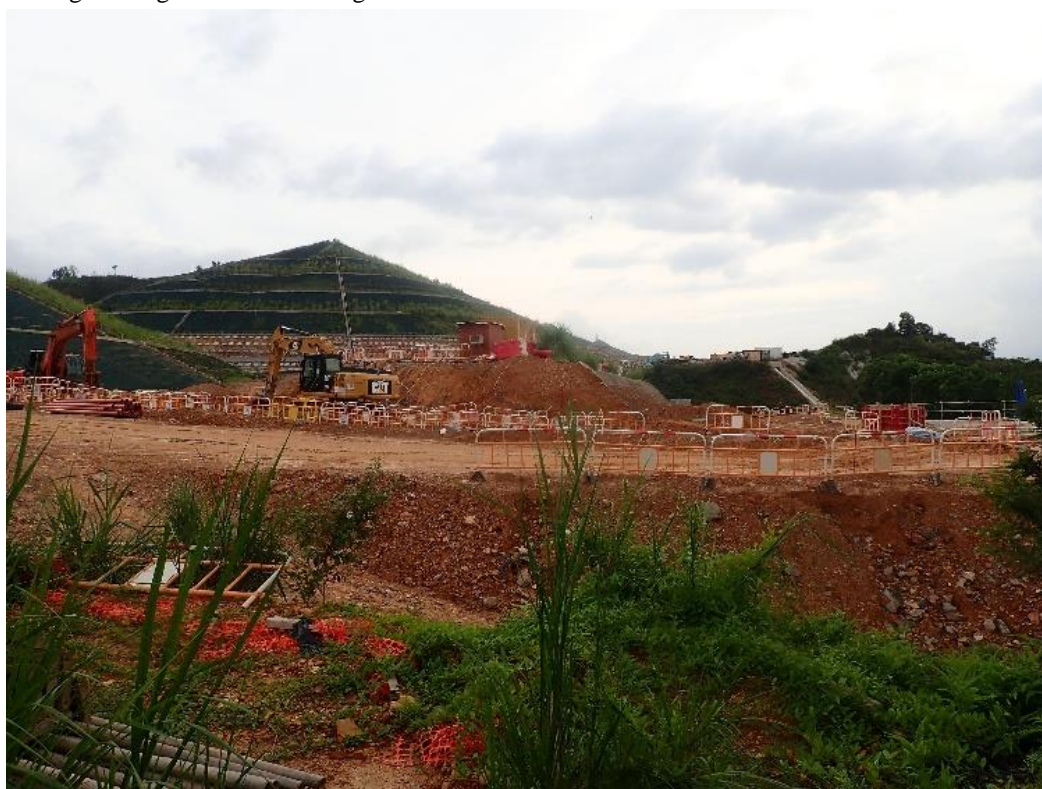
**Picture 2**

The engineering site in monitoring area.
