**JOB No.: TCS00881/18 & TCS00944/18**

**SITE FORMATION AND ASSOCIATED INFRASTRUCTURAL  
WORKS FOR DEVELOPMENT OF COLUMBARIUM,  
CREMATORIUM AND RELATED FACILITIES AT SANDY  
RIDGE CEMETERY**

**MONTHLY ENVIRONMENTAL MONITORING AND AUDIT  
REPORT (NO.38) – SEPTEMBER 2021**

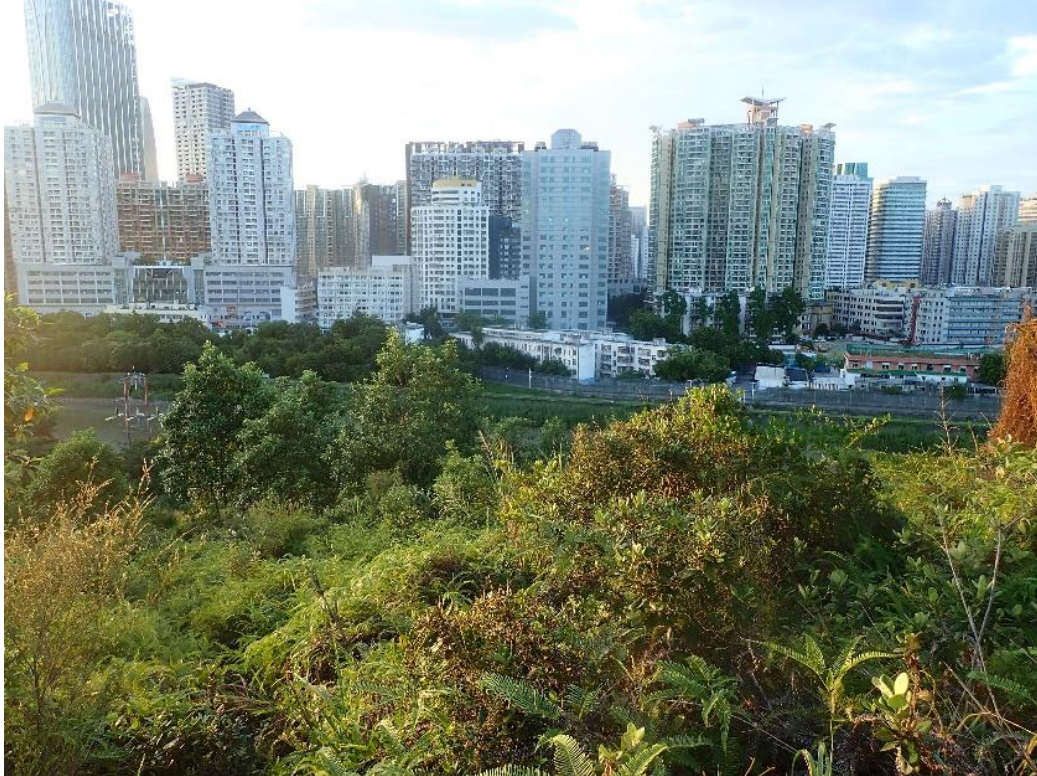
Wet woodland in monitoring area.

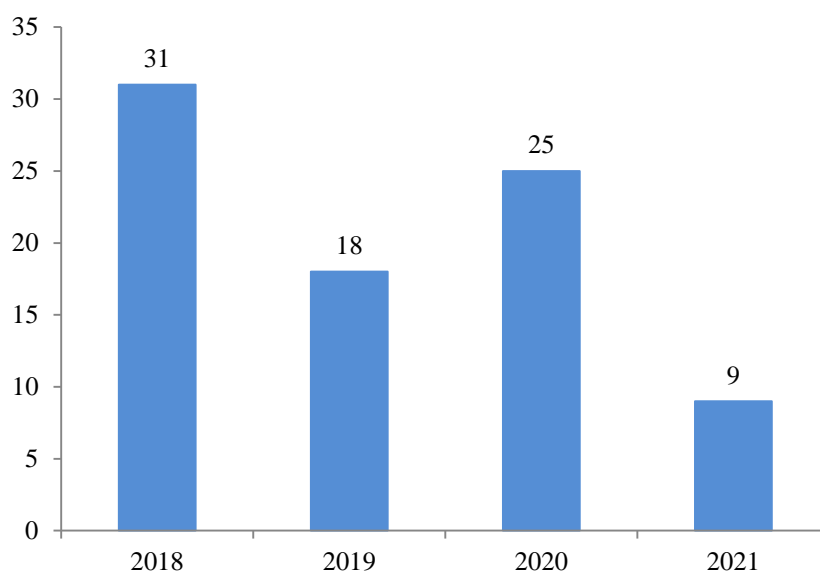
5.1 Total abundance and species richness in September over years were compared to show the trends. Figures 1 and 2 indicate the total species richness and total abundance within the site boundary respectively.

Figure 1: Bar chart showing the total species richness within site boundary from 2018 to 2021 (Actual quantity annotated at the top of each bar)

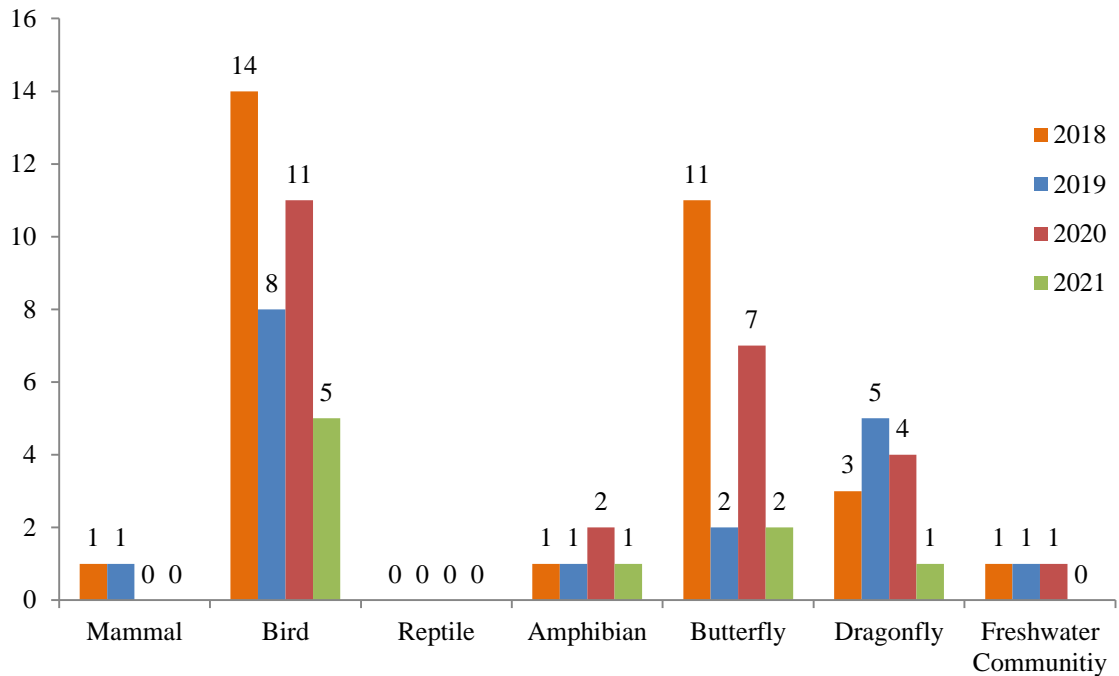
5.2 As results in section 4 were categorized by taxa, a detailed breakdown of each taxon is shown in figure 3 to further investigate the trend of specific taxa over contract period.

Figure 3: Bar chart showing the species richness within site boundary by taxa from 2018 to 2021  
 (Actual quantity annotated at the top of each bar)

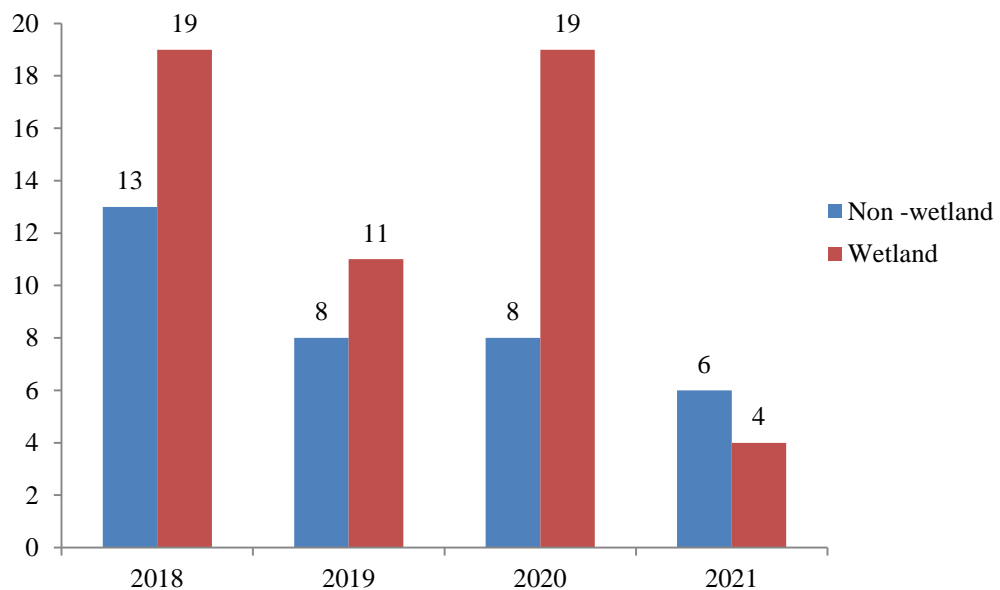
5.3 According to EM&A Manual, monitoring measures was determined by the species diversity of types of sensitive habitats, i.e. non-wetland and wetland habitats. Abundance and species richness by habitat type in September over years were compared in Figures 4 and 5.

Figure 4: bar chart showing the species richness based on habitat type from 2018 to 2021  
 (Actual quantity annotated at the top of each bar)

5.4 After analysing survey results in September from 2018 to 2021, it is found that the both species diversity and abundance decreased in wetland and non-wetland habitats. The reduction could be due to natural fluctuation. Good practice during construction is required to prevent environmental contamination as well as unnecessary site clearance. Continuous monitoring is also recommended to inspect any significant decrease in species diversity.

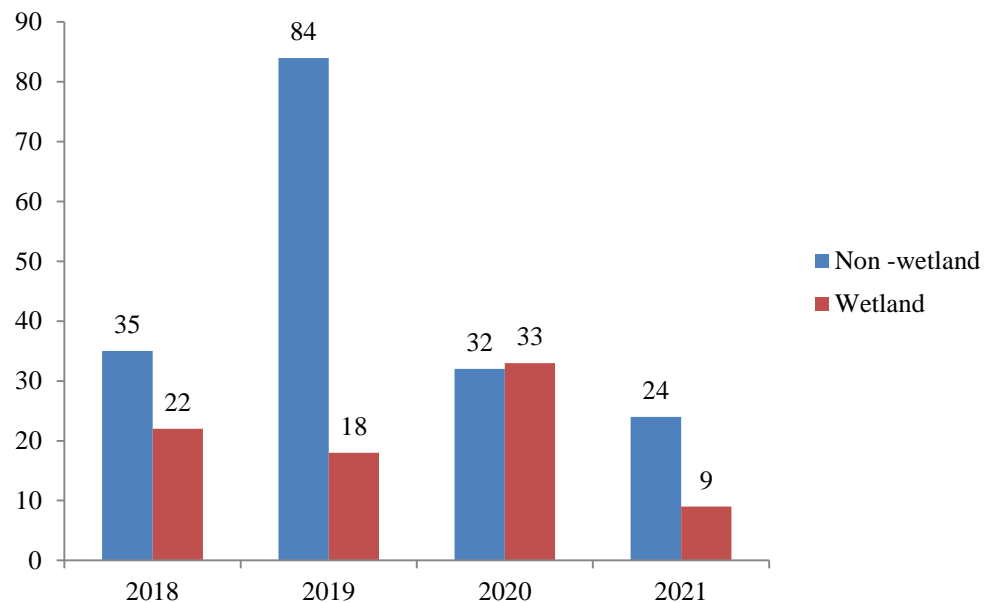
Figure 5: bar chart showing the abundance based on habitat type from 2018 to 2021  
(Actual quantity annotated at the top of each bar)

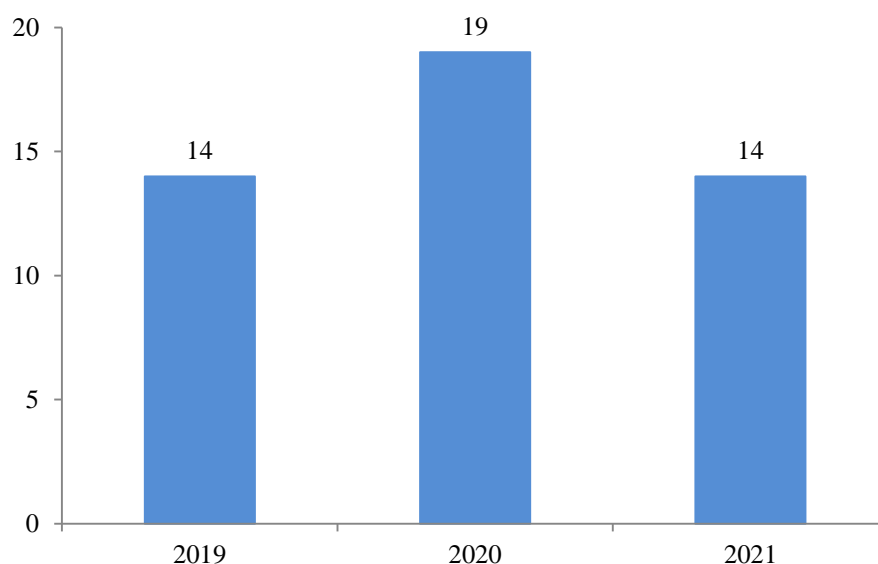
5.1 Total abundance and species richness in September over years were compared to show the trends. Figures 1 and 2 indicate total species richness and total abundance within the site boundary respectively.

Figure 1: Bar chart showing the total species richness within site boundary from 2019 to 2021 (Actual quantity annotated at the top of each bar)

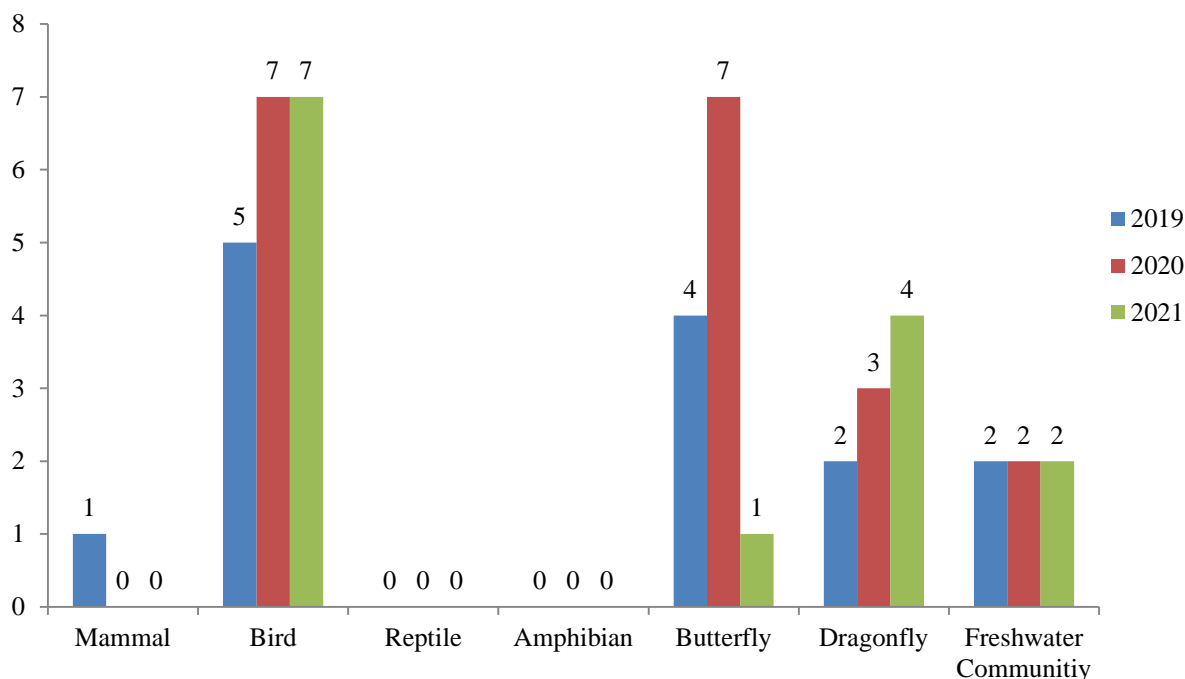
5.2 As results in section 4 were categorized by taxa, a detailed breakdown of each taxon is shown in figure 3 to further investigate the trend of specific taxa over contract period.

Figure 3: Bar chart showing the species richness within site boundary by taxa from 2019 to 2021  
(Actual quantity annotated at the top of each bar)

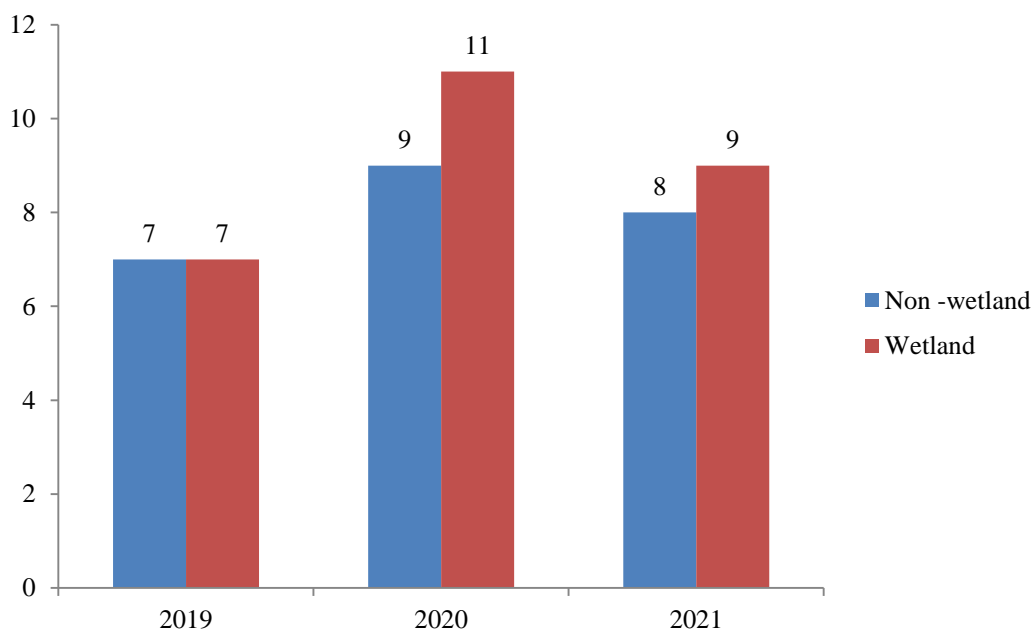
5.3 According to EM&A Manual, monitoring measures was determined by the species diversity of types of sensitive habitats, i.e. non-wetland and wetland habitats. Abundance and species richness by habitat type in September over years were compared in figures 4 and 5.

Figure 4: bar chart showing the species richness based on habitat type from 2019 to 2021  
(Actual quantity annotated at the top of each bar)

5.4 After analysing survey results in September 2019 to 2021, there was no significant drop in species richness and abundance for wetland and non-wetland habitats. A good practice during construction is required to prevent environmental contamination as well as unnecessary site clearance. Moreover, continuous monitoring is required to inspect any significant reduction of species diversity.

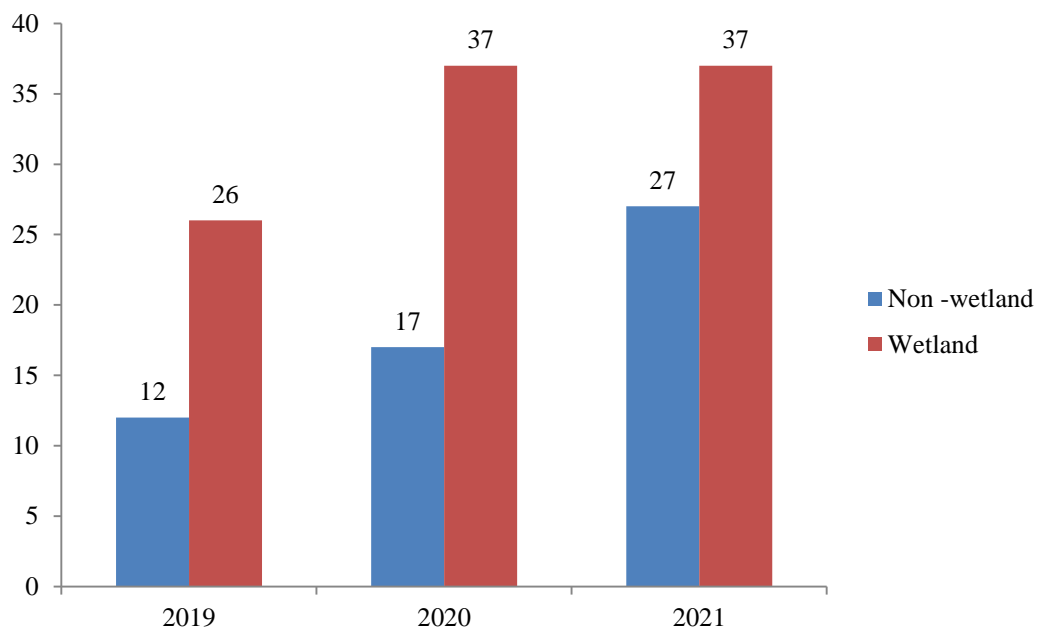
Figure 5: bar chart showing the abundance based on habitat type from 2019 to 2021  
 (Actual quantity annotated at the top of each bar)
