**JOB No.: TCS00881/18 & TCS00944/18**

**SITE FORMATION AND ASSOCIATED INFRASTRUCTURAL  
WORKS FOR DEVELOPMENT OF COLUMBARIUM,  
CREMATORIUM AND RELATED FACILITIES AT SANDY  
RIDGE CEMETERY**

**MONTHLY ENVIRONMENTAL MONITORING AND AUDIT  
REPORT (No.39) – OCTOBER 2021**

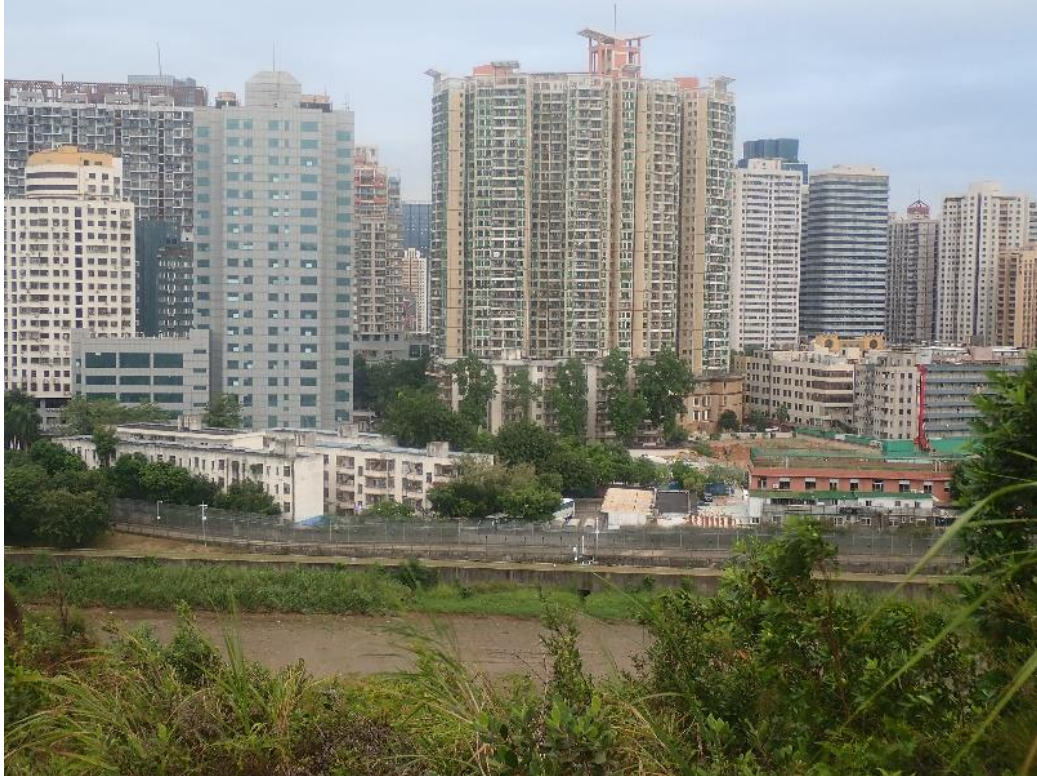
**Picture 1**

Upland grassland in monitoring area.

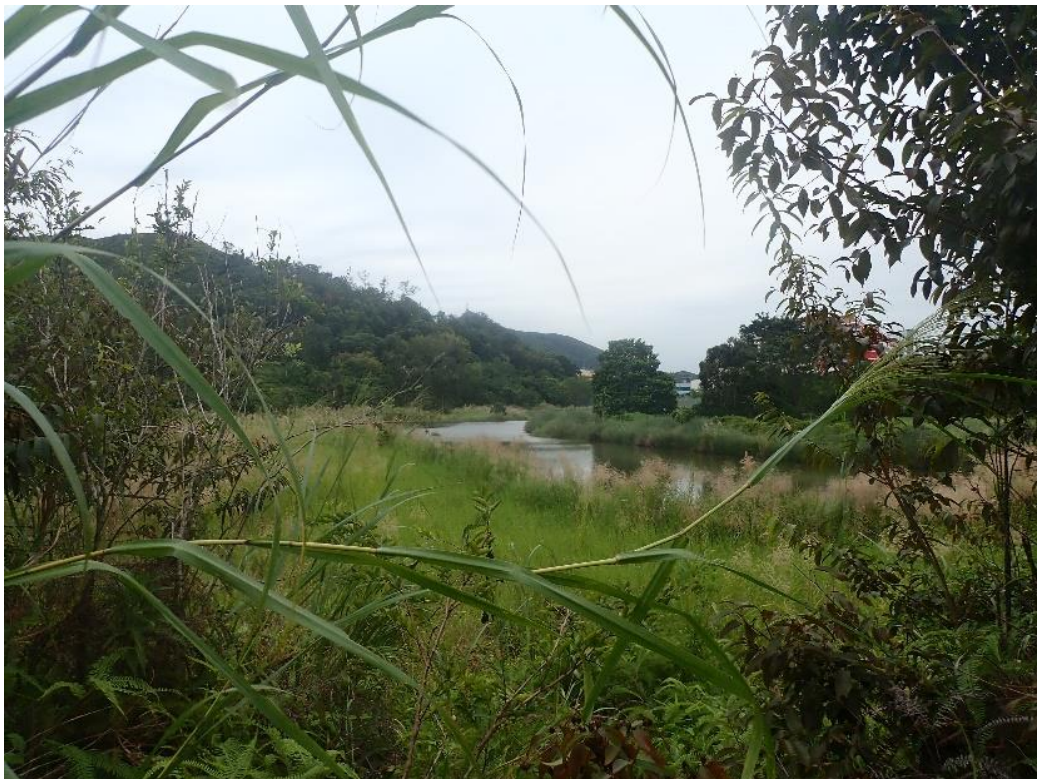
**Picture 2**

Marsh in monitoring area.

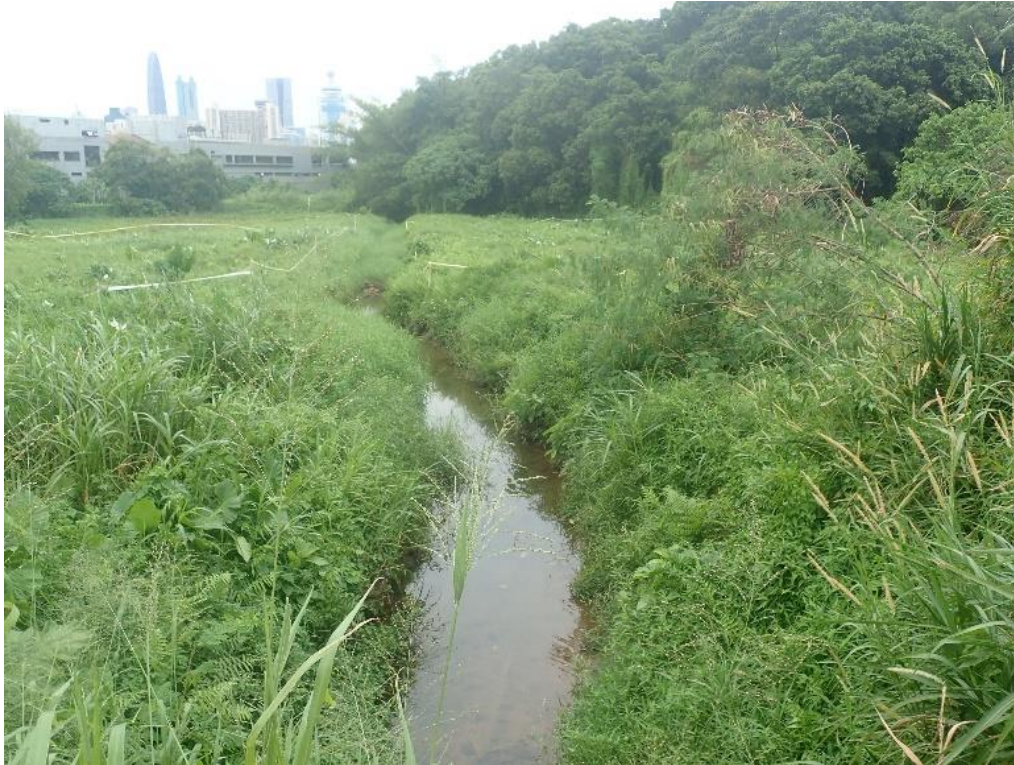
Watercourse in monitoring area. (at daytime)

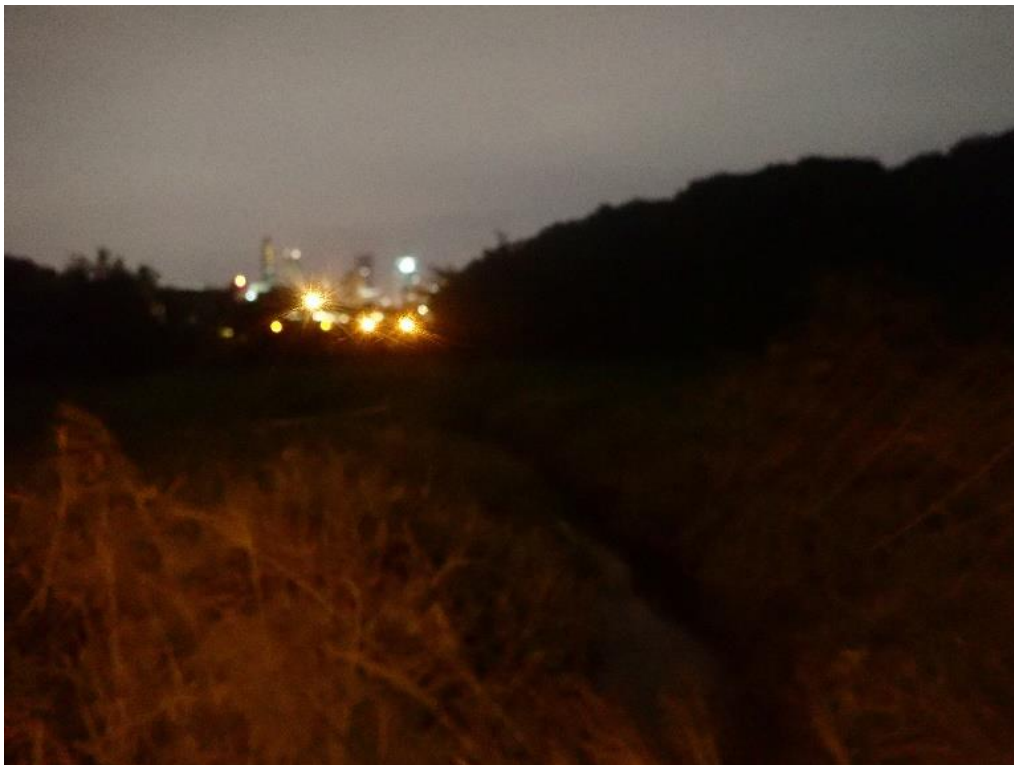
**Picture 2**

Watercourse in monitoring area. (at night)
