**JOB No.: TCS00881/18 & TCS00944/18**

**SITE FORMATION AND ASSOCIATED INFRASTRUCTURAL  
WORKS FOR DEVELOPMENT OF COLUMBARIUM,  
CREMATORIUM AND RELATED FACILITIES AT SANDY  
RIDGE CEMETERY**

**MONTHLY ENVIRONMENTAL MONITORING AND AUDIT  
REPORT (NO.41) – DECEMBER 2021**

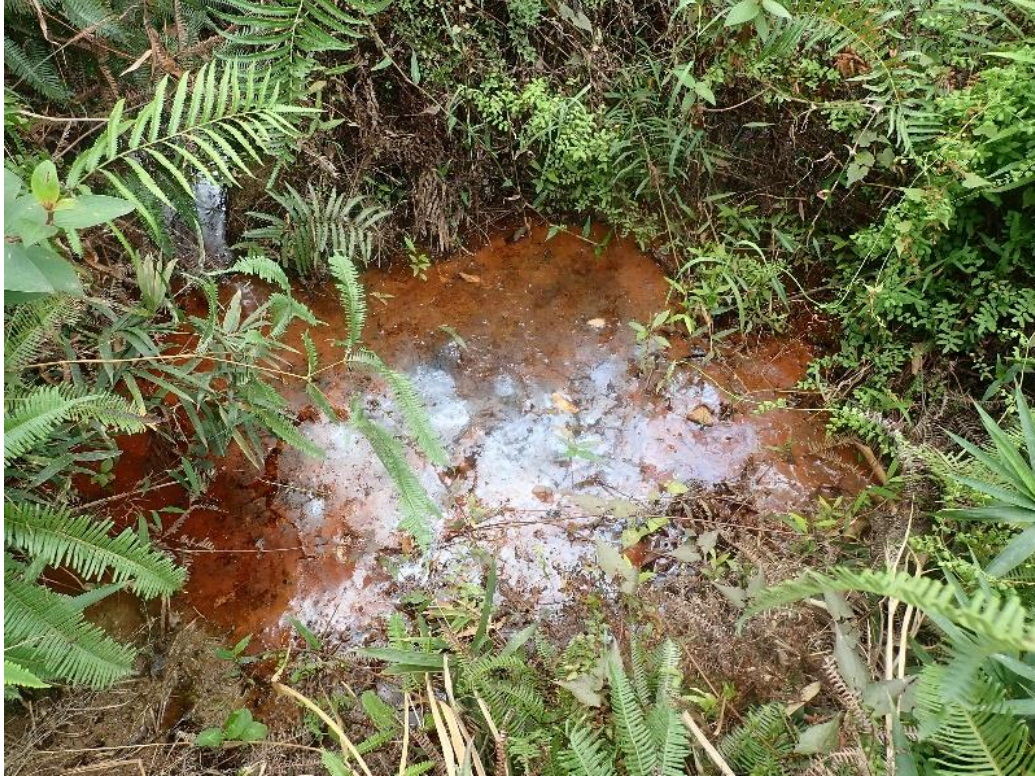
**Picture 1**

Wet woodland in monitoring area.

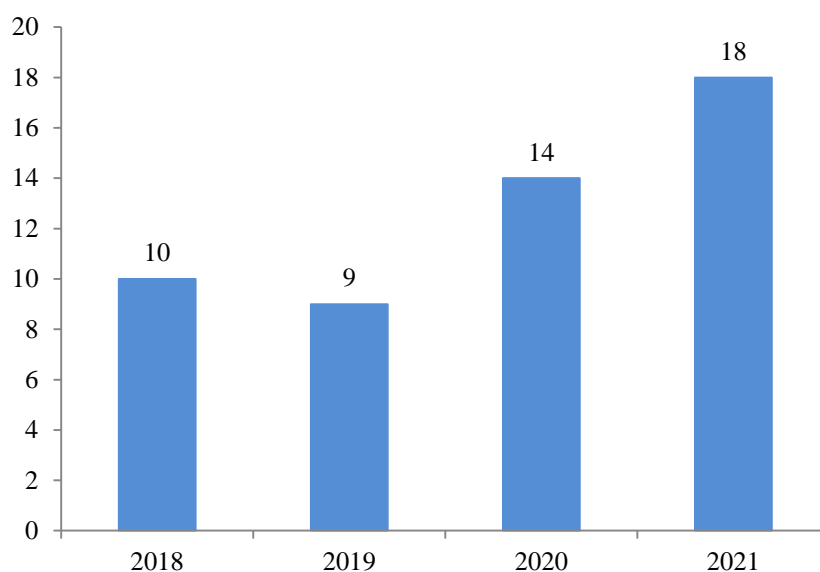
5.1 Total abundance and species richness in December over years were compared to show the trends. Figures 1 and 2 indicate the total species richness and total abundance within the site boundary respectively.

Figure 1: Bar chart showing the total species richness within site boundary from 2018 to 2021 (Actual quantity annotated at the top of each bar)

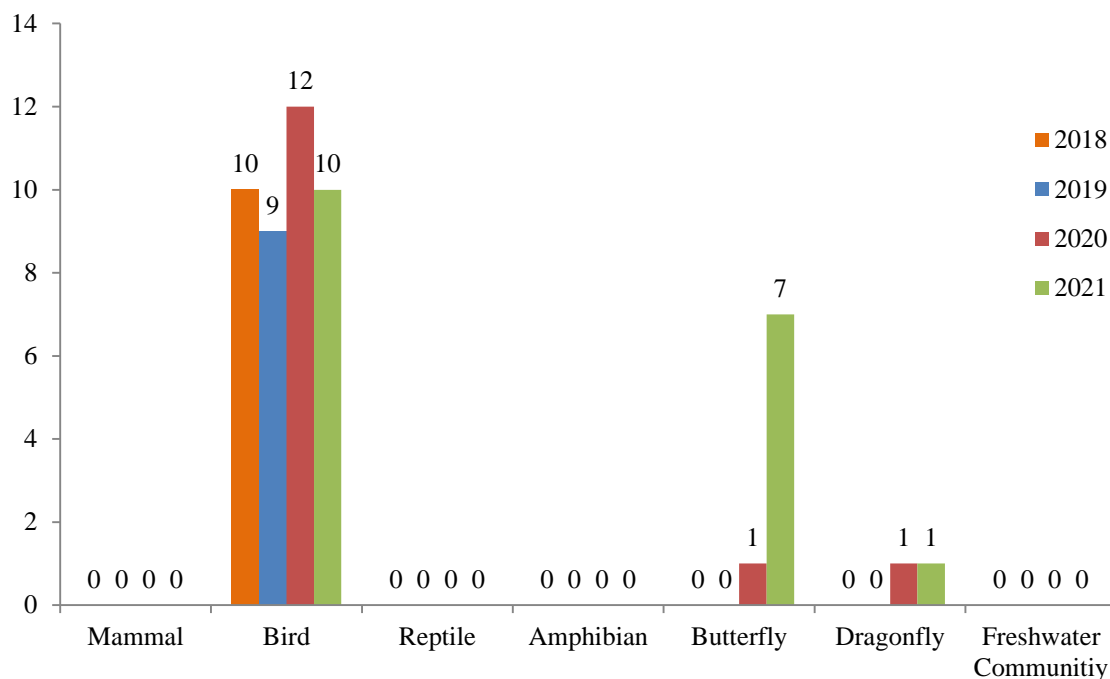
5.2 As results in section 4 were categorized by taxa, a detailed breakdown of each taxon is shown in figure 3 to further investigate the trend of specific taxa over contract period.

Figure 3: Bar chart showing the species richness within site boundary by taxa from 2018 to 2021  
 (Actual quantity annotated at the top of each bar)

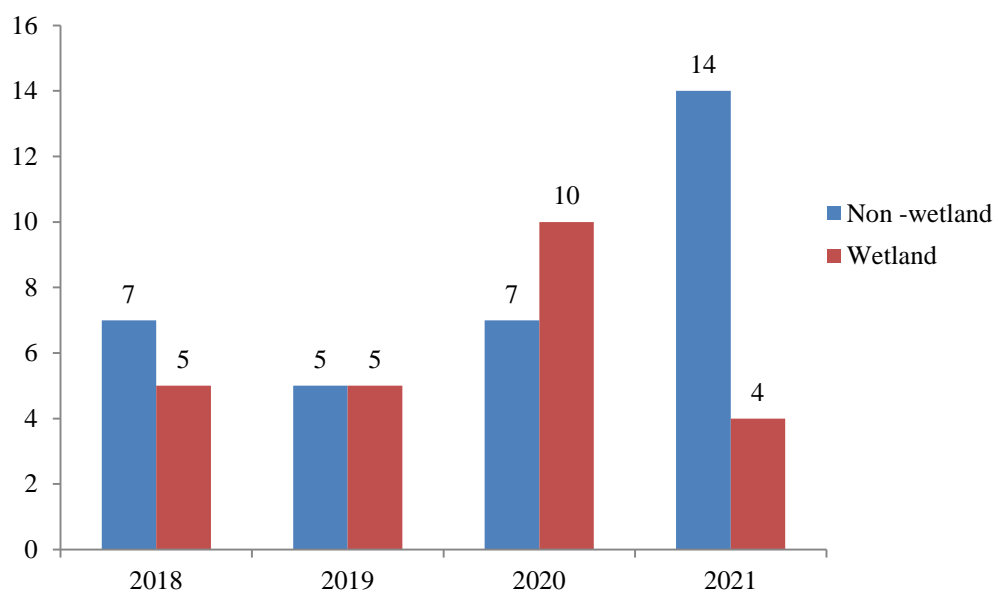
5.3 According to EM&A Manual, monitoring measures was determined by the species diversity of types of sensitive habitats, i.e. non-wetland and wetland habitats. Abundance and species richness by habitat type in December over years were compared in Figures 4 and 5.

Figure 4: bar chart showing the species richness based on habitat type from 2018 to 2021  
 (Actual quantity annotated at the top of each bar)

5.4 After analysing survey results in December from 2018 to 2021, there were a slight decrease in abundance and a drop in species richness for wetland habitat. These reductions could be due to natural fluctuation. Yet, good site practice during construction, with reference to EM&A Manual, is required to prevent or alleviate environmental impacts. For instance, the size of work areas should be minimized and disturbed areas should be reinstated immediately after completion of construction works. Unnecessary site clearance should be avoided as well. In addition, implementing proper waste disposal is necessary to reduce contamination to water and soil. Continuous monitoring is also recommended to inspect any significant decrease in species diversity.

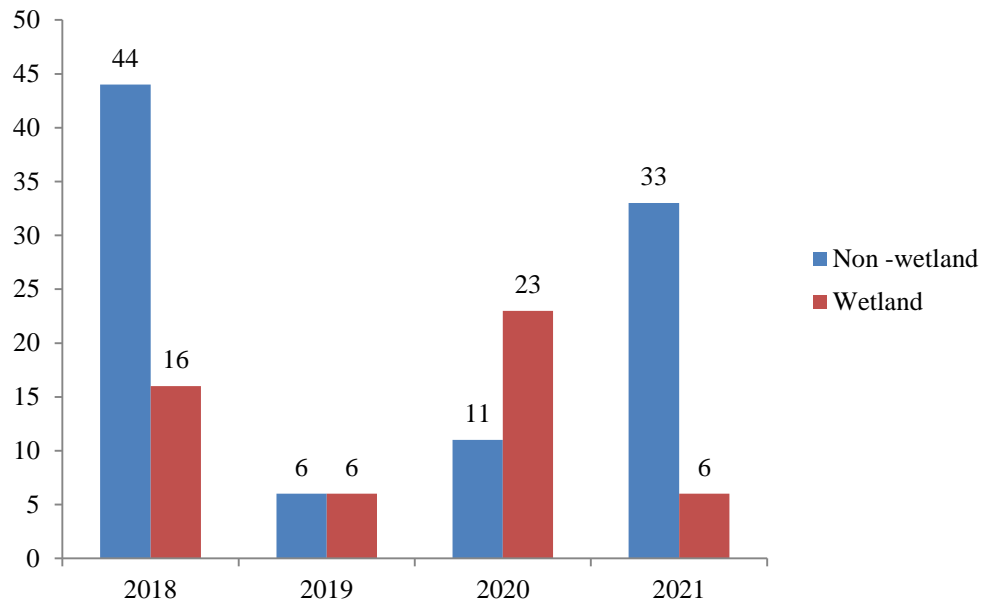
Figure 5: bar chart showing the abundance based on habitat type from 2018 to 2021  
(Actual quantity annotated at the top of each bar)

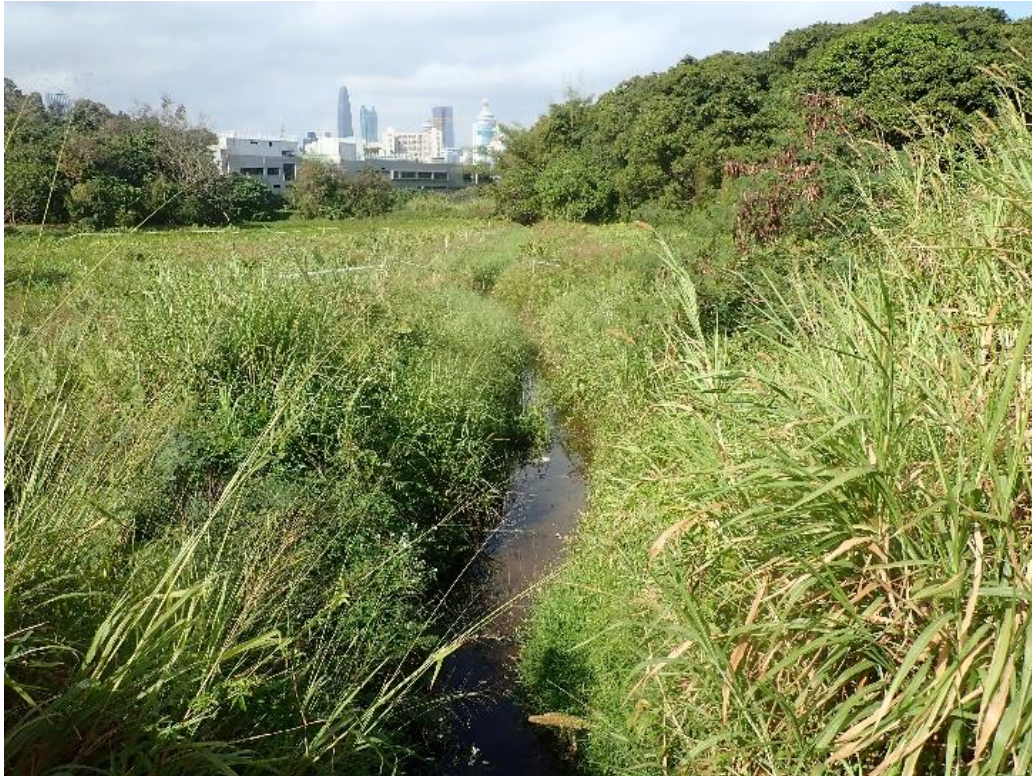
Watercourse in monitoring area.

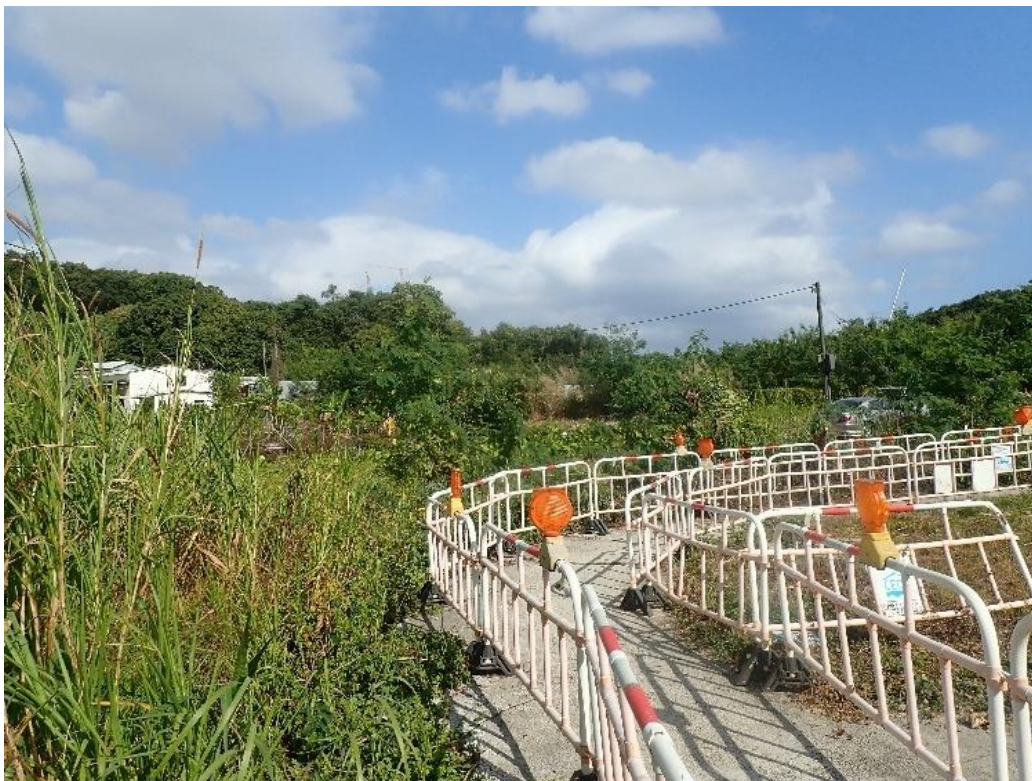
**Picture 2**

The engineering site in monitoring area.

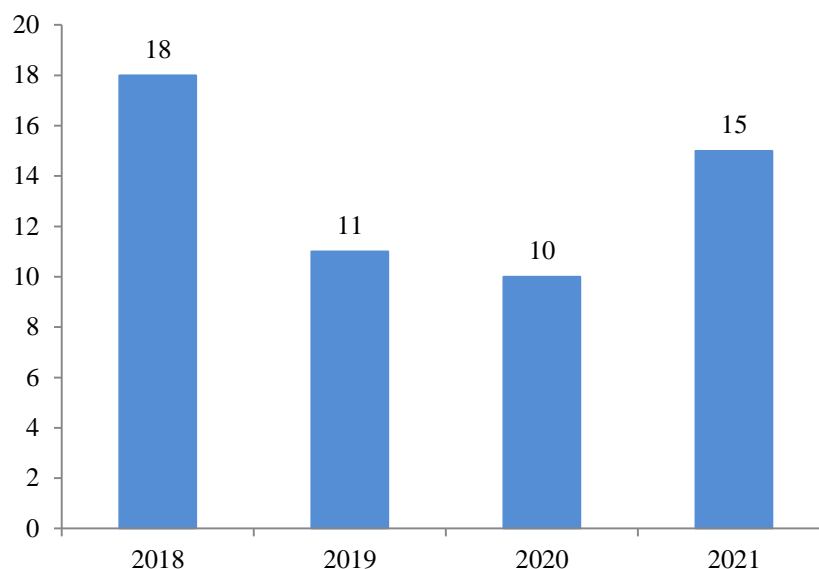
5.1 Total abundance and species richness in December over years were compared to show the trends. Figures 1 and 2 indicate total species richness and total abundance within the site boundary respectively.

Figure 1: Bar chart showing the total species richness within site boundary from 2018 to 2021 (Actual quantity annotated at the top of each bar)

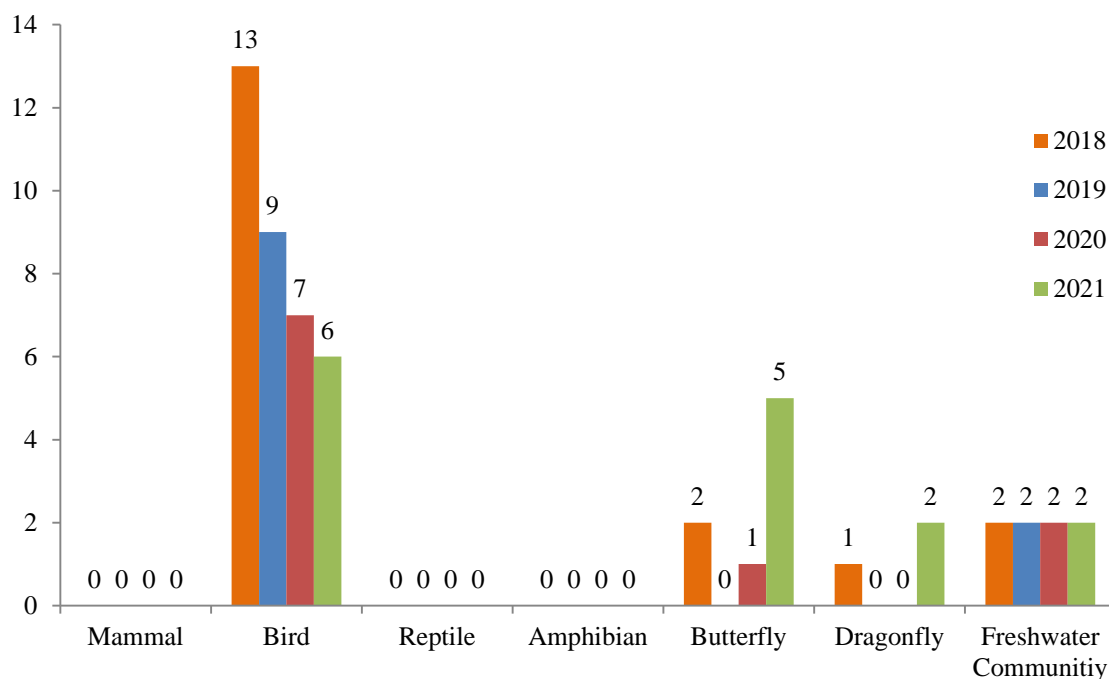
5.2 As results in section 4 were categorized by taxa, a detailed breakdown of each taxon is shown in figure 3 to further investigate the trend of specific taxa over contract period.

Figure 3: Bar chart showing the species richness within site boundary by taxa from 2018 to 2021  
 (Actual quantity annotated at the top of each bar)

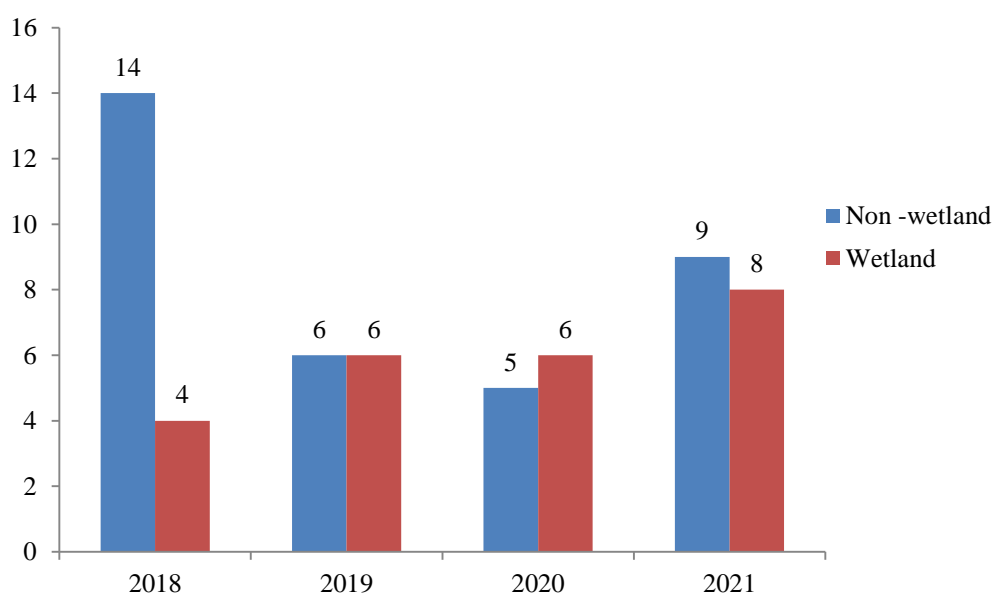
5.3 According to EM&A Manual, monitoring measures was determined by the species diversity of types of sensitive habitats, i.e. non-wetland and wetland habitats. Abundance and species richness by habitat type in December over years were compared in figures 4 and 5.

Figure 4: bar chart showing the species richness based on habitat type from 2018 to 2021  
 (Actual quantity annotated at the top of each bar)

5.4 After analysing survey results in December from 2018 to 2021, there was no significant drop in species richness and abundance for wetland and non-wetland habitats. Still, a good site practice during construction, with reference to EM&A Manual, is required to prevent or alleviate environmental impacts. For instance, the size of work areas should be minimized and disturbed areas should be reinstated immediately after completion of construction works. Unnecessary site clearance should be avoided as well. In addition, implementing proper waste disposal is necessary to reduce contamination to water and soil. Continuous monitoring is also recommended to inspect any significant decrease in species diversity.

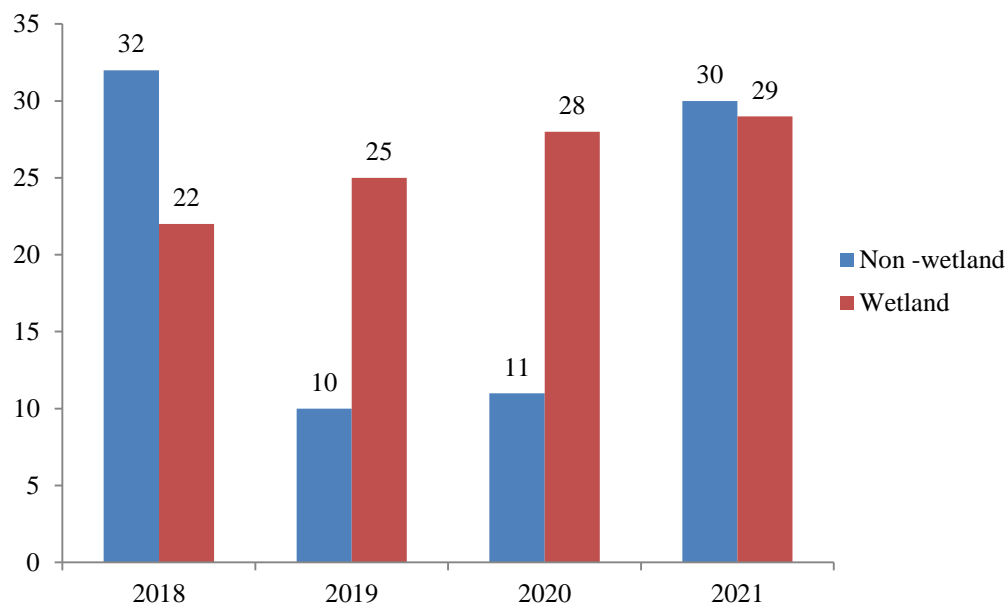
Figure 5: bar chart showing the abundance based on habitat type from 2018 to 2021  
 (Actual quantity annotated at the top of each bar)
