**SITE FORMATION AND ASSOCIATED INFRASTRUCTURAL
WORKS FOR DEVELOPMENT OF COLUMBARIUM,
CREMATORIUM AND RELATED FACILITIES AT SANDY
RIDGE CEMETERY**

**MONTHLY ENVIRONMENTAL MONITORING AND AUDIT
REPORT (NO.42) – JANUARY 2022**

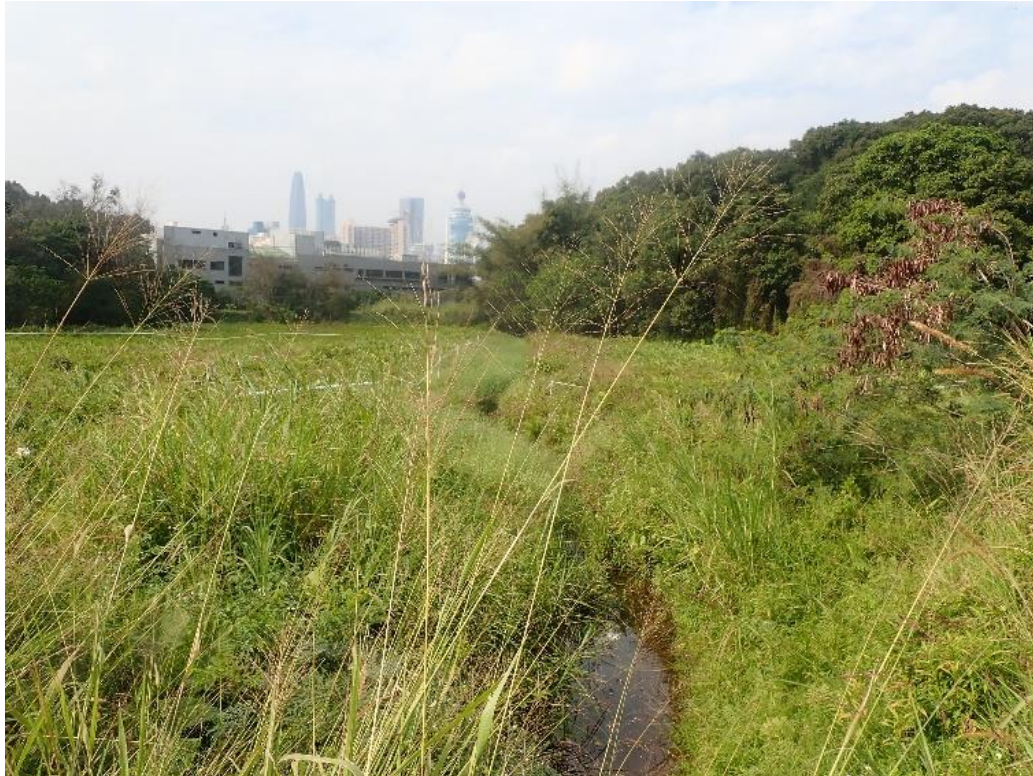
Watercourse in monitoring area.

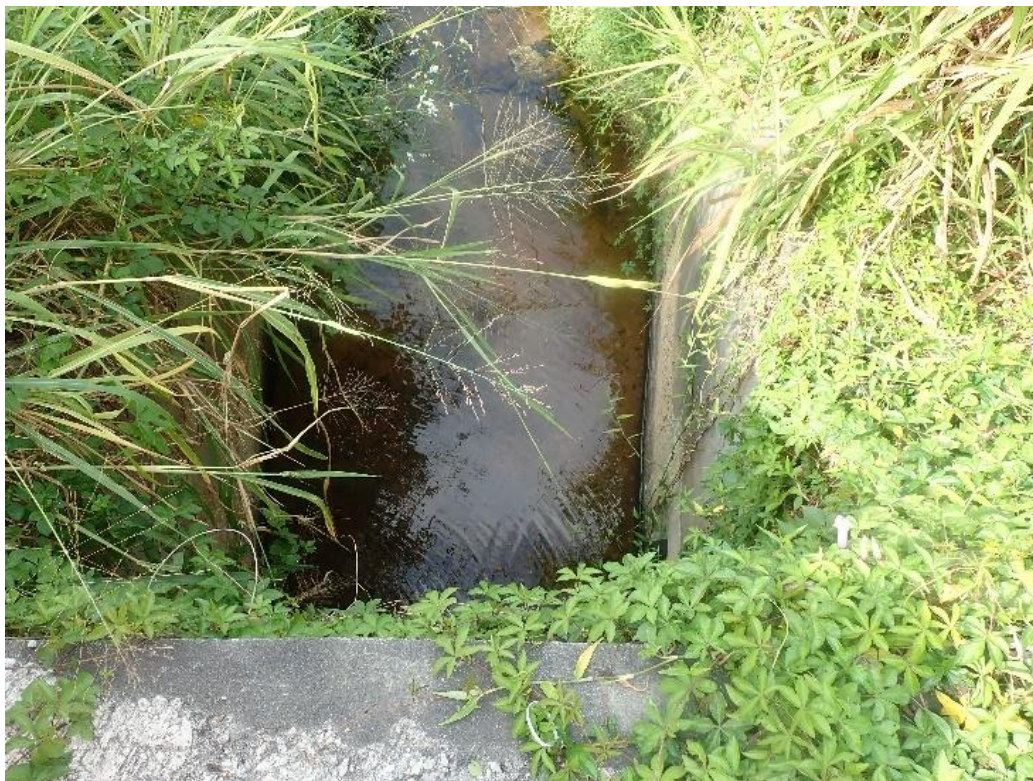
Picture 2

Watercourse in monitoring area.
