**SITE FORMATION AND ASSOCIATED INFRASTRUCTURAL
WORKS FOR DEVELOPMENT OF COLUMBARIUM,
CREMATORIUM AND RELATED FACILITIES AT SANDY
RIDGE CEMETERY**

**MONTHLY ENVIRONMENTAL MONITORING AND AUDIT
REPORT (NO.46) – MAY 2022**

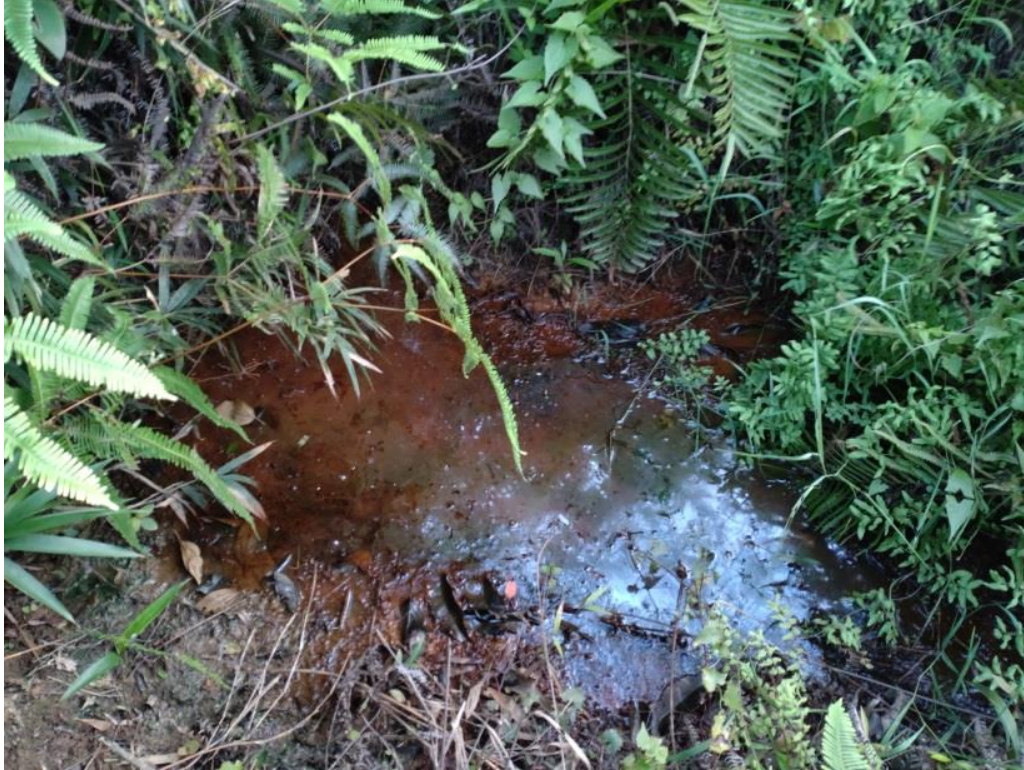
Picture 1

Wet woodland in monitoring area.

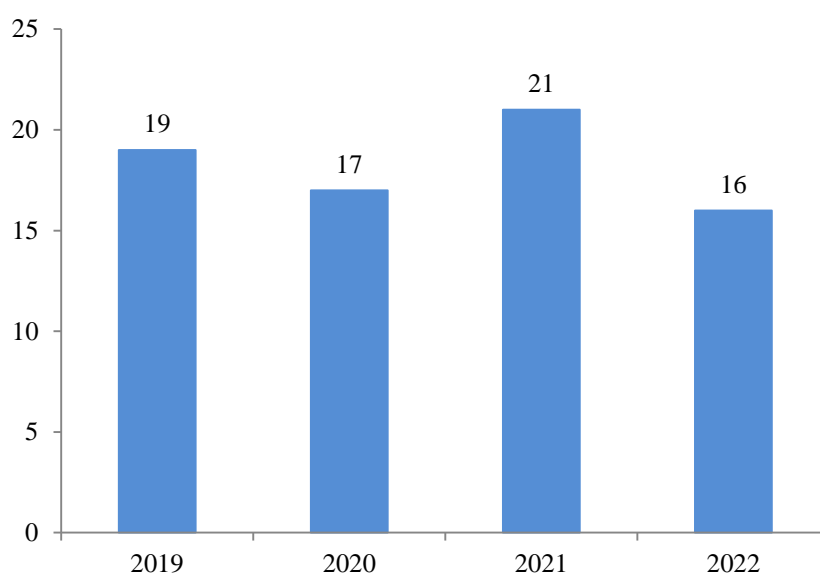
Figure 1: Bar chart showing the total species richness within site boundary from 2019 to 2022 (Actual quantity annotated at the top of each bar)

5.1 Total abundance and species richness in May over years were compared to show the trends. Figures 1 and 2 indicate the total species richness and total abundance within the site boundary respectively.

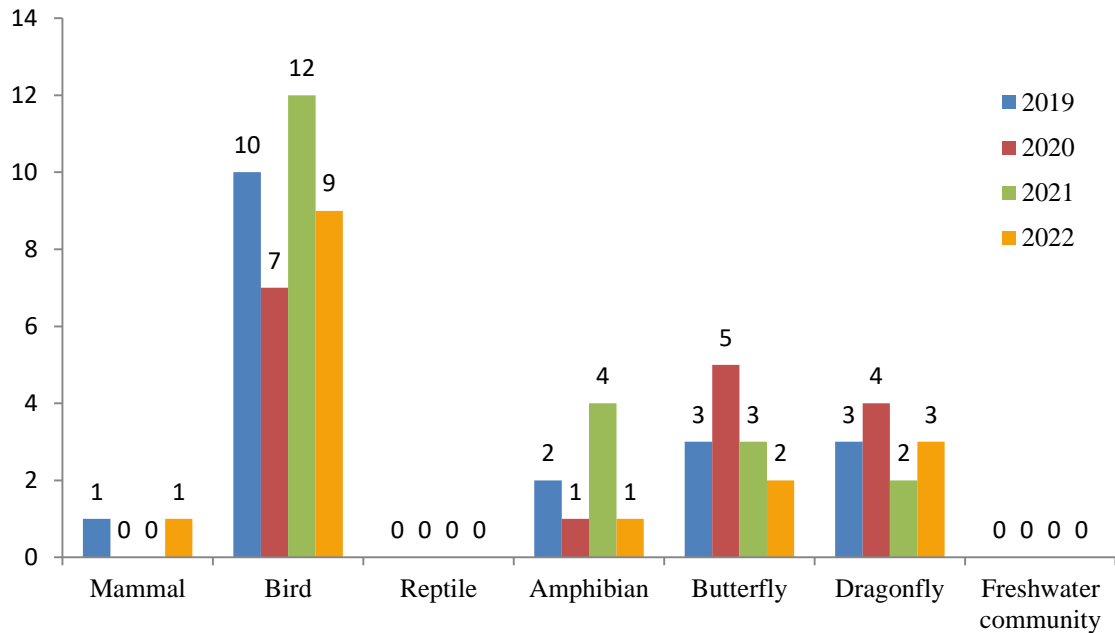
Figure 3: Bar chart showing the species richness within site boundary by taxa from 2019 to 2022
 (Actual quantity annotated at the top of each bar)

5.2 As results in section 4 were categorized by taxa, a detailed breakdown of each taxon is shown in figure 3 to further investigate the trend of specific taxa over contract period.

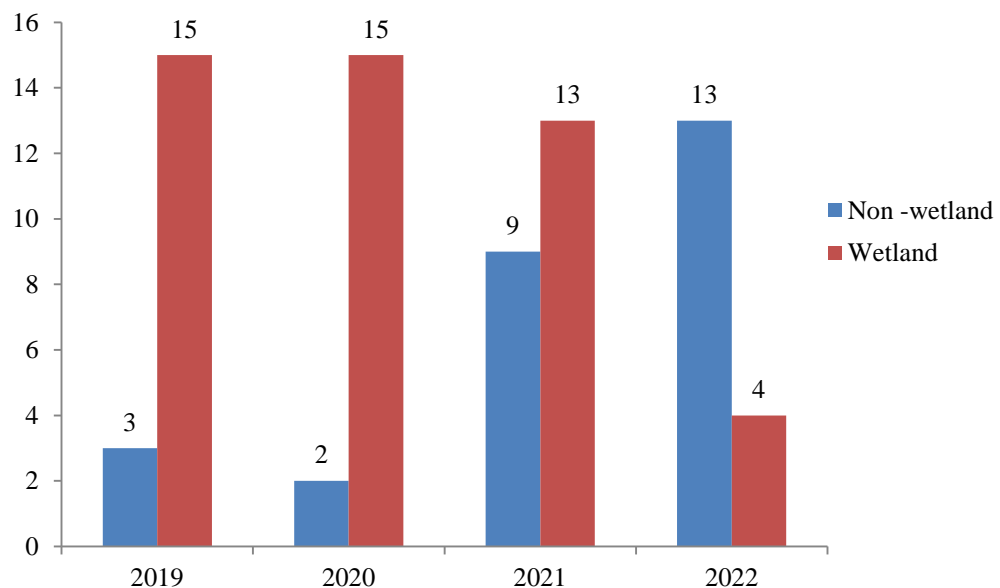
Figure 4: bar chart showing the species richness based on habitat type from 2019 to 2022
 (Actual quantity annotated at the top of each bar)

5.4 After analysing survey results in May from 2019 to 2022, there was a decrease in species richness and abundance for wetland habitat. The reduction could be due to natural fluctuation. Yet, good site practice during construction, with reference to EM&A Manual, is required to prevent or alleviate environmental impacts. For instance, the size of work areas should be minimized and disturbed areas should be reinstated immediately after completion of construction works. Unnecessary site clearance should be avoided as well. In addition, implementing proper waste disposal is necessary to reduce contamination to water and soil. Continuous monitoring is also recommended to inspect any significant decrease in species diversity.

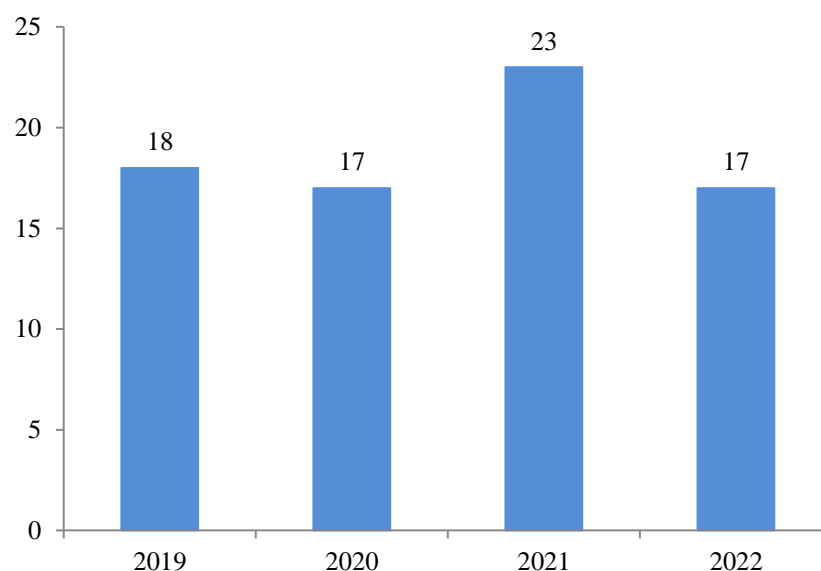
Figure 1: Bar chart showing the total species richness within site boundary from 2019 to 2022 (Actual quantity annotated at the top of each bar)

5.1 Total abundance and species richness in May over years were compared to show the trends. Figures 1 and 2 indicate total species richness and total abundance within the site boundary respectively.

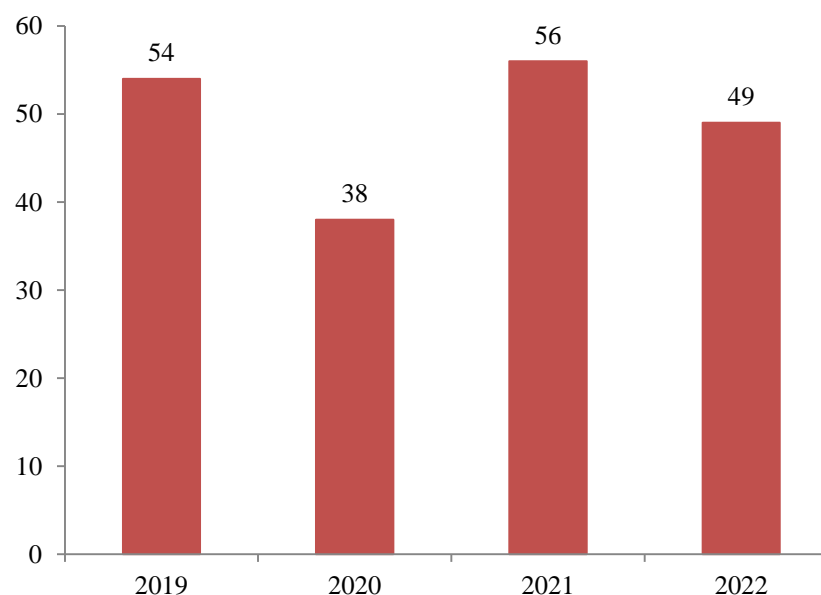
Figure 2: Bar chart showing the total abundance within site boundary from 2019 to 2022 (Actual quantity annotated at the top of each bar)

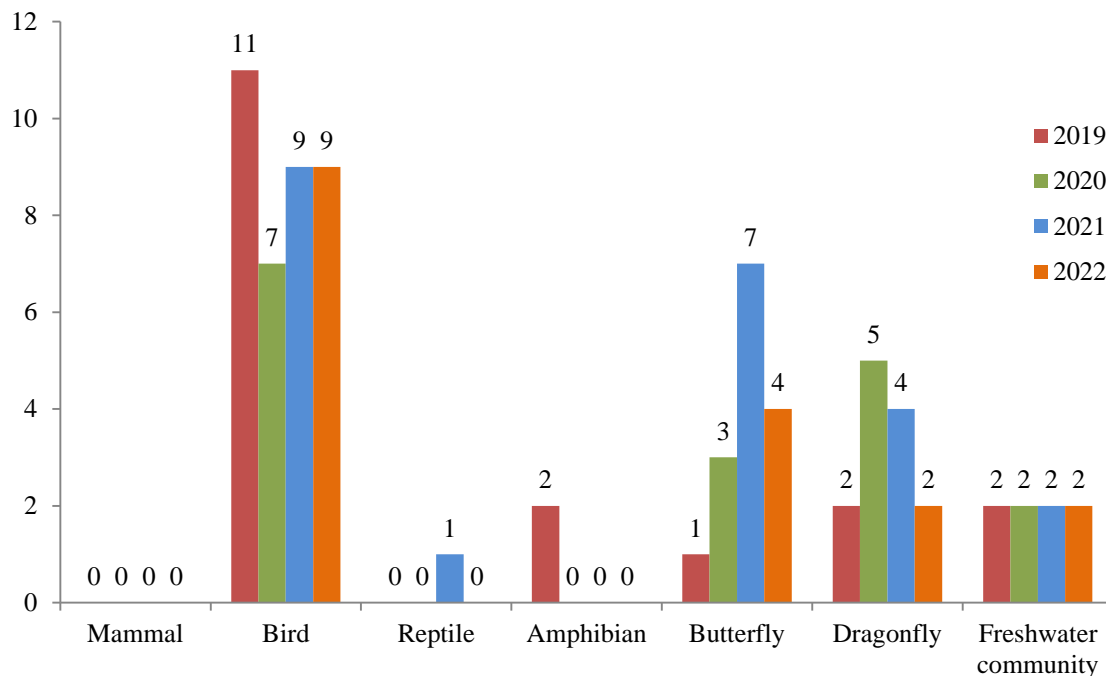
Figure 3: Bar chart showing the species richness within site boundary by taxa from 2019 to 2022
 (Actual quantity annotated at the top of each bar)

5.2 As results in section 4 were categorized by taxa, a detailed breakdown of each taxon is shown in figure 3 to further investigate the trend of specific taxa over contract period.

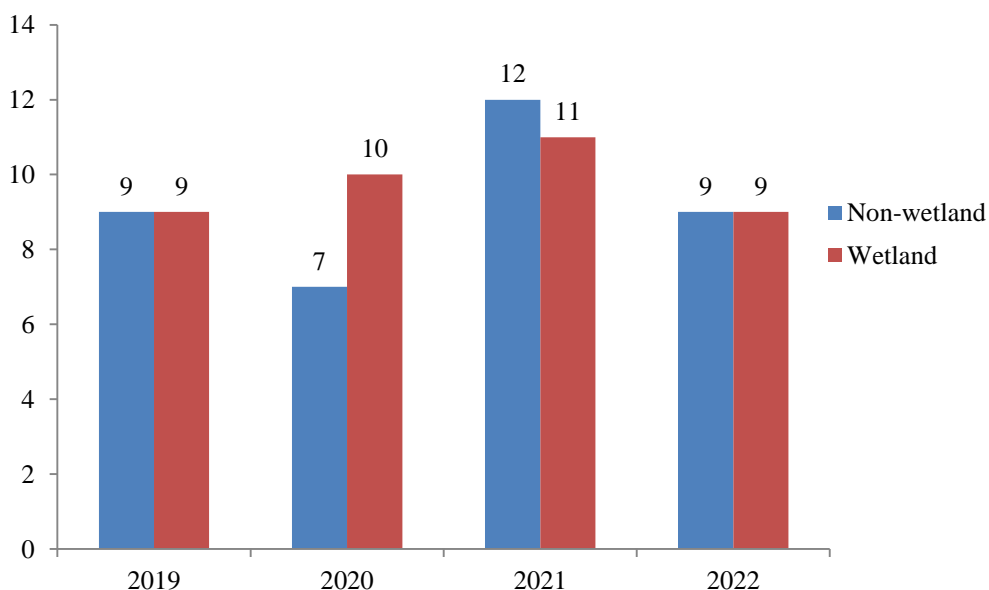
Figure 4: bar chart showing the species richness based on habitat type from 2019 to 2022
 (Actual quantity annotated at the top of each bar)

5.4 After analysing survey results in May from 2019 to 2022, there was no significant drop in species richness and abundance for wetland and non-wetland habitats. Still, a good site practice during construction, with reference to EM&A Manual, is required to prevent or alleviate environmental impacts. For instance, the size of work areas should be minimized and disturbed areas should be reinstated immediately after completion of construction works. Unnecessary site clearance should be avoided as well. In addition, implementing proper waste disposal is necessary to reduce contamination to water and soil. Continuous monitoring is also recommended to inspect any significant decrease in species diversity.

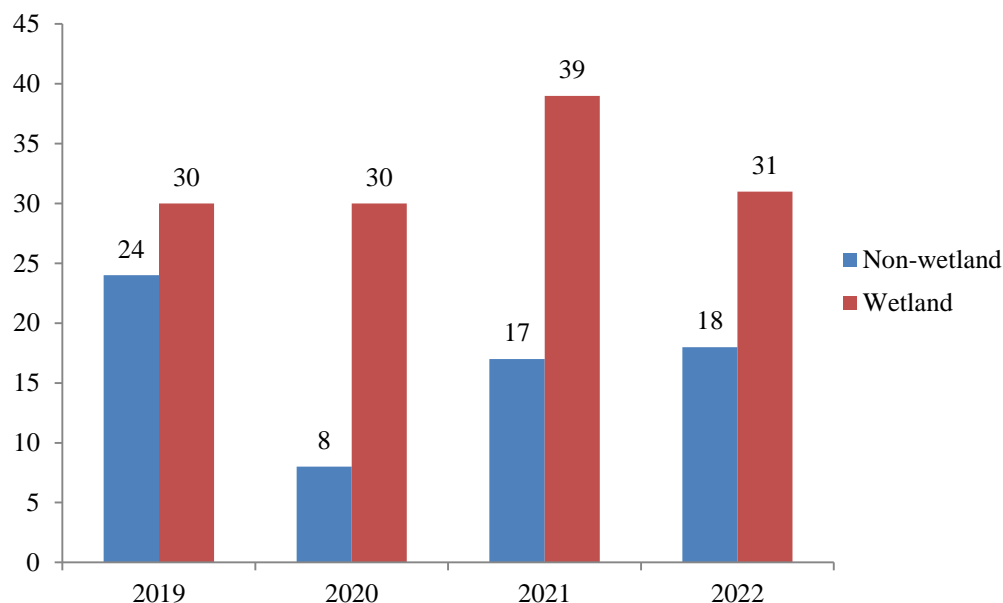
Figure 5: bar chart showing the abundance based on habitat type from 2019 to 2022
(Actual quantity annotated at the top of each bar)
