**JOB No.: TCS00881/18 & TCS00944/18**

**SITE FORMATION AND ASSOCIATED INFRASTRUCTURAL  
WORKS FOR DEVELOPMENT OF COLUMBARIUM,  
CREMATORIUM AND RELATED FACILITIES AT SANDY  
RIDGE CEMETERY**

**MONTHLY ENVIRONMENTAL MONITORING AND AUDIT  
REPORT (NO.49) – AUGUST 2022**

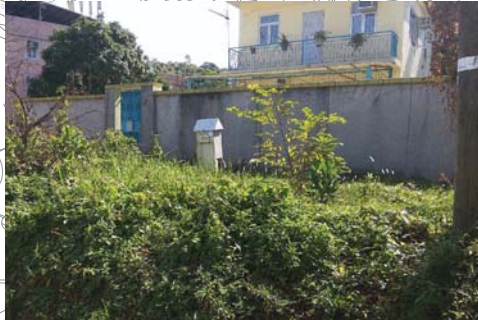
HVS shifted to outside premises of San Uk Ling Village House No.1 for impact air quality monitoring

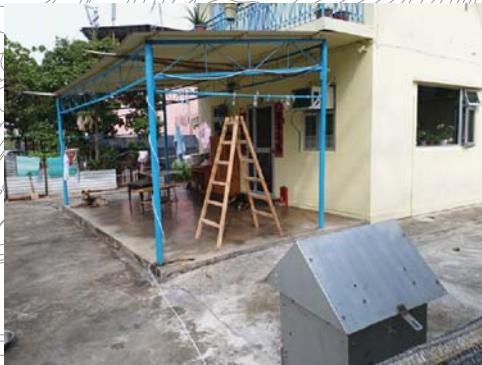
HVS placed inside premises of San Uk Ling Village House No.1 during baseline air quality monitoring

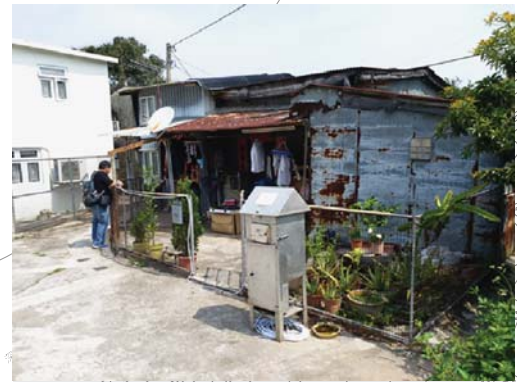
Location ASR-3 at Muk Wu Nga Yiu House No. 28 during baseline monitoring

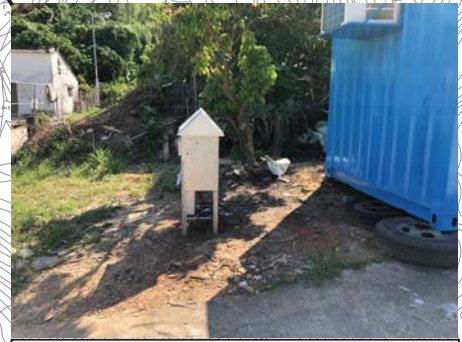
Proposed Location ASR-3a at Muk Wu Nga Yiu House No. 2A for impact monitoring

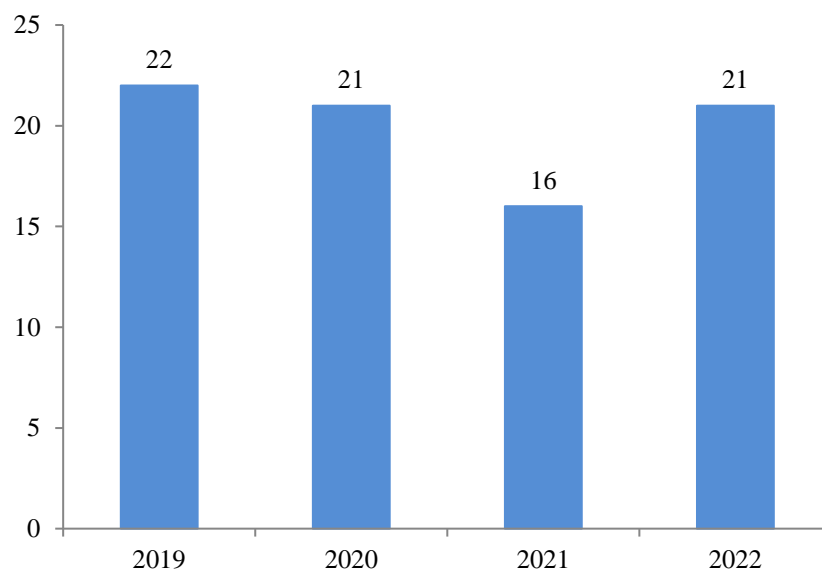
Figure 1: Bar chart showing the total species richness within site boundary from 2019 to 2022 (Actual quantity annotated at the top of each bar)

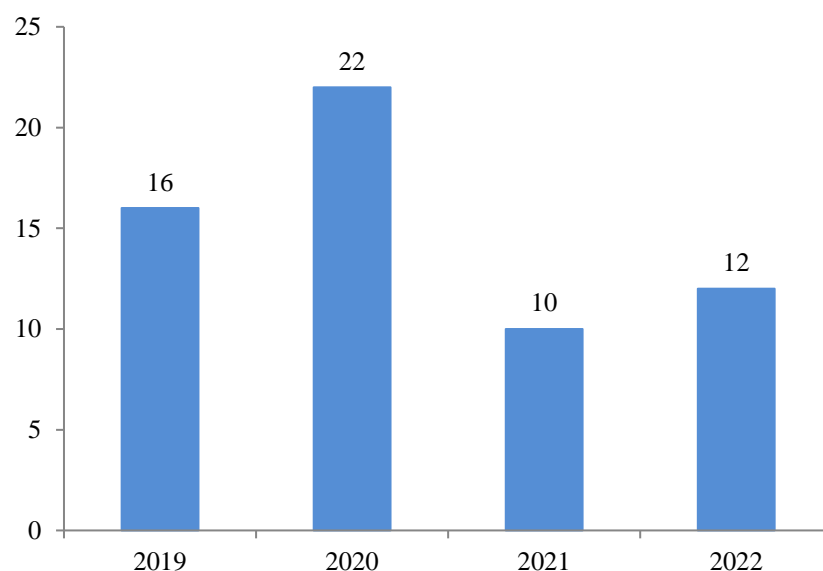
5.1 Total abundance and species richness in August over years were compared to show the trends. Figures 1 and 2 indicate total species richness and total abundance within the site boundary respectively.

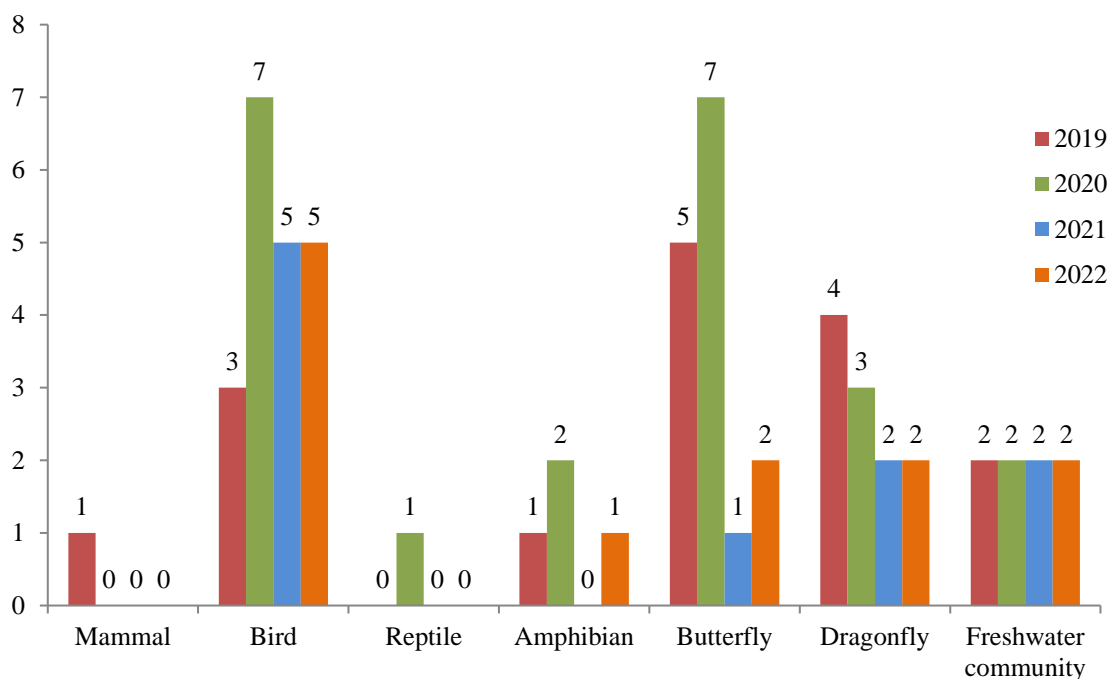
5.2 As results in section 4 were categorized by taxa, a detailed breakdown of each taxon is shown in figure 3 to further investigate the trend of specific taxa over contract period.

Figure 3: Bar chart showing the species richness within site boundary by taxa from 2019 to 2022  
(Actual quantity annotated at the top of each bar)

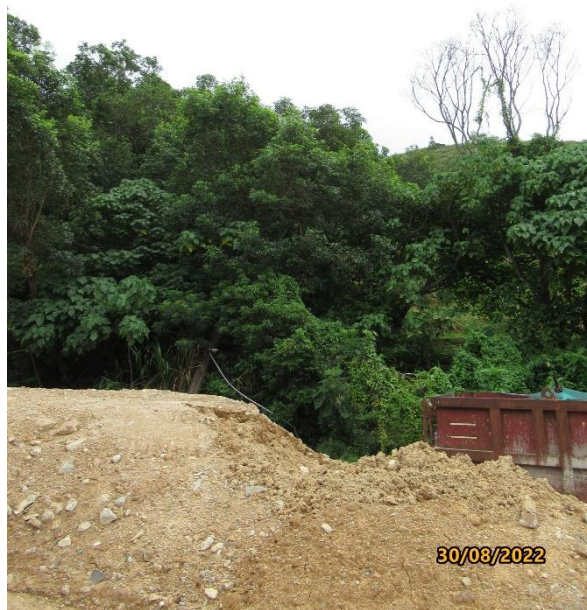
**Fig F.**

Transplanted tree (T-2468) - Removed

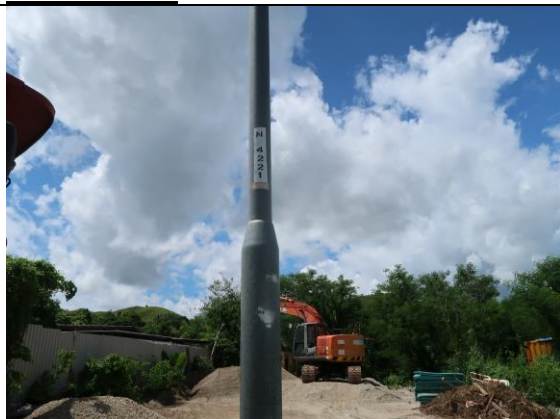
**Photo 1**

Photo of complaint location as provided by EPD. The suspected site near lamppost N4221 is the Aggregate Stockpile Area belongs to Sang Hing.

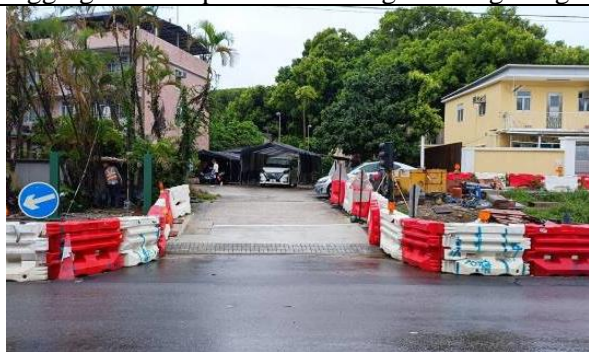
**Photo 3**

Road widening, drainage construction and noise barrier were conducted at TTA3 on Lin Ma Hang Road. No noticeable dust impact and muddy water discharge was observed during site inspection on 12 August 2022.

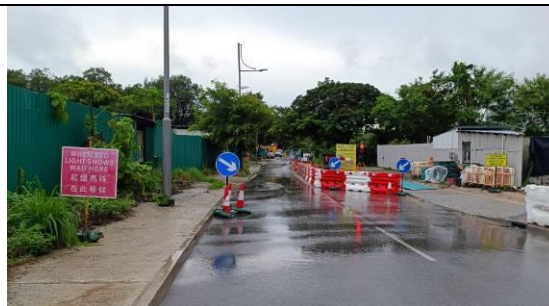
**Photo 4**

Road widening, drainage construction and noise barrier were conducted at TTA3 on Lin Ma Hang Road. No noticeable dust impact and muddy water discharge was observed during inspection on 12 August 2022.

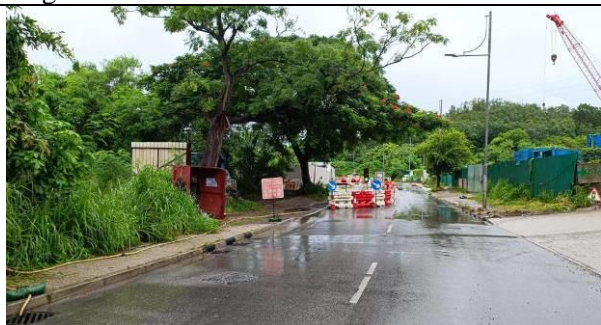
**Photo 5**

Footpath construction was conducted at TTA2 on Lin Ma Hang Road. No noticeable dust impact and muddy water discharge was observed during inspection on 12 August 2022.

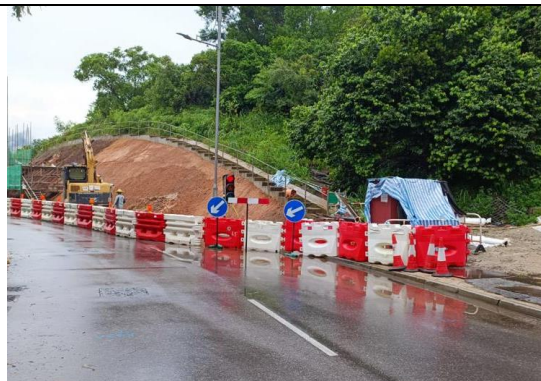
**Photo 6**

Footpath construction was conducted at TTA2 on Lin Ma Hang Road. No noticeable dust impact and muddy water discharge was observed during inspection on 12 August 2022.

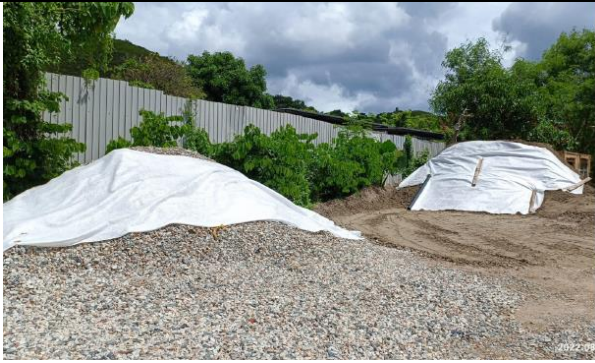
**Photo 7**

Soil nail work was conducted at TTA1 on Lin Ma Hang Road. The finished slope was fully compacted. No noticeable dust impact and muddy water discharge was observed during inspection on 12 August 2022.

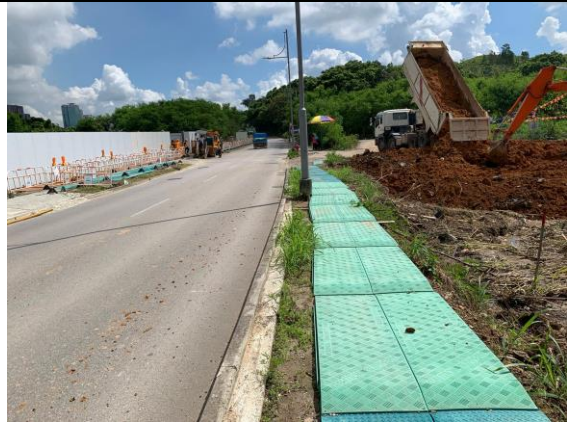
**Photo 8**

There was no construction activities carried out within the ASA. The unused aggregate have been covered by impervious sheet to prevent muddy water discharge.

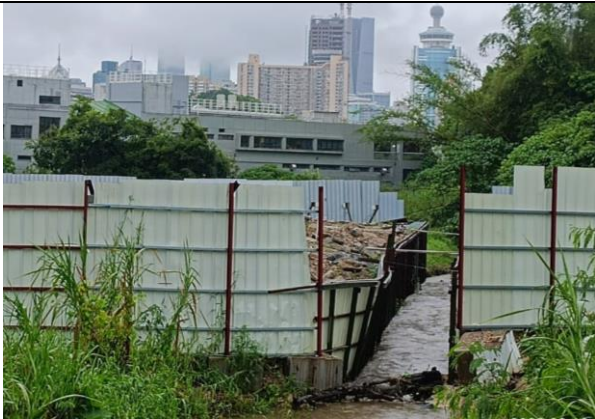
**Photo 9**

As advised by Sang Hing, there were several private owner depots located on Lin Ma Hang Road, and carrying of mud from the private owner depots were observed occasionally.

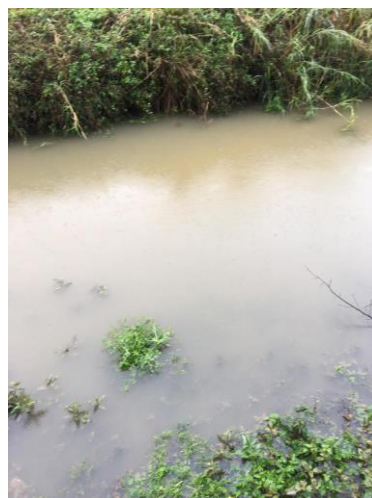
**Photo 2**

During the water quality monitoring on 5 August 2022, the water flowing at M1 was slightly turbid.

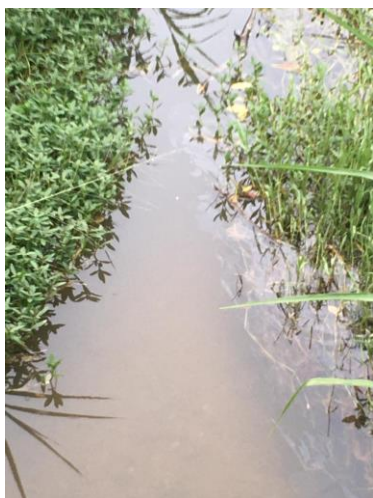
**Photo 3**

During the water quality monitoring on 5 August 2022, muddy water was observed at M2. M2 was receiving water from seasonal channel and M1, no works were carried out near location M2.

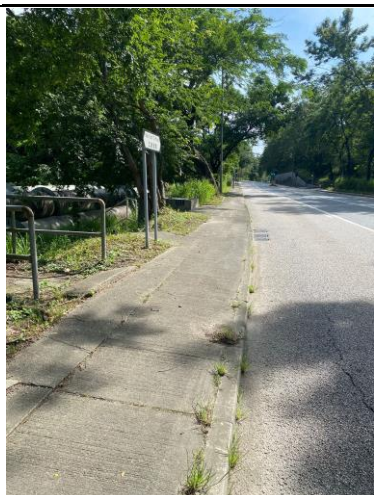
**Photo 5**

In view of the geographic location of Contract 2, M1 is located at upstream of Nam Hang Stream and outside site boundary of Contract 2, it acts as upstream of M2. There was no works carried out near M1.

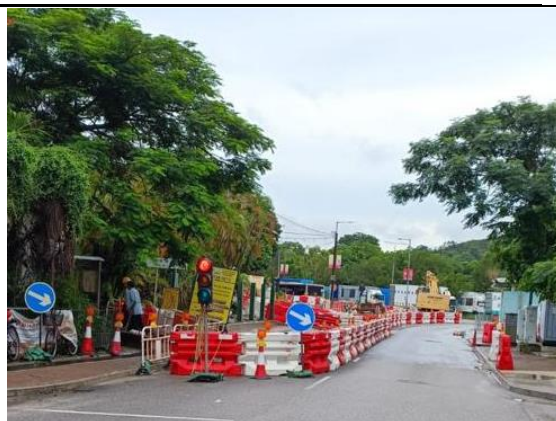
**Photo 6**

Construction of footpath was conducted near M4, there was no discharge in view of the work nature and no adverse water quality impact was observed after rainy day.

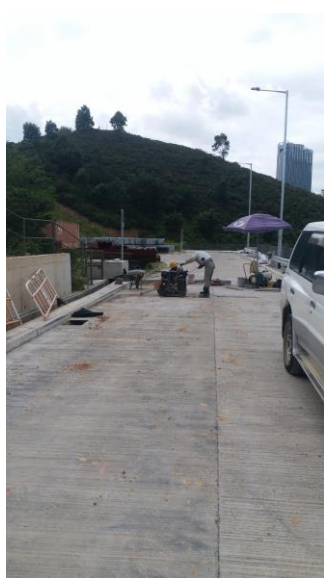
**Photo 7**

Construction of road works was conducted on Sandy Ridge, most of area was hard paved and no adverse water quality impact was observed after rainy day.

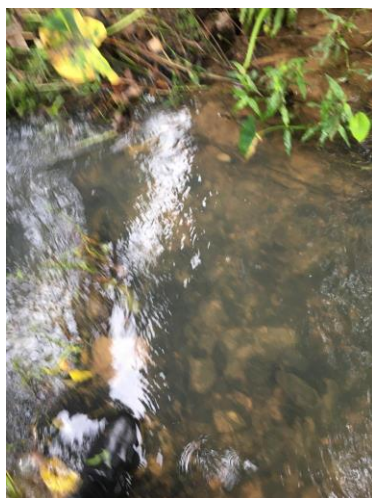
**Photo 1**

During the water quality monitoring on 10 August 2022, the water flowing at M1 was slightly turbid.

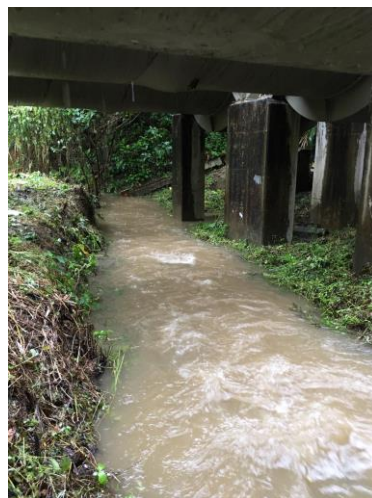
**Photo 2**

During the water quality monitoring on 12 August 2022, the water flowing at M1 was turbid.

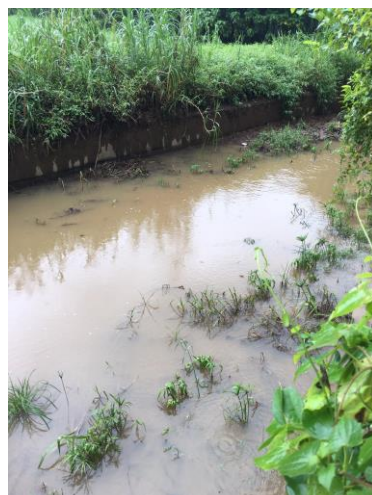
**Photo 4**

During the water quality monitoring on 10 August 2022, muddy water was observed at M2. M2 was receiving water from seasonal channel and M1, no works were carried out near location M2.

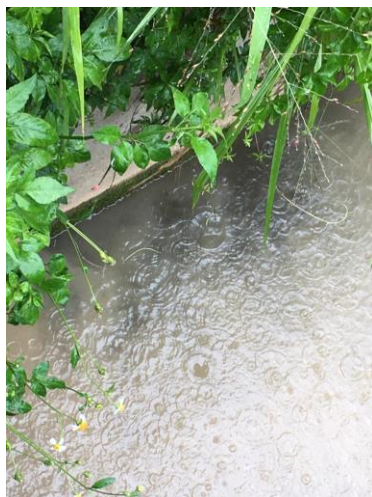
**Photo 5**

During the water quality monitoring on 12 August 2022, muddy water was observed at M2. M2 was receiving water from seasonal channel and M1, no works were carried out near location M2.

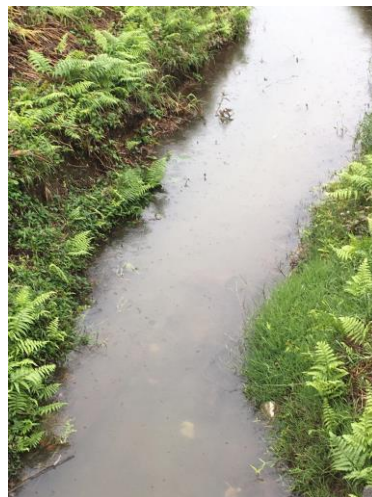
**Photo 6**

During the water quality monitoring on 12 August 2022, the water quality M4 was slightly turbid.

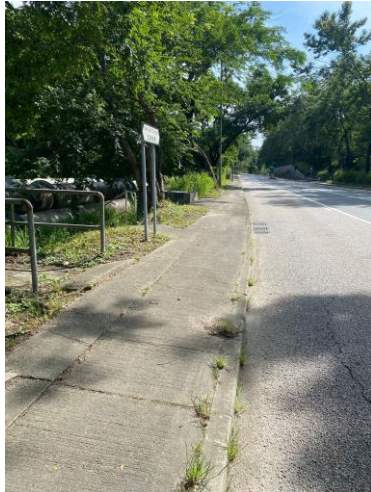
**Photo 9**

In view of the geographic location of Contract 2, M1 is located at upstream of Nam Hang Stream and outside site boundary of Contract 2, it acts as upstream of M2. There was no works carried out near M1.

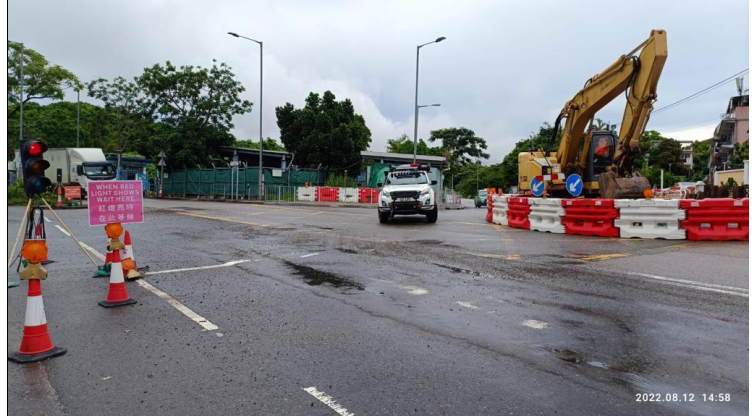
**Photo 10**

Construction of footpath was conducted near M4, there was no discharge in view of the work nature and no adverse water quality impact was observed after rainy day.

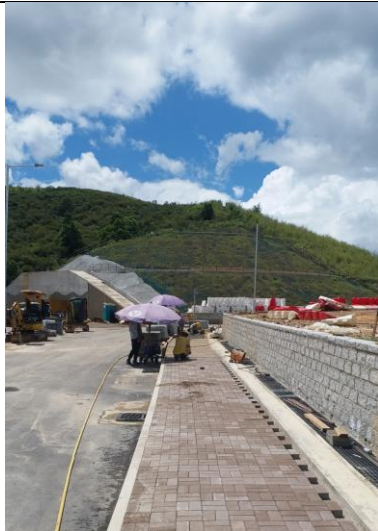
**Photo 11**

Construction of road works was conducted on Sandy Ridge, most of area was hard paved and no adverse water quality impact was observed after rainy day.

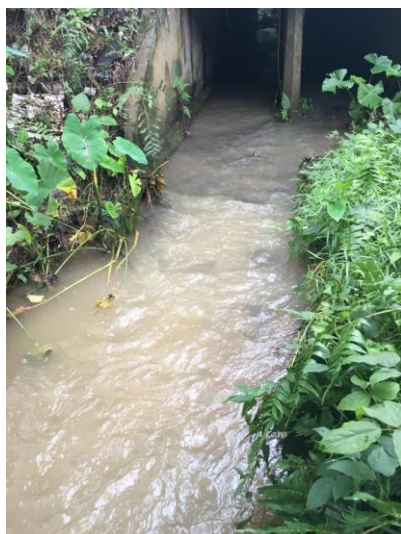
**Photo 1**

During the water quality monitoring on 17 August 2022, the water flowing at M1 was slightly turbid.

<b>Action to be taken</b>	Investigation concluded that the exceedance was not project-related, therefore, increase of monitoring frequency is not required according to EM&A Manual 7.8.1.3.			
<b>Remark</b>	N/A

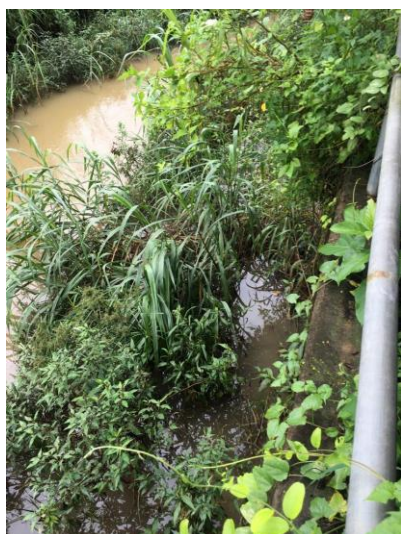
**Photo 3**

During the water quality monitoring on 19 August 2022, the water flowing at M1 was turbid.

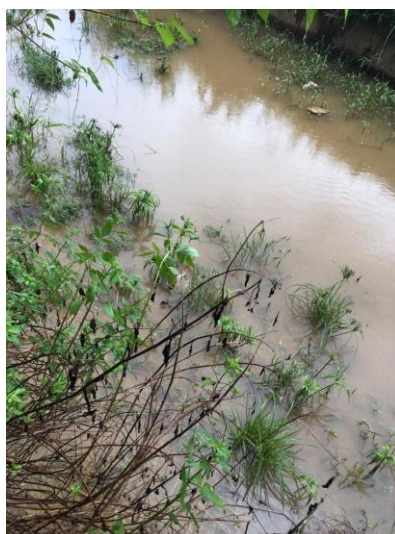
**Photo 4**

During the water quality monitoring on 17 August 2022, muddy water was observed at M2. M2 was receiving water from seasonal channel and M1, no works were carried out near location M2.

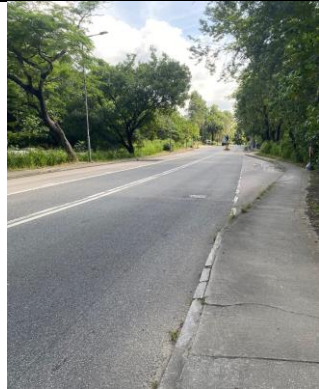
<p>Photo 6</p> <p>According to the weather data from Observatory, it was rainy on 19 August 2022.</p>

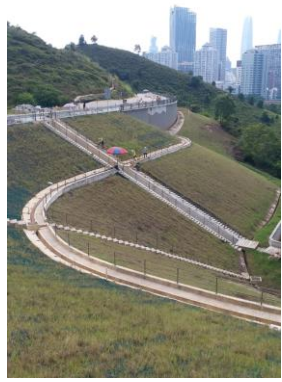
<p>Photo 8</p> <p>Construction of road works was conducted on Sandy Ridge, most of area was hard paved and no adverse water quality impact was observed.</p>
