**SITE FORMATION AND ASSOCIATED INFRASTRUCTURAL
WORKS FOR DEVELOPMENT OF COLUMBARIUM,
CREMATORIUM AND RELATED FACILITIES AT SANDY
RIDGE CEMETERY**

**MONTHLY ENVIRONMENTAL MONITORING AND AUDIT
REPORT (NO.50) – SEPTEMBER 2022**

**PREPARED FOR
HSIN CHONG TSUN YIP JOINT VENTURE &
SANG HING CIVIL CONTRACTORS CO., LTD**

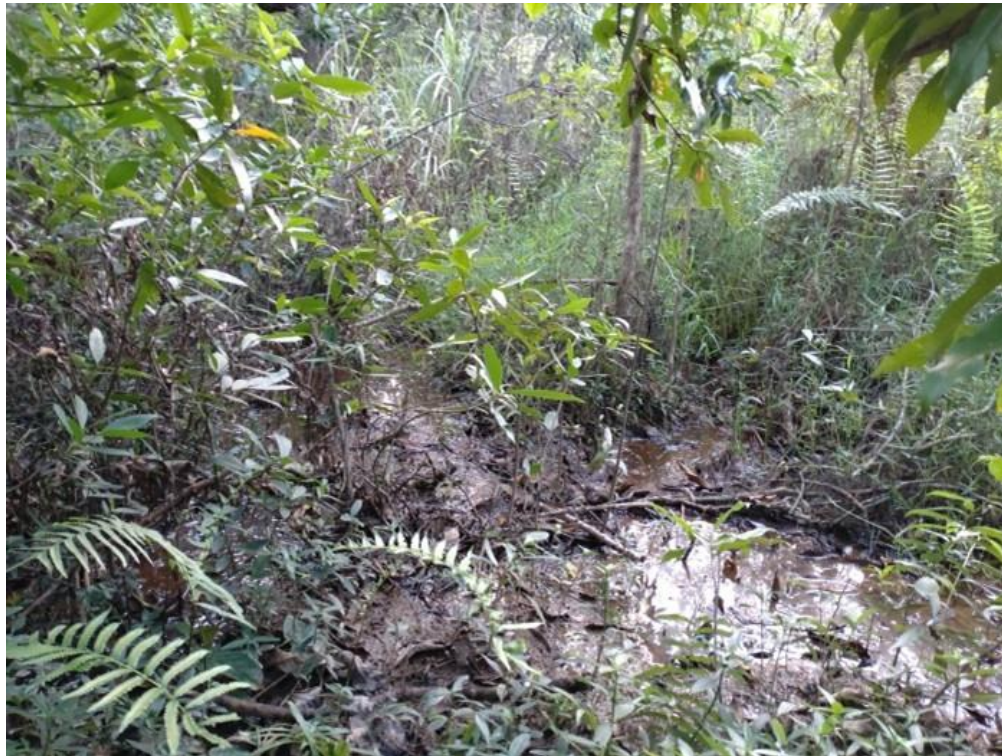
Picture 1

Wet woodland in monitoring area.
