**SITE FORMATION AND ASSOCIATED INFRASTRUCTURAL
WORKS FOR DEVELOPMENT OF COLUMBARIUM,
CREMATORIUM AND RELATED FACILITIES AT SANDY
RIDGE CEMETERY**

**MONTHLY ENVIRONMENTAL MONITORING AND AUDIT
REPORT (NO.51) – OCTOBER 2022**

**PREPARED FOR
HSIN CHONG TSUN YIP JOINT VENTURE &
SANG HING CIVIL CONTRACTORS CO., LTD**

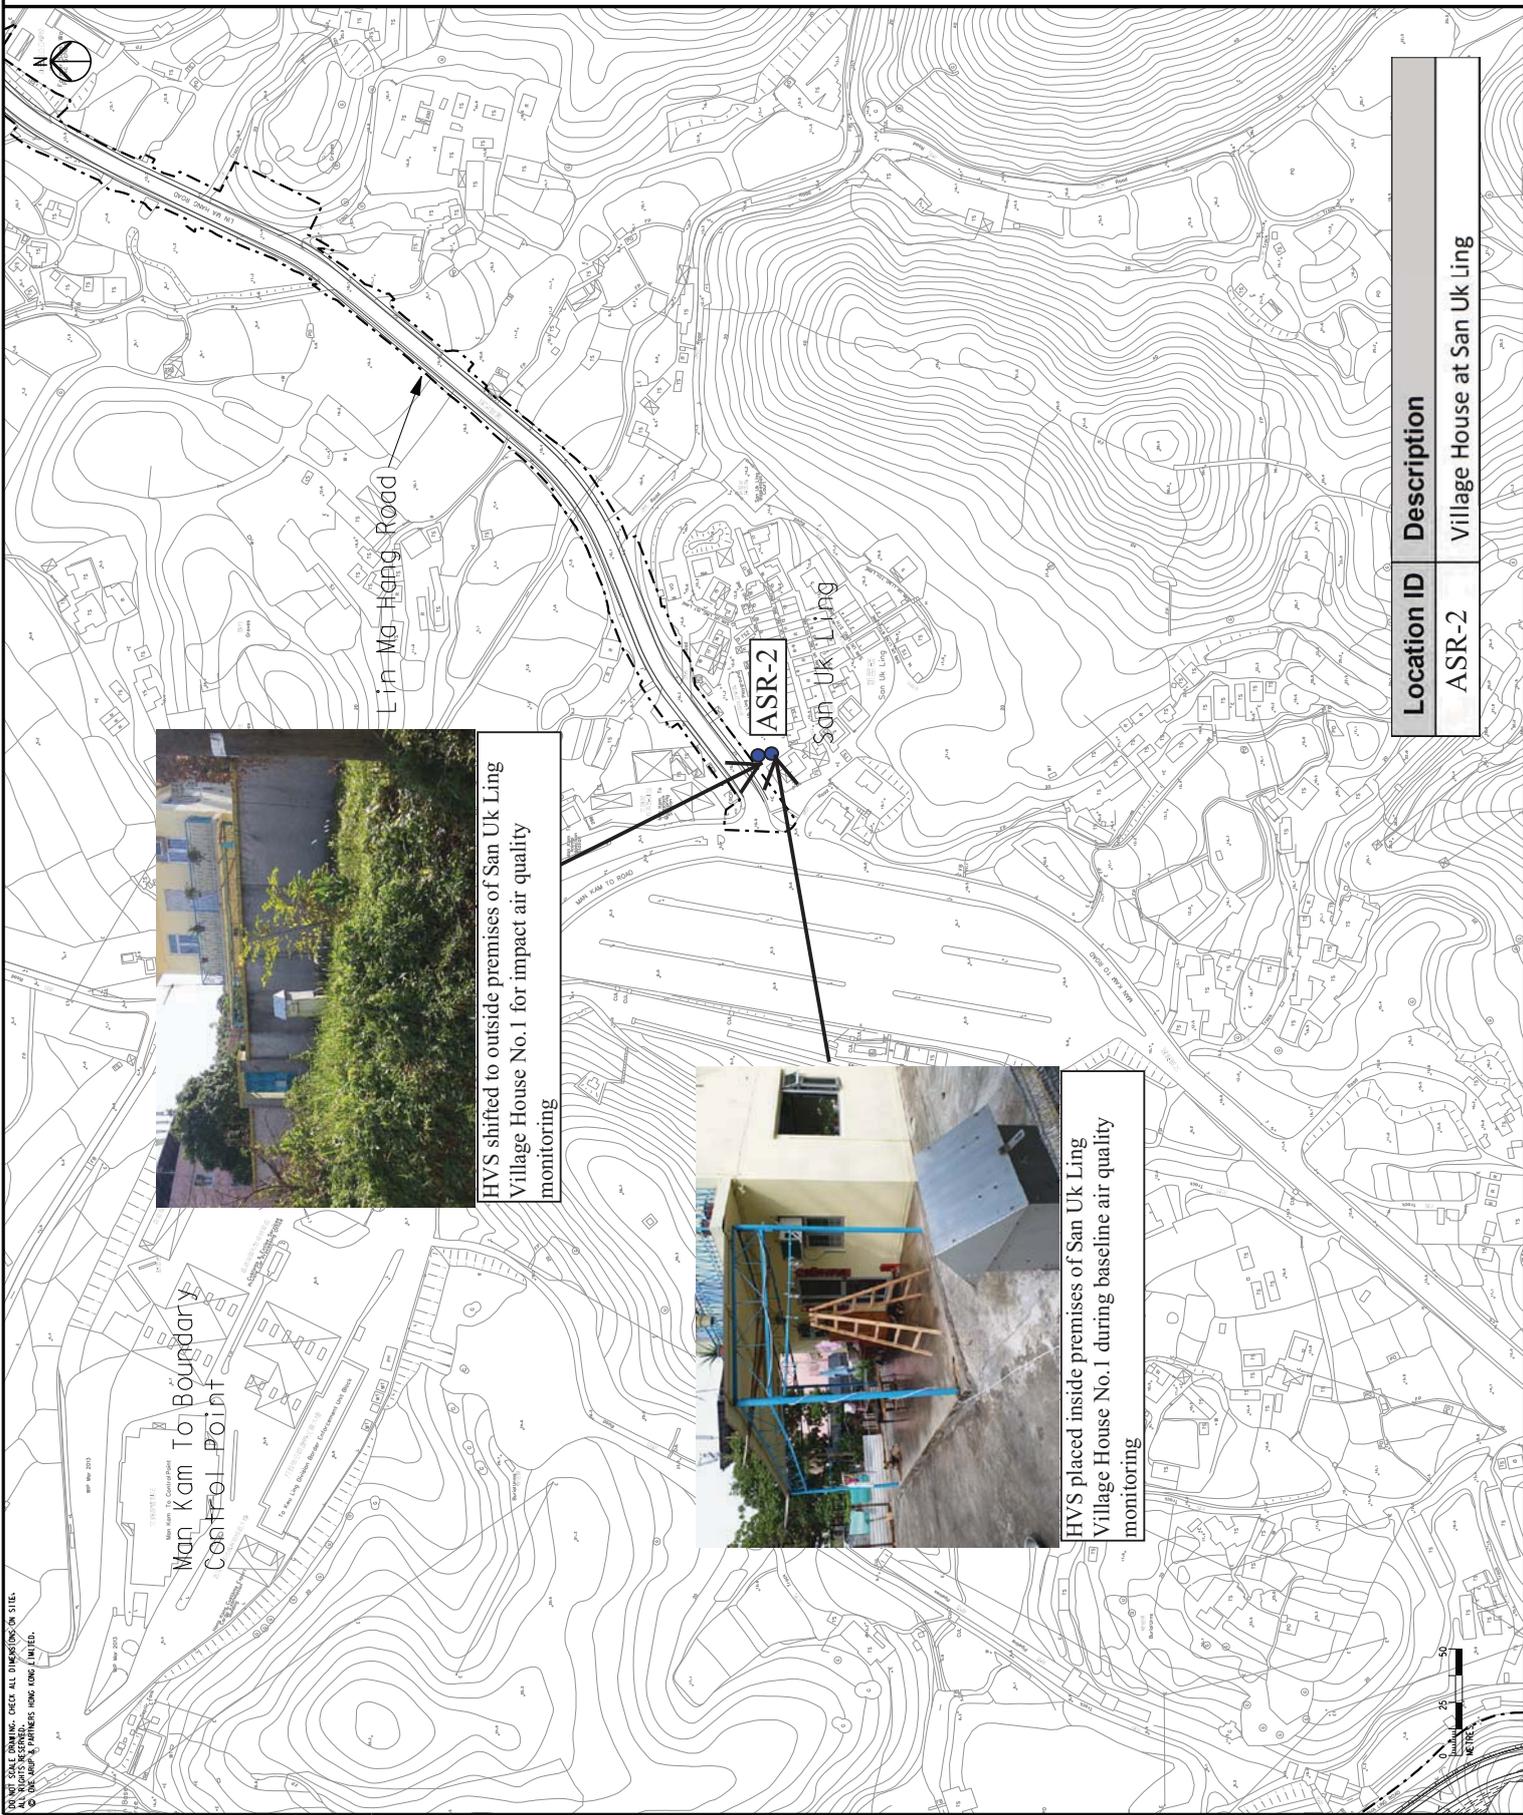
HVS shifted to outside premises of San Uk Ling Village House No. 1 for impact air quality monitoring

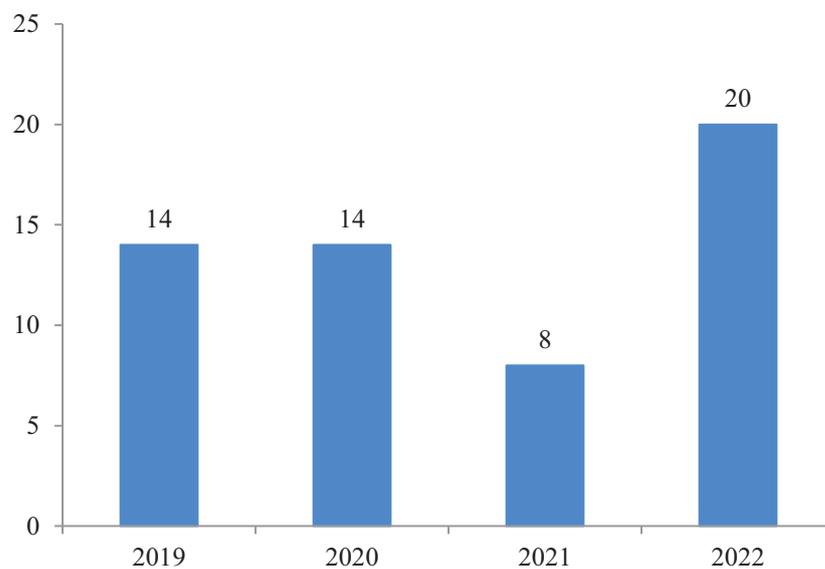
Figure 1: Bar chart showing the total species richness within site boundary from 2019 to 2022 (Actual quantity annotated at the top of each bar)

5.1 Total abundance and species richness in October over years were compared to show the trends. Figures 1 and 2 indicate the total species richness and total abundance within the site boundary respectively.

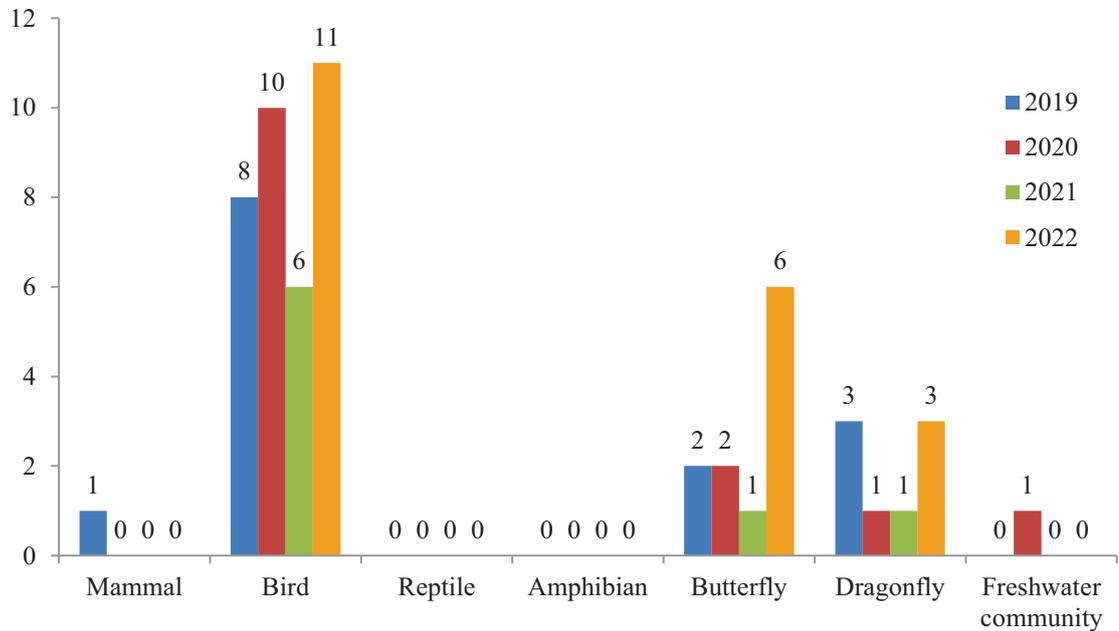
Figure 3: Bar chart showing the species richness within site boundary by taxa from 2019 to 2022 (Actual quantity annotated at the top of each bar)

5.2 As results in section 4 were categorized by taxa, a detailed breakdown of each taxon is shown in figure 3 to further investigate the trend of specific taxa over contract period.

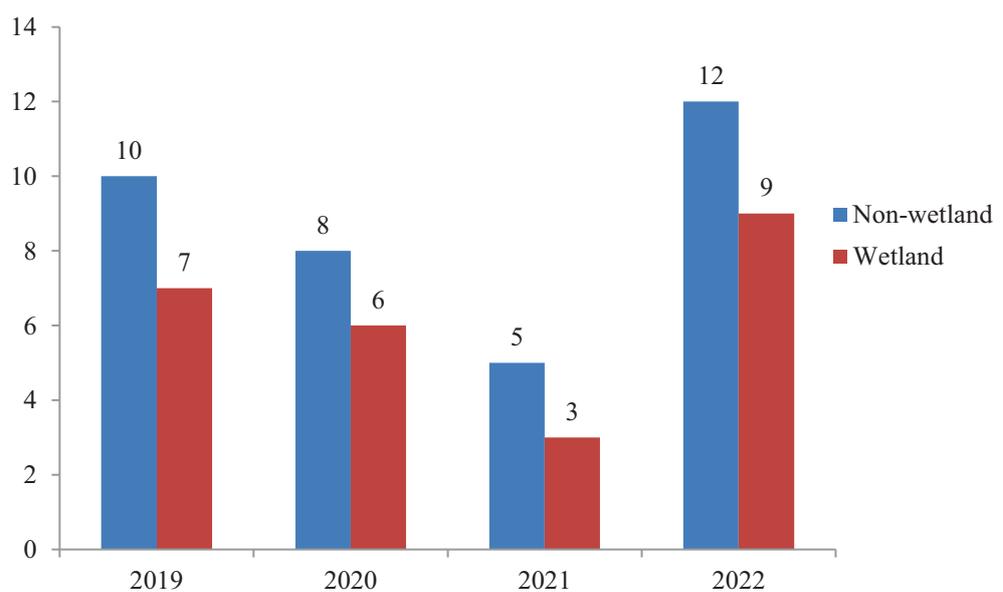
Figure 4: bar chart showing the species richness based on habitat type from 2019 to 2022 (Actual quantity annotated at the top of each bar)

5.3 According to EM&A Manual, monitoring measures was determined by the species diversity of types of sensitive habitats, i.e. non-wetland and wetland habitats. Abundance and species richness by habitat type in October over years were compared in Figures 4 and 5.

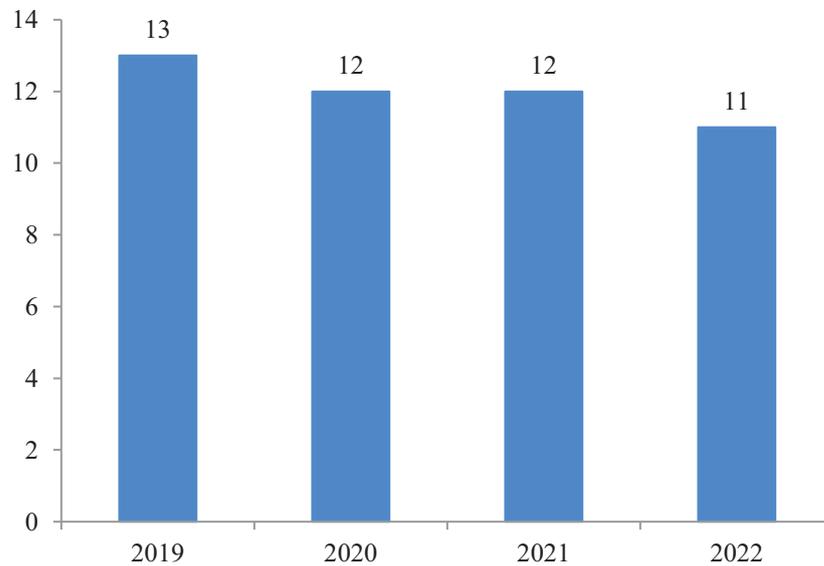
Figure 1: Bar chart showing the total species richness within site boundary from 2019 to 2022 (Actual quantity annotated at the top of each bar)

5.1 Total abundance and species richness in October over years were compared to show the trends. Figures 1 and 2 indicate total species richness and total abundance within the site boundary respectively.

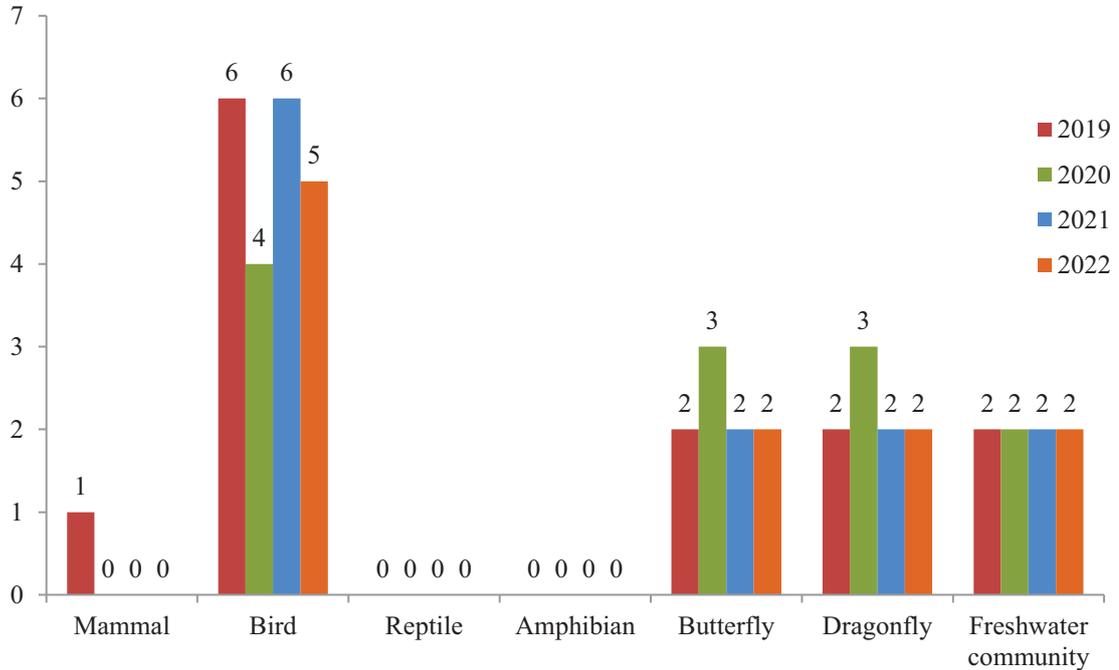
Figure 3: Bar chart showing the species richness within site boundary by taxa from 2019 to 2022 (Actual quantity annotated at the top of each bar)

5.2 As results in section 4 were categorized by taxa, a detailed breakdown of each taxon is shown in figure 3 to further investigate the trend of specific taxa over contract period.

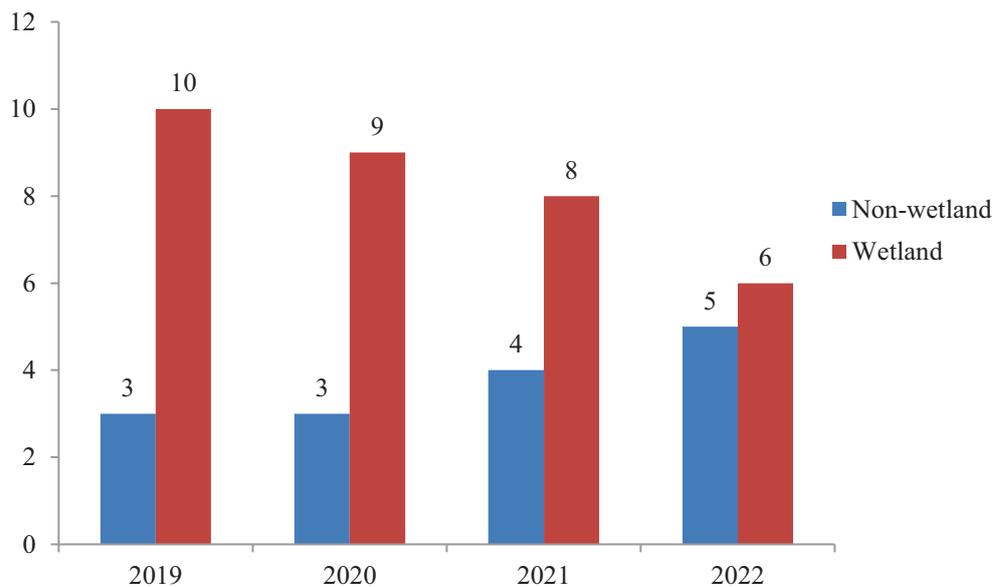
Figure 4: bar chart showing the species richness based on habitat type from 2019 to 2022 (Actual quantity annotated at the top of each bar)

5.3 According to EM&A Manual, monitoring measures was determined by the species diversity of types of sensitive habitats, i.e. non-wetland and wetland habitats. Abundance and species richness by habitat type in October over years were compared in figures 4 and 5.
