JOB No.: TCS00881/18 & TCS00944/18

**SITE FORMATION AND ASSOCIATED INFRASTRUCTURAL
WORKS FOR DEVELOPMENT OF COLUMBARIUM,
CREMATORIUM AND RELATED FACILITIES AT SANDY
RIDGE CEMETERY**

**MONTHLY ENVIRONMENTAL MONITORING AND AUDIT
REPORT (NO.60) – JULY 2023**

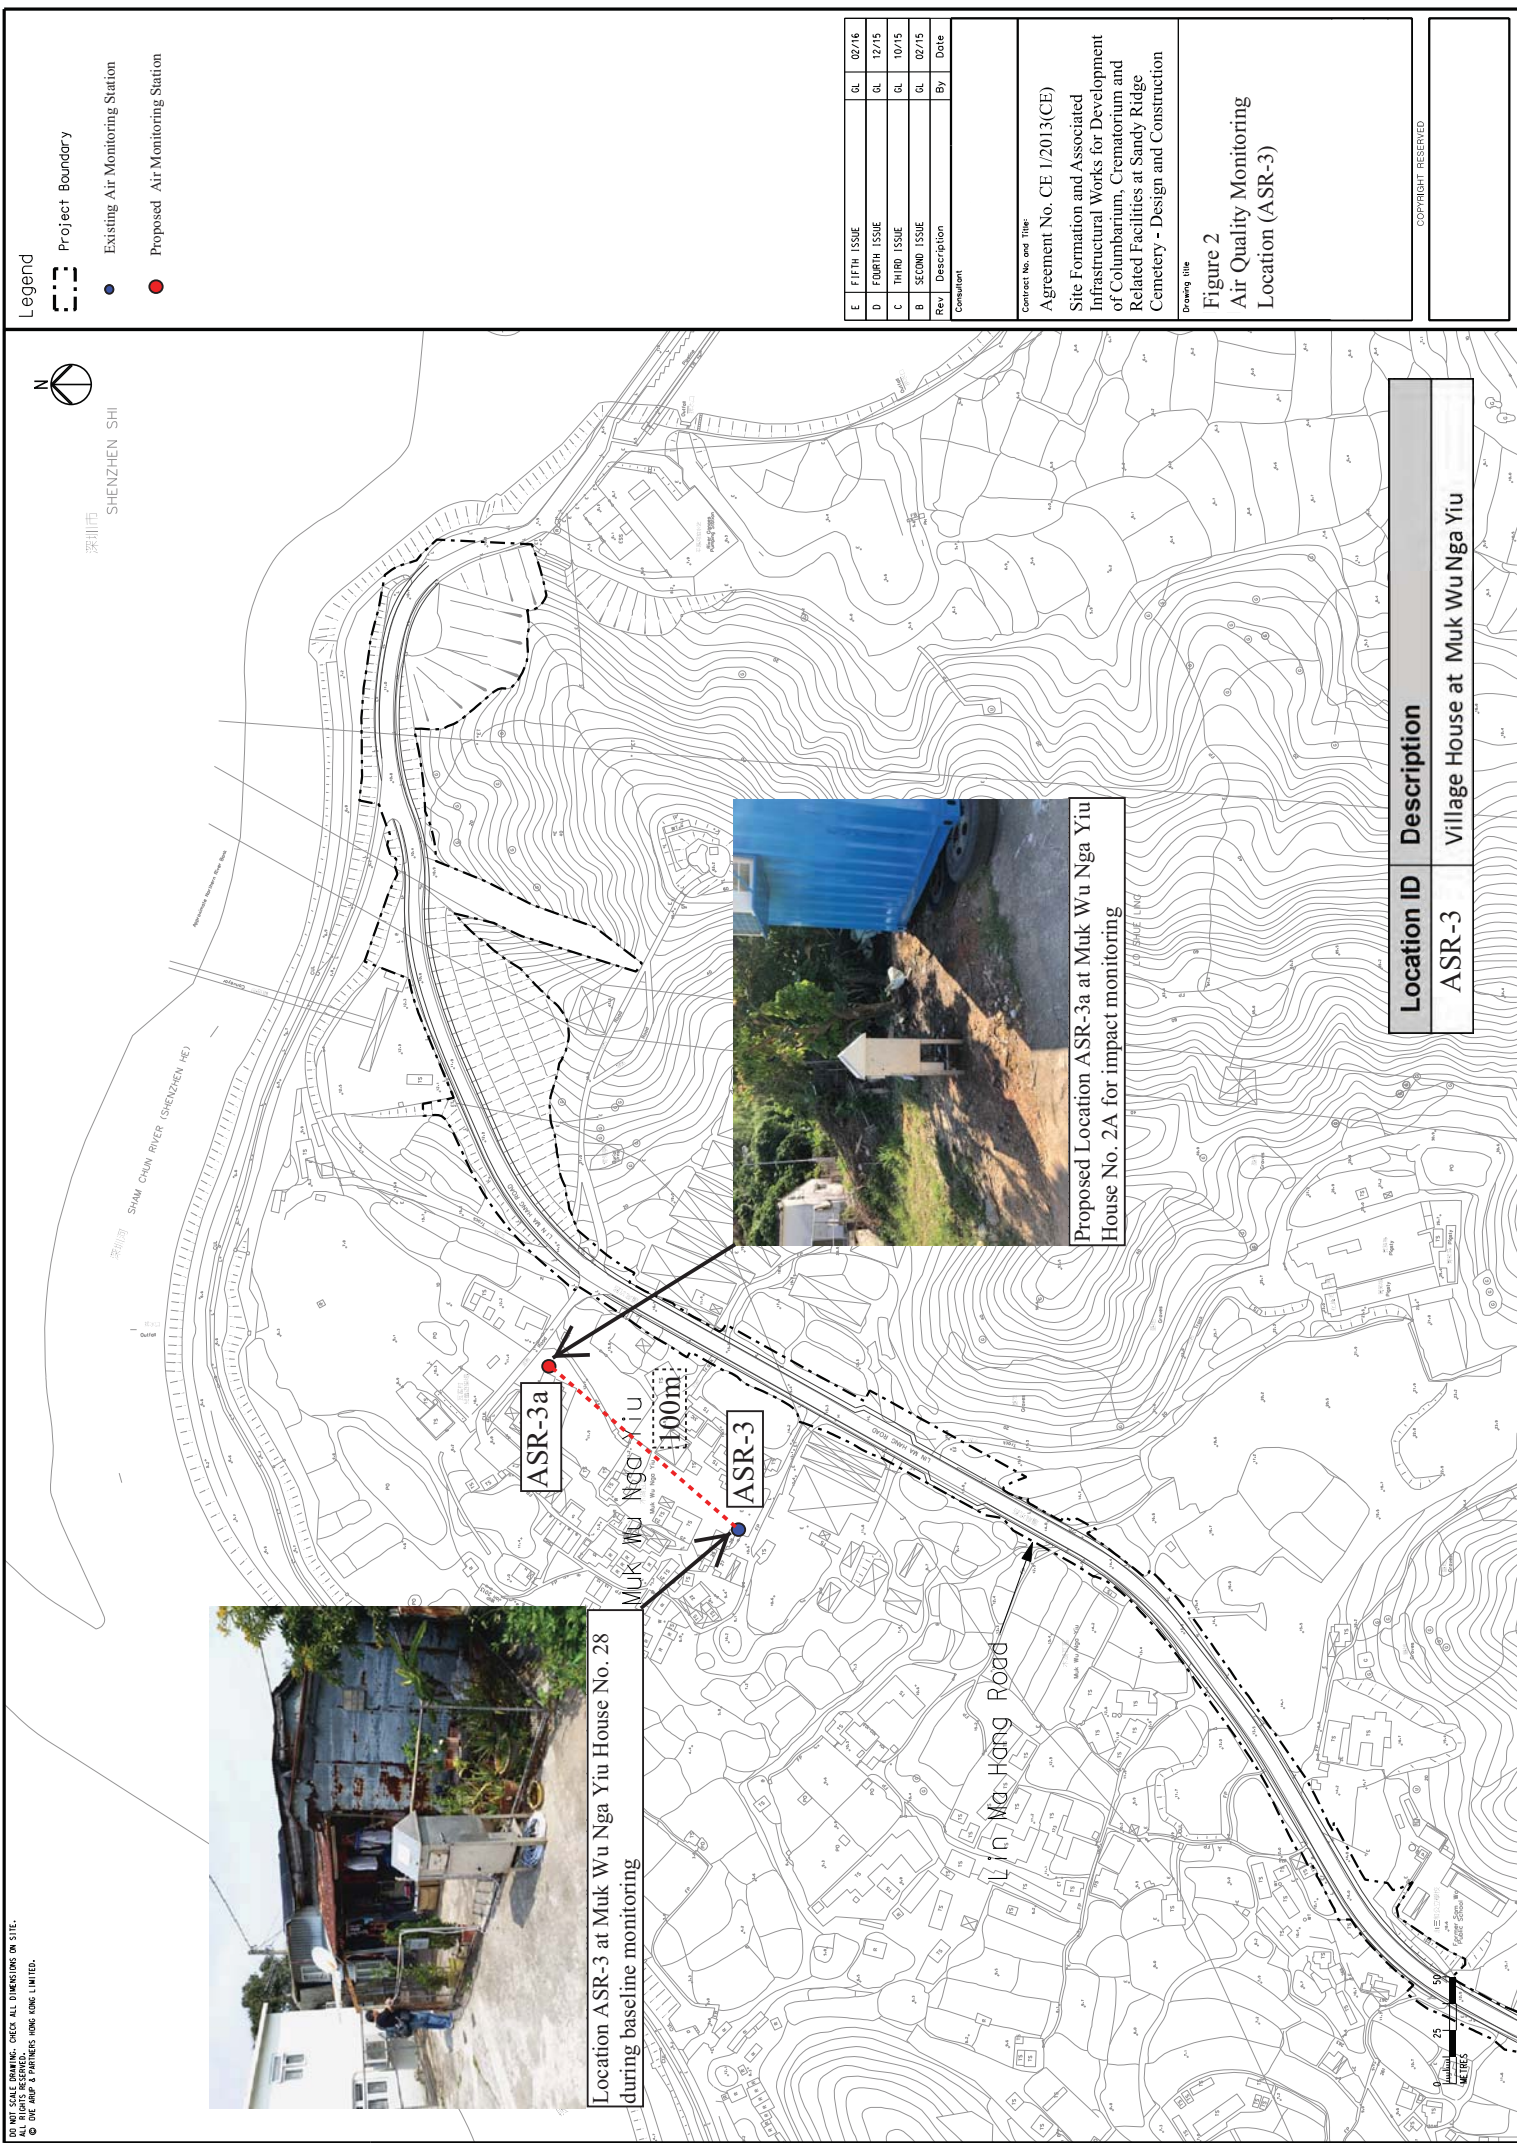
Air Quality Monitoring Location

3.3.3 There were three (3) designated air quality monitoring stations recommended in the Approved EM&A Manual Section 5.6.1.1. There was proposed relocation of air quality monitoring location ASR-3 in October 2018 since the landlord refused to set up the HVS at his premises and nearby Conservation Area due to noise nuisance and Muk Wu Nga Yiu House No. 2A was proposed as alternative location ASR-3a. The proposal dated on 9 November 2018 which verified by IEC was submitted to EPD for approval. Based on rationale in Section 3.3.2, the Contract-related air quality monitoring location for construction phase were summarized in *Table 3-2* and illustrated in *Appendix D*.

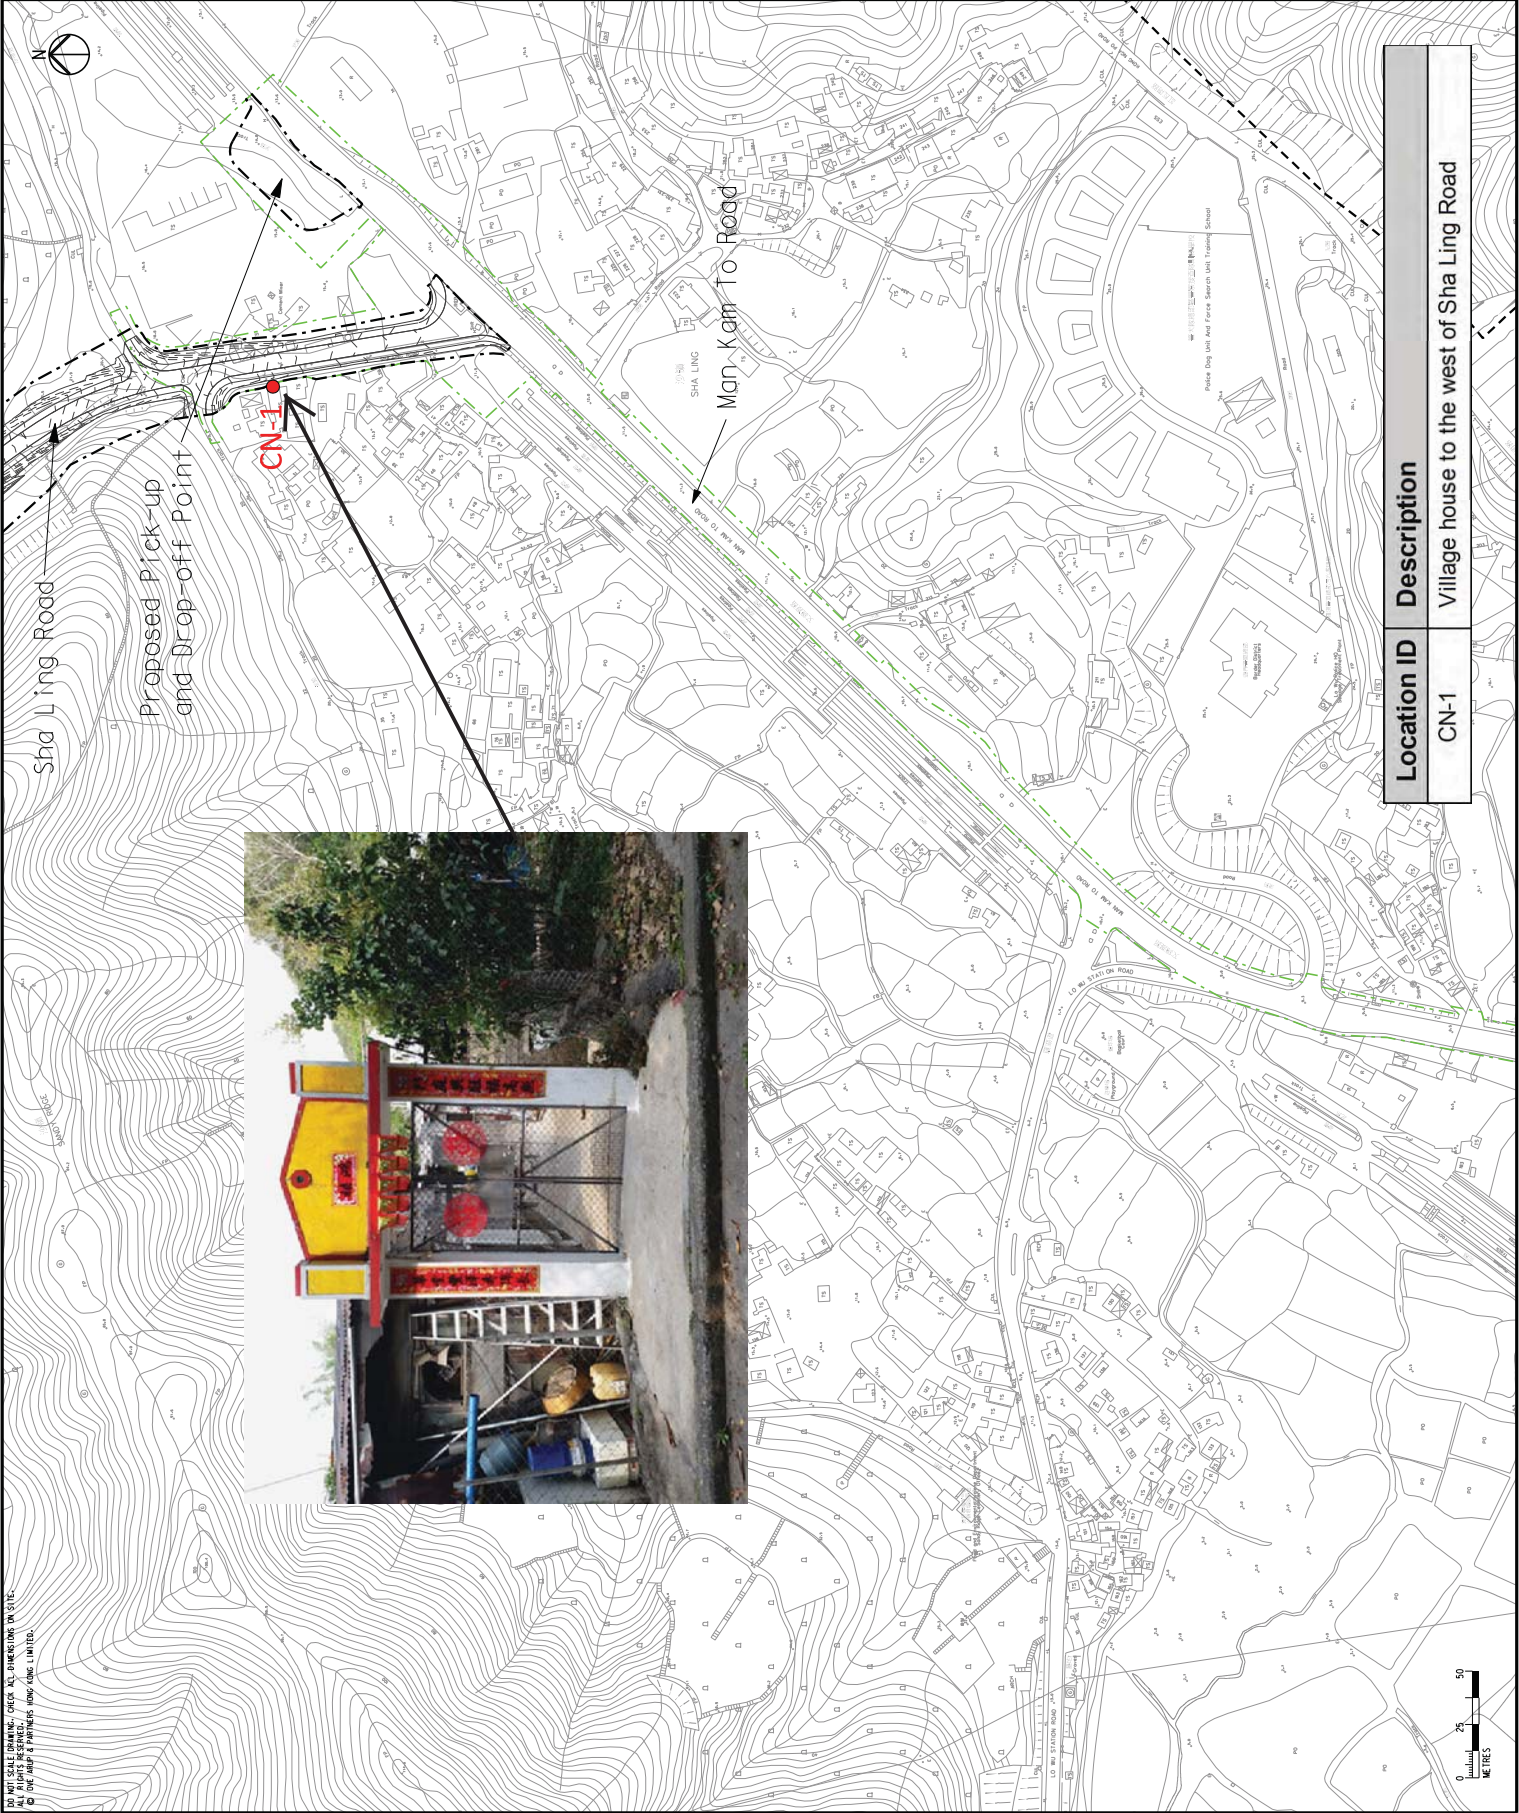
Noise Monitoring Location

3.3.5 There were four (4) designated noise monitoring locations recommended in the Approved EM&A Manual Section 6.5.1.1. Based on rationale in Section 3.3.2, the Contract-related noise quality monitoring location for construction phase were summarized in **Table 3-3** and illustrated in **Appendix D**.

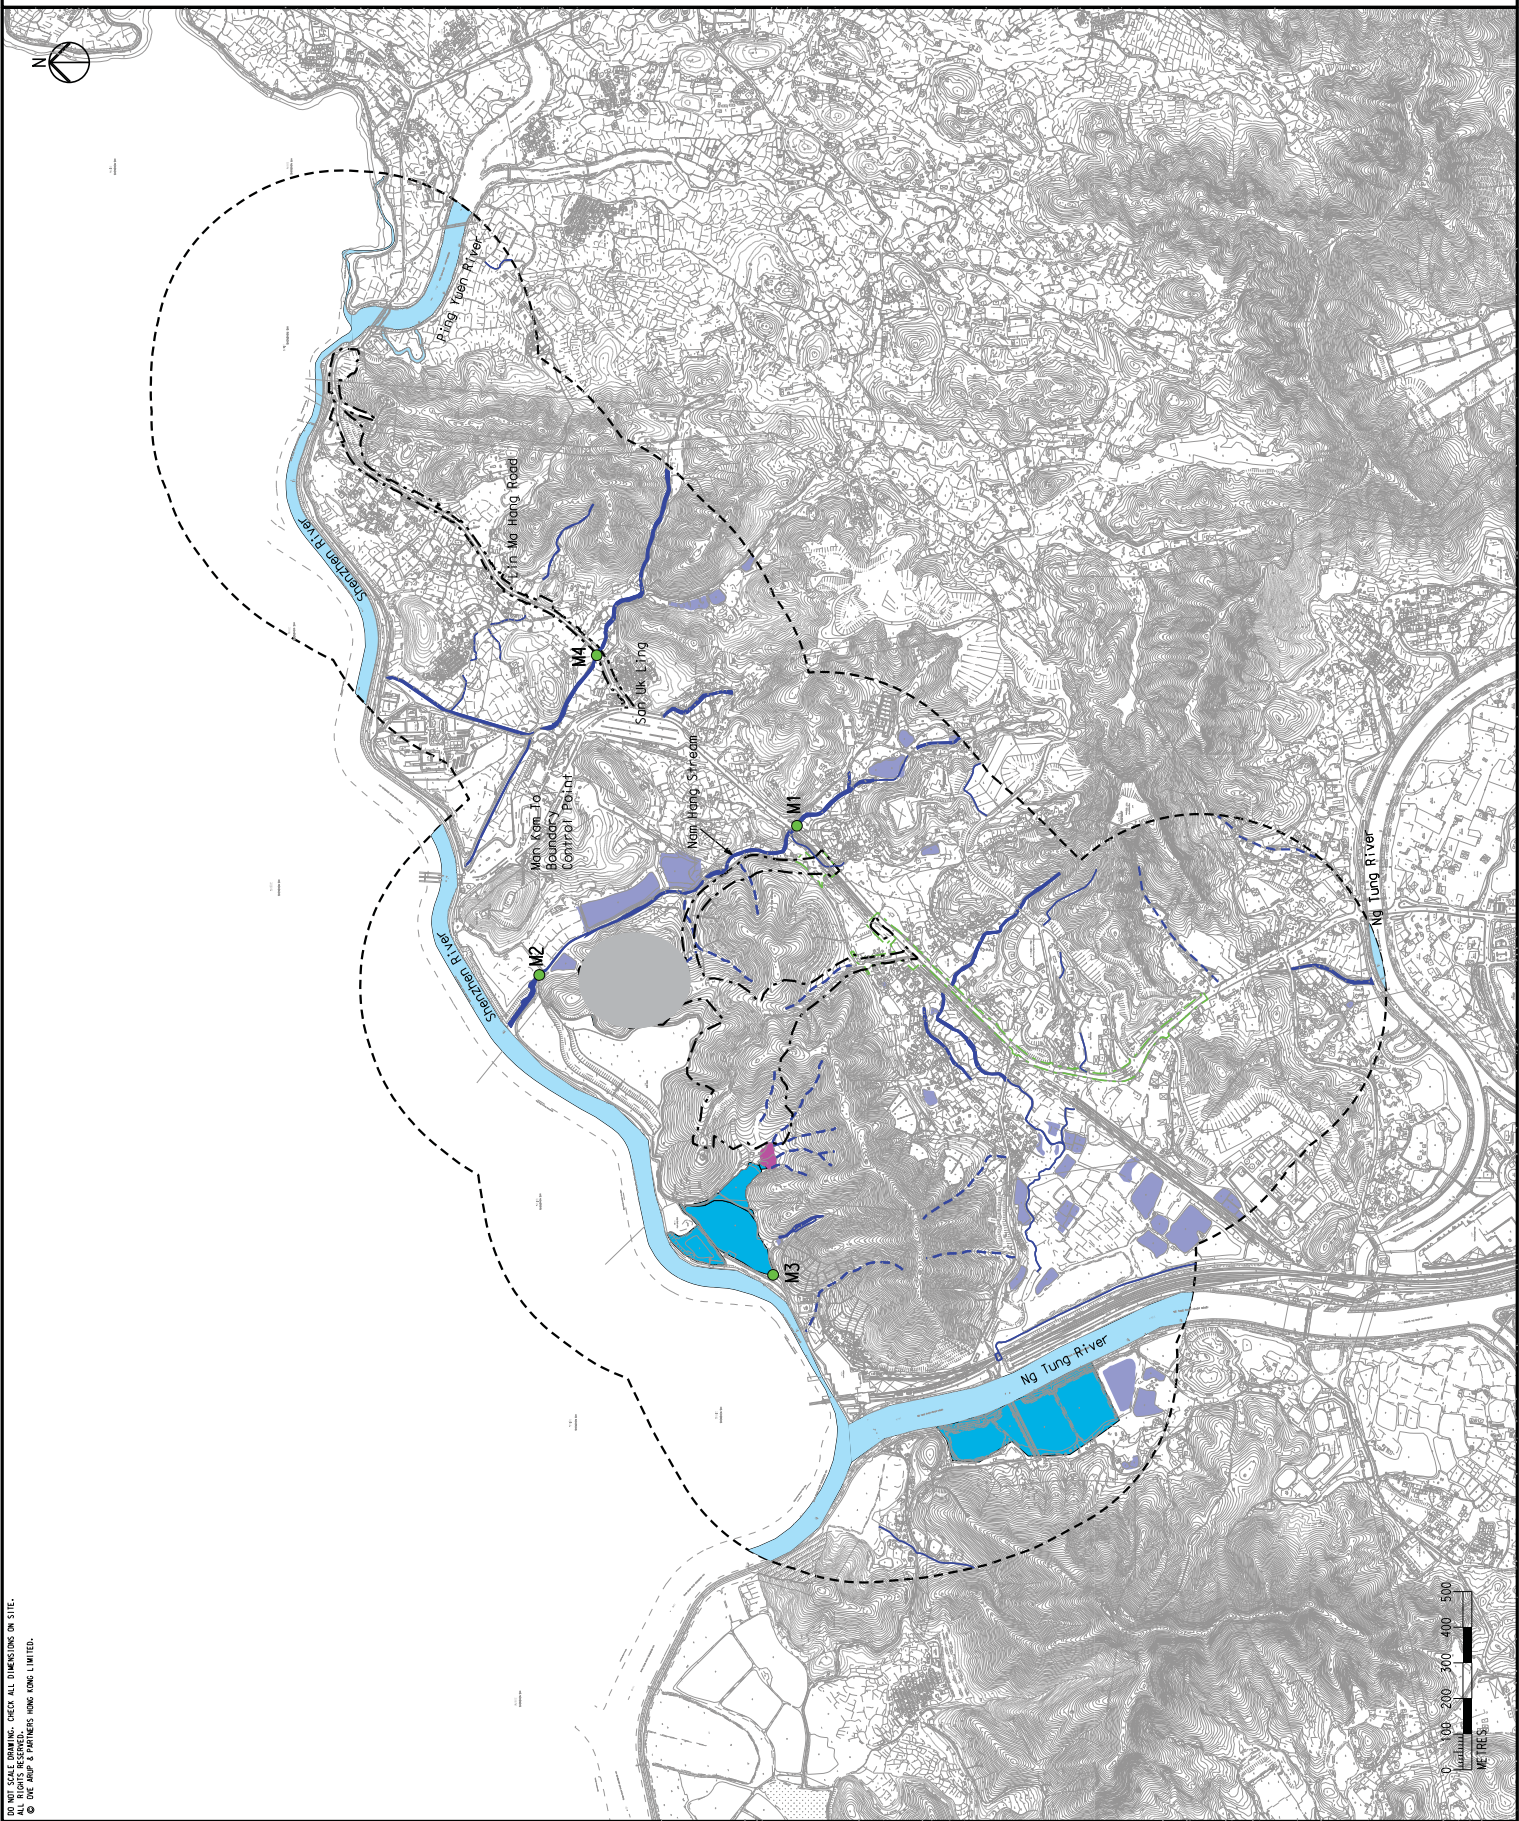
Water Quality Monitoring Station

- 3.3.6 There were four (4) water quality monitoring locations recommended in the Approved EM&A Manual Section 7.6.1.2. The locations and coordinates of water quality monitoring were listed in **Table 3-4**. Based on rationale in Section 3.3.2, the Contract-related water quality monitoring location for construction phase were summarized in **Table 3-4** and illustrated in [Appendix D](#).

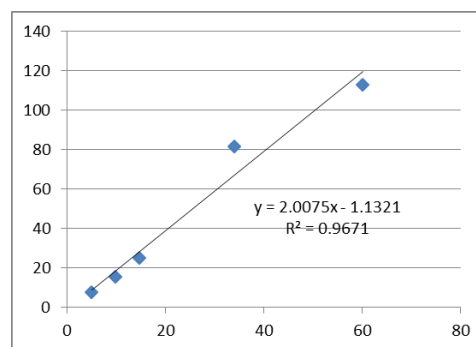
Correlation Coefficient (R) 0.9834

1. **Strong** Correlation ($R > 0.8$)
2. Factor 2.0075 (ug/m³)/CPM should be apply for TSP monitoring

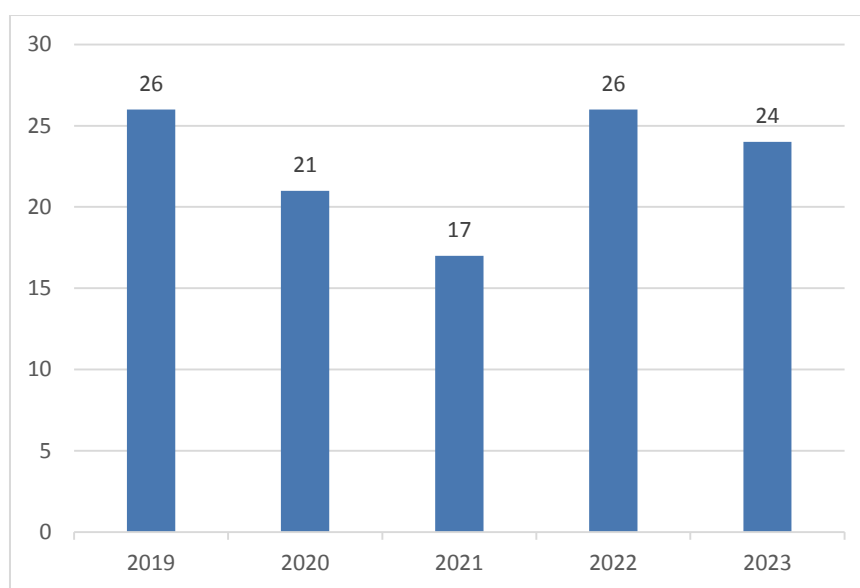
5.1 Total abundance and species richness in July over years were compared to show the trends. Figures 1 and 2 indicate the total species richness and total abundance within the site boundary respectively.

Figure 1: Bar chart showing the total species richness within site boundary from 2019 to 2023
(Actual quantity annotated at the top of each bar)

5.4 After analysing survey results in July from 2019 to 2023, stable number of species richness and a significant increase in the abundance for Wetland and Non-wetland habitat are recorded in July 2023. This could be benefited by some positive factors such as the major construction works were completed and most of the PME has been removed from site. Besides, compensation planting works have been conducted in early Jan 2023. Therefore, disturbance to fauna species from construction works have been largely minimised. In addition, woodland compensation and grassland reinstatement would be implemented in the second and third quarter of 2023. Hence, the habitat of fauna species would be gradually recovered and expectation of increase in the species richness and abundance for wetland habitat is high.

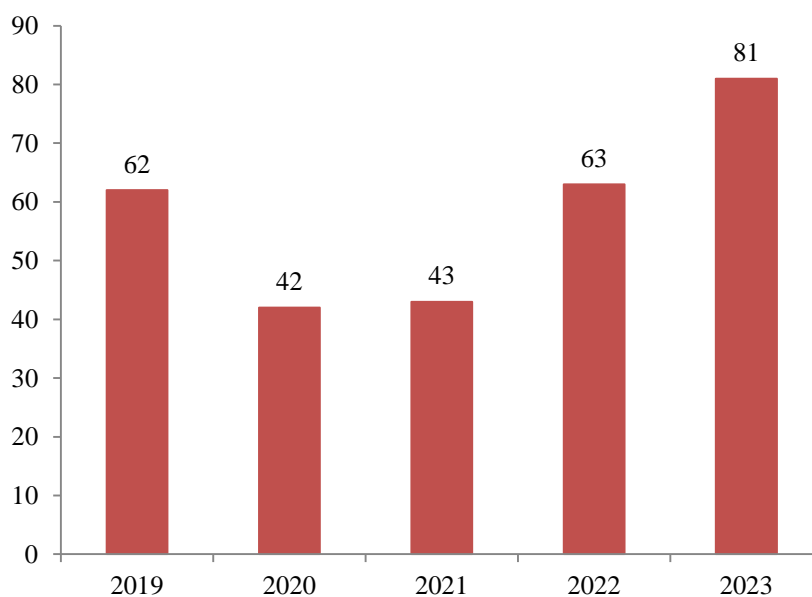
Figure 2: Bar chart showing the total abundance within site boundary from 2019 to 2023
(Actual quantity annotated at the top of each bar)

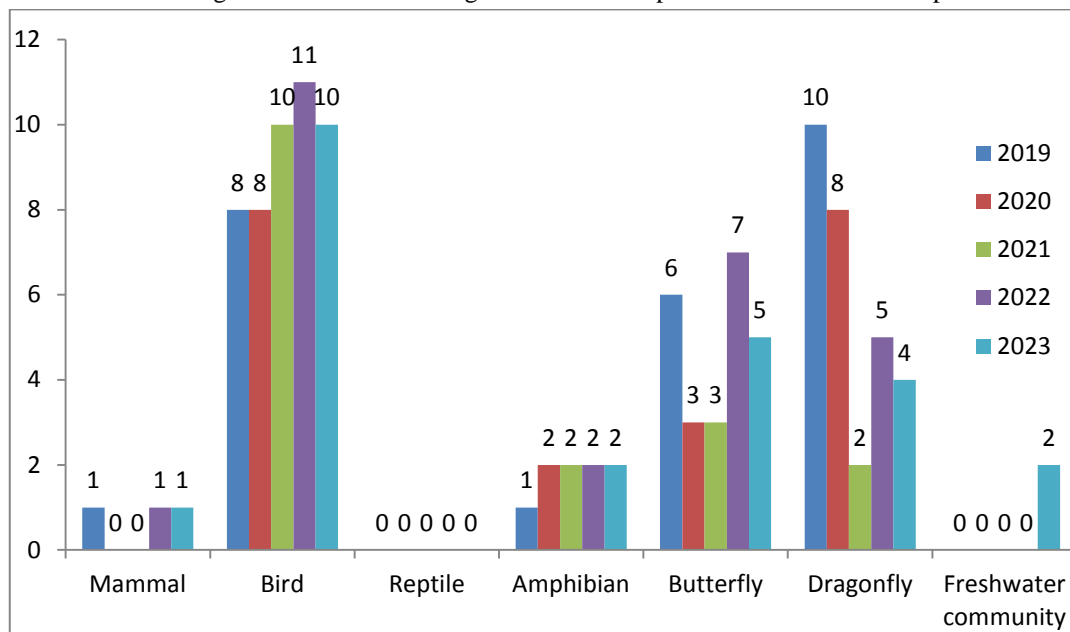
5.2 As results in section 4 were categorized by taxa, a detailed breakdown of each taxon is shown in figure 3 to further investigate the trend of specific taxa over contract period.

Figure 3: Bar chart showing the species richness within site boundary by taxa from 2019 to 2023
 (Actual quantity annotated at the top of each bar)

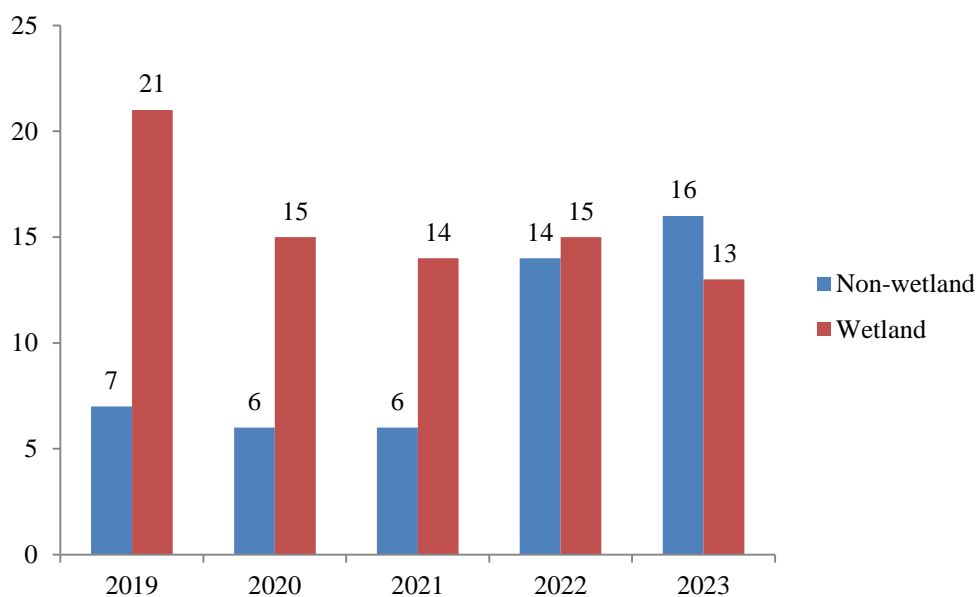
5.3 According to EM&A Manual, monitoring measures was determined by the species diversity of types of sensitive habitats, i.e. non-wetland and wetland habitats. Abundance and species richness by habitat type in July over years were compared in Figures 4 and 5.

Figure 4: Bar chart showing the species richness based on habitat type from 2019 to 2023
 (Actual quantity annotated at the top of each bar)

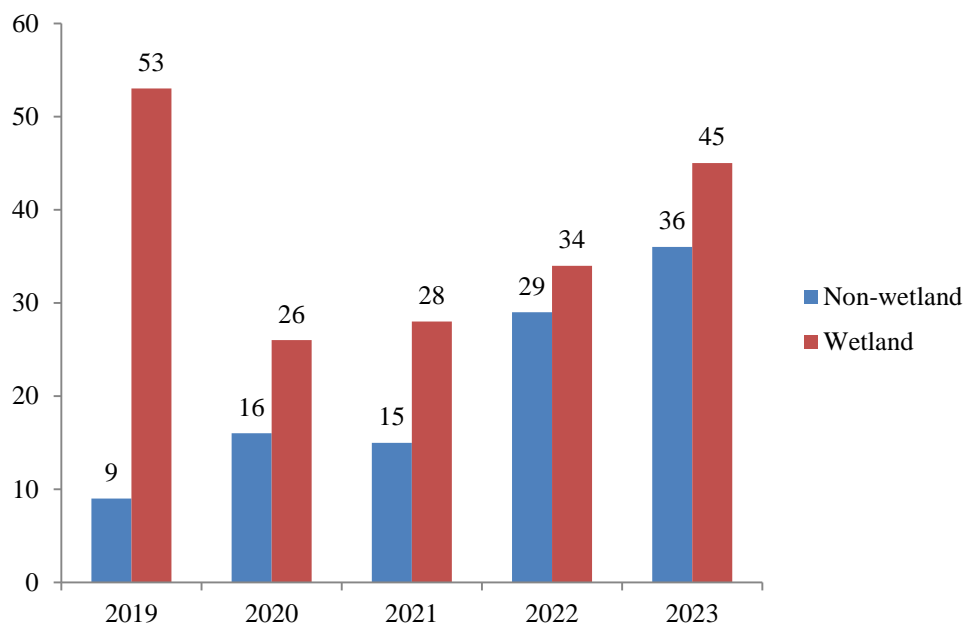
Figure 5: Bar chart showing the abundance based on habitat type from 2019 to 2023
 (Actual quantity annotated at the top of each bar)

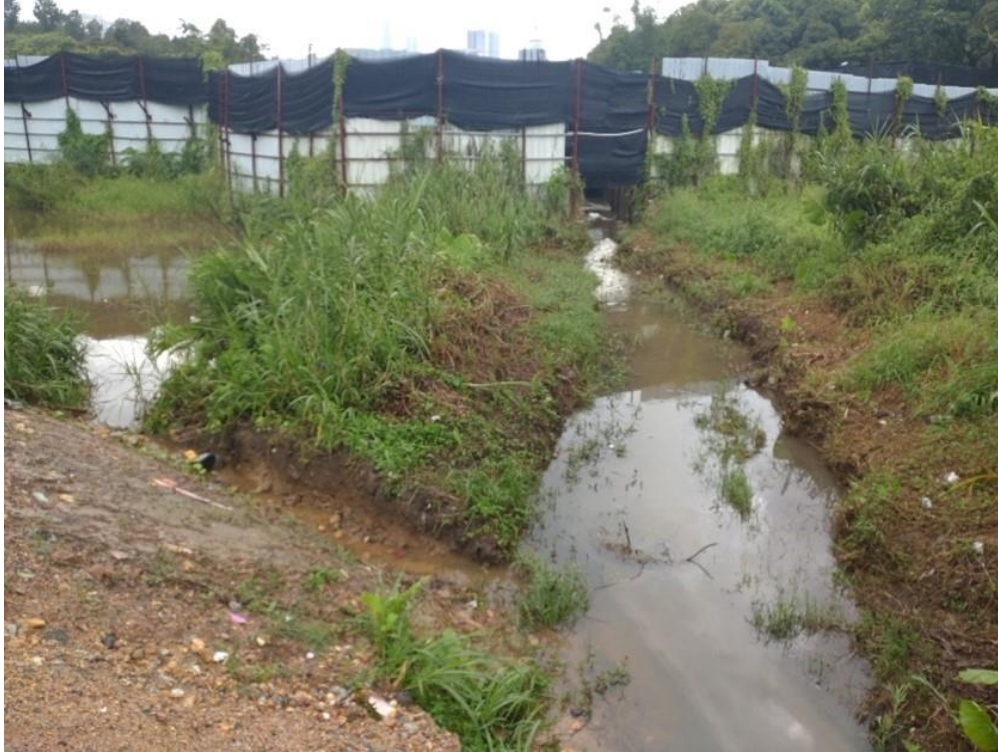
Picture 1

Watercourse in monitoring area.

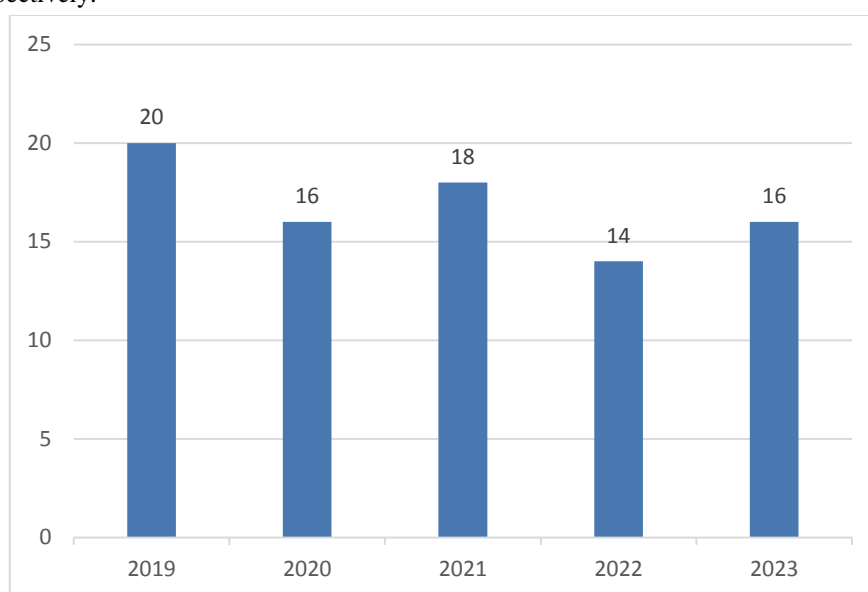
5.1 Total abundance and species richness in July over years were compared to show the trends. Figures 1 and 2 indicate total species richness and total abundance within the site boundary respectively.

Figure 1: Bar chart showing the total species richness within site boundary from 2019 to 2023 (Actual quantity annotated at the top of each bar)

5.4 After analysing survey results in July from 2019 to 2023, records in species richness and abundance for wetland and non-wetland habitats are unstable, this may due to natural fluctuation. According to the recent on-site observation, there are new built workshops by others situated on both sides of Lin Ma Hang Road so the disturbance to fauna species from construction works could be increased. Due to the cause was not related to this project, remedial action to remove or reduce source of disturbance is limited.

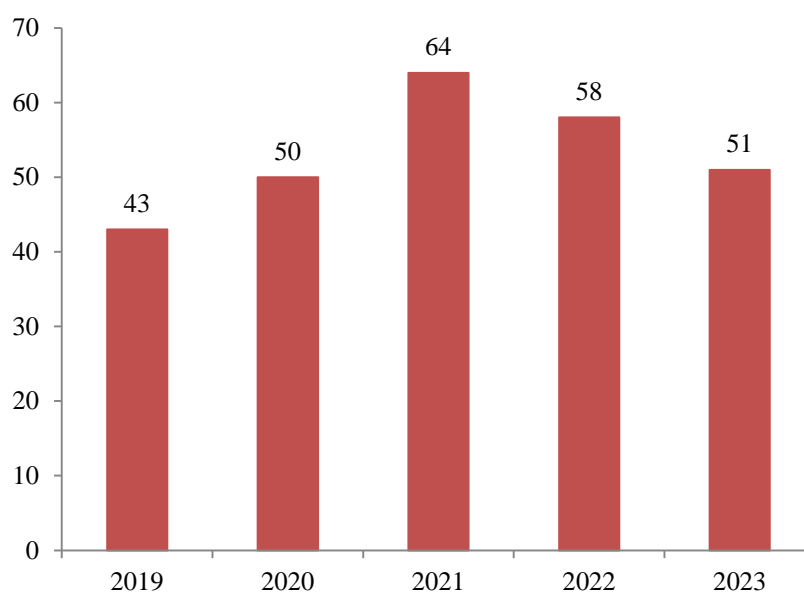
Figure 2: Bar chart showing the total abundance within site boundary from 2019 to 2023 (Actual quantity annotated at the top of each bar)

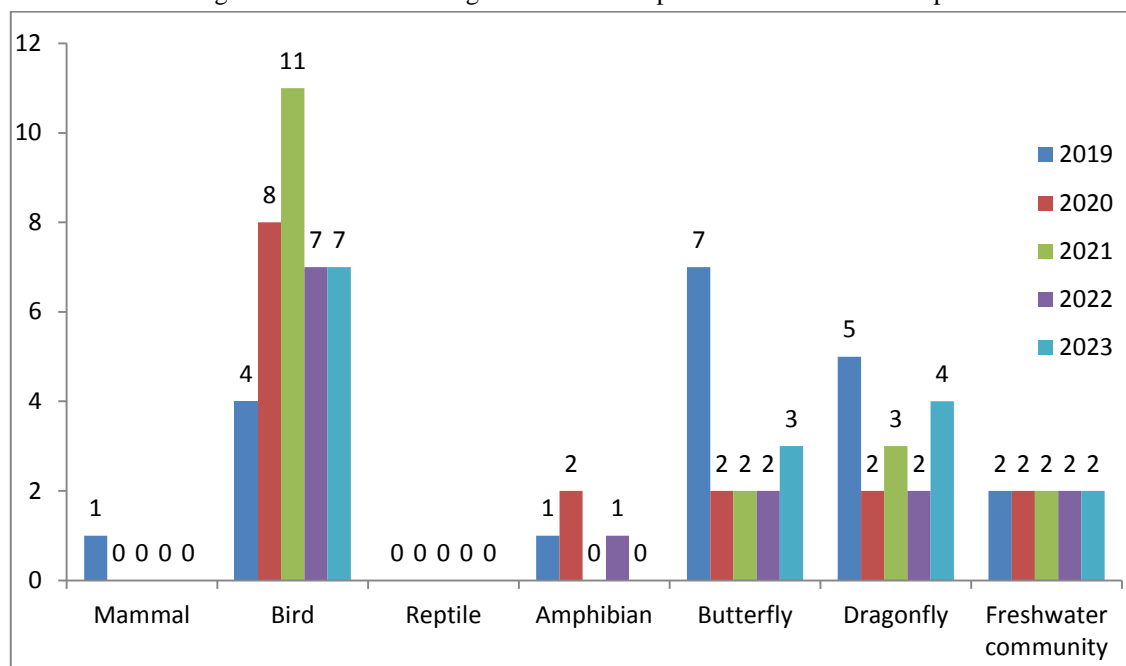
5.2 As results in section 4 were categorized by taxa, a detailed breakdown of each taxon is shown in figure 3 to further investigate the trend of specific taxa over contract period.

Figure 3: Bar chart showing the species richness within site boundary by taxa from 2019 to 2023
 (Actual quantity annotated at the top of each bar)

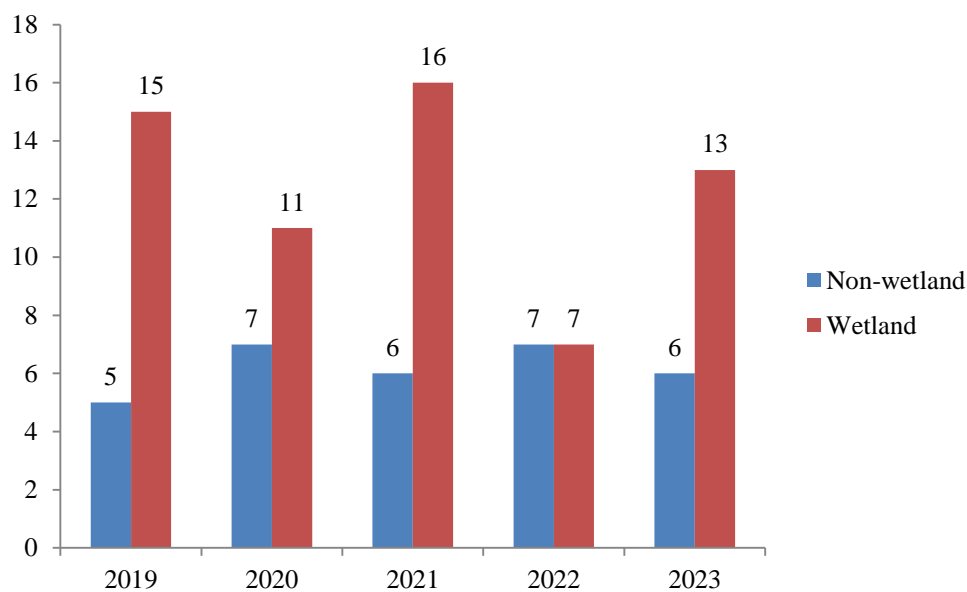
5.3 According to EM&A Manual, monitoring measures was determined by the species diversity of types of sensitive habitats, i.e. non-wetland and wetland habitats. Abundance and species richness by habitat type in July over years were compared in figures 4 and 5.

Figure 4: bar chart showing the species richness based on habitat type from 2019 to 2023
 (Actual quantity annotated at the top of each bar)

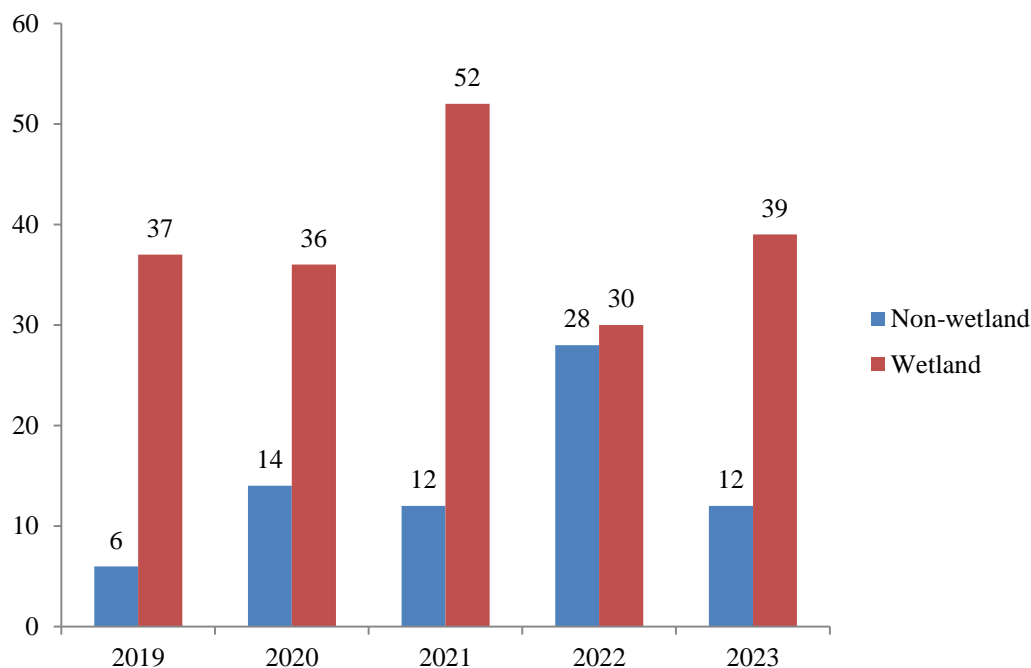
Figure 5: bar chart showing the abundance based on habitat type from 2019 to 2023
 (Actual quantity annotated at the top of each bar)

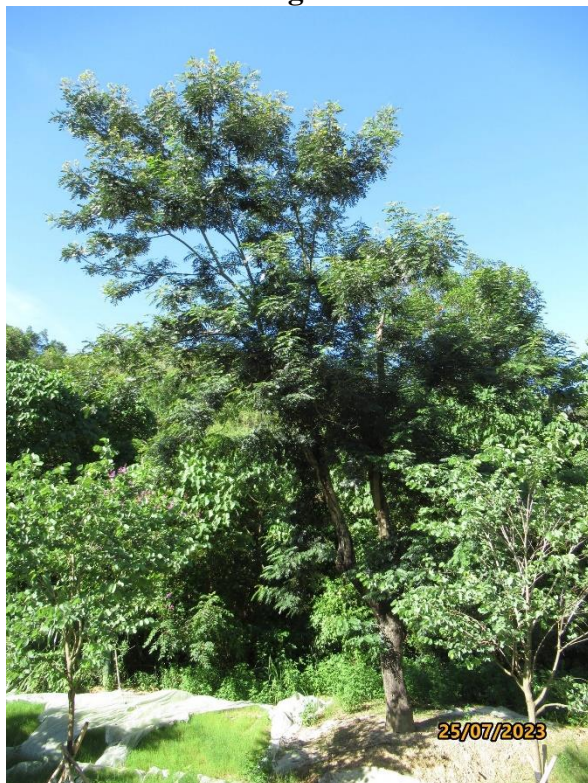
Fig E.

Transplanted tree (T-2465)

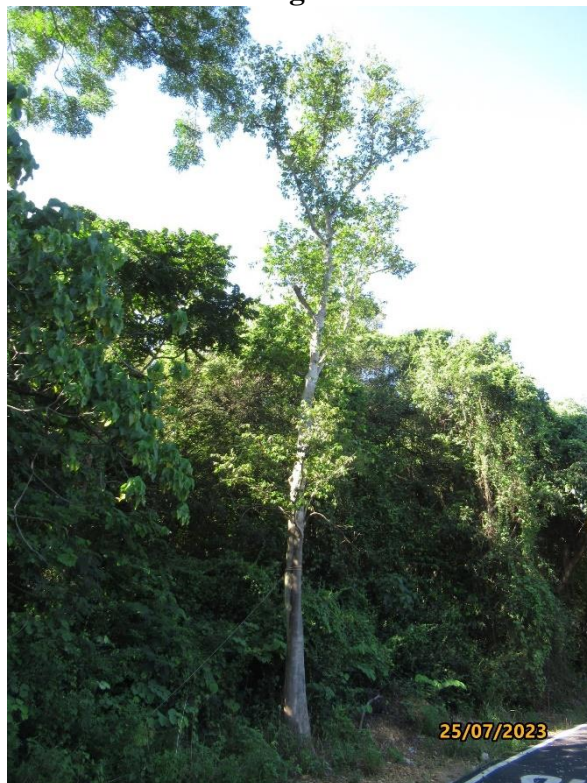
Fig F.

Transplanted tree (T-2928)
