**SITE FORMATION AND ASSOCIATED INFRASTRUCTURAL
WORKS FOR DEVELOPMENT OF COLUMBARIUM,
CREMATORIUM AND RELATED FACILITIES AT SANDY
RIDGE CEMETERY**

**MONTHLY ENVIRONMENTAL MONITORING AND AUDIT
REPORT (NO.62) – SEPTEMBER 2023**

**PREPARED FOR
HSIN CHONG TSUN YIP JOINT VENTURE &
SANG HING CIVIL CONTRACTORS CO., LTD**

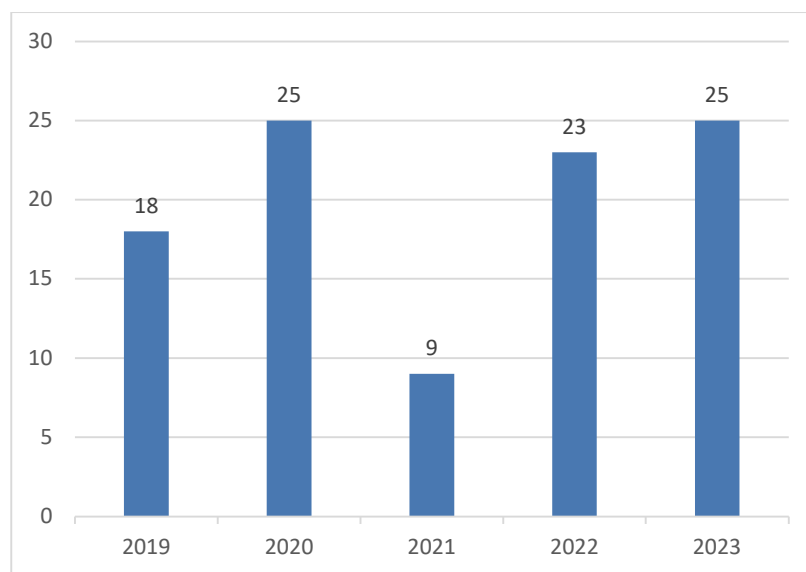
Figure 1: Bar chart showing the total species richness within site boundary from 2019 to 2023
(Actual quantity annotated at the top of each bar)

5.1 Total abundance and species richness in September over years were compared to show the trends. Figures 1 and 2 indicate the total species richness and total abundance within the site boundary respectively.

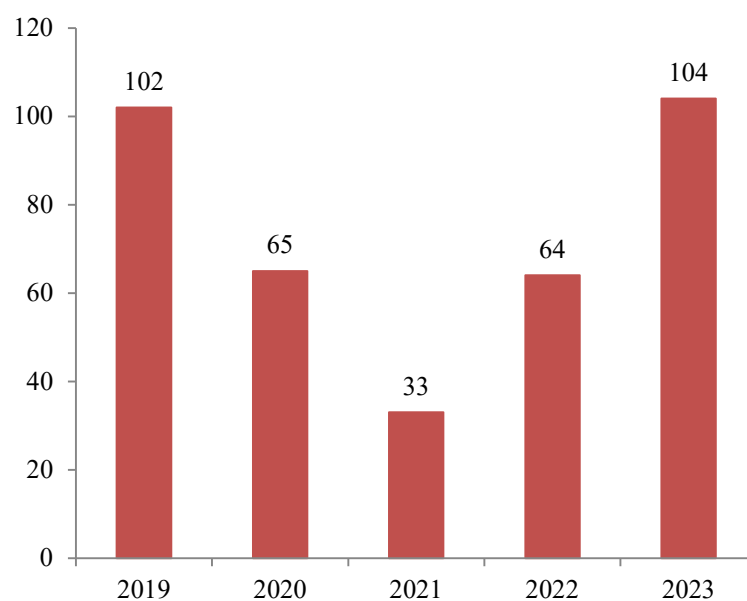
Figure 2: Bar chart showing the total abundance within site boundary from 2019 to 2023
(Actual quantity annotated at the top of each bar)

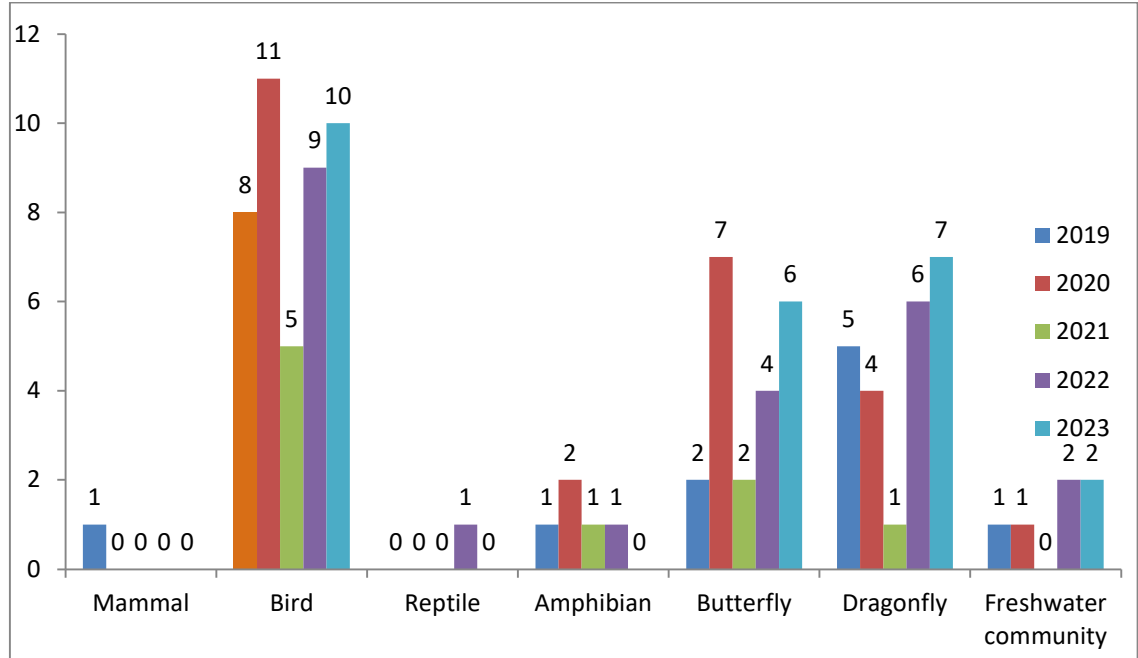
Figure 3: Bar chart showing the species richness within site boundary by taxa from 2019 to 2023
(Actual quantity annotated at the top of each bar)

5.2 As results in section 4 were categorized by taxa, a detailed breakdown of each taxon is shown in figure 3 to further investigate the trend of specific taxa over contract period.

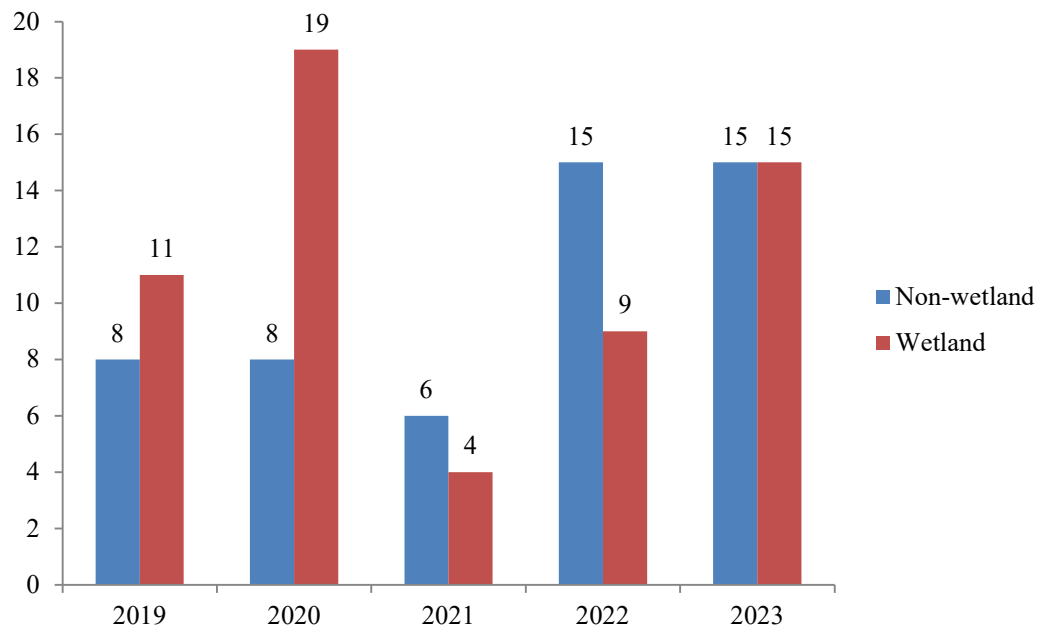
Figure 4: Bar chart showing the species richness based on habitat type from 2019 to 2023
(Actual quantity annotated at the top of each bar)

5.3 According to EM&A Manual, monitoring measures was determined by the species diversity of types of sensitive habitats, i.e. non-wetland and wetland habitats. Abundance and species richness by habitat type in September over years were compared in Figures 4 and 5.

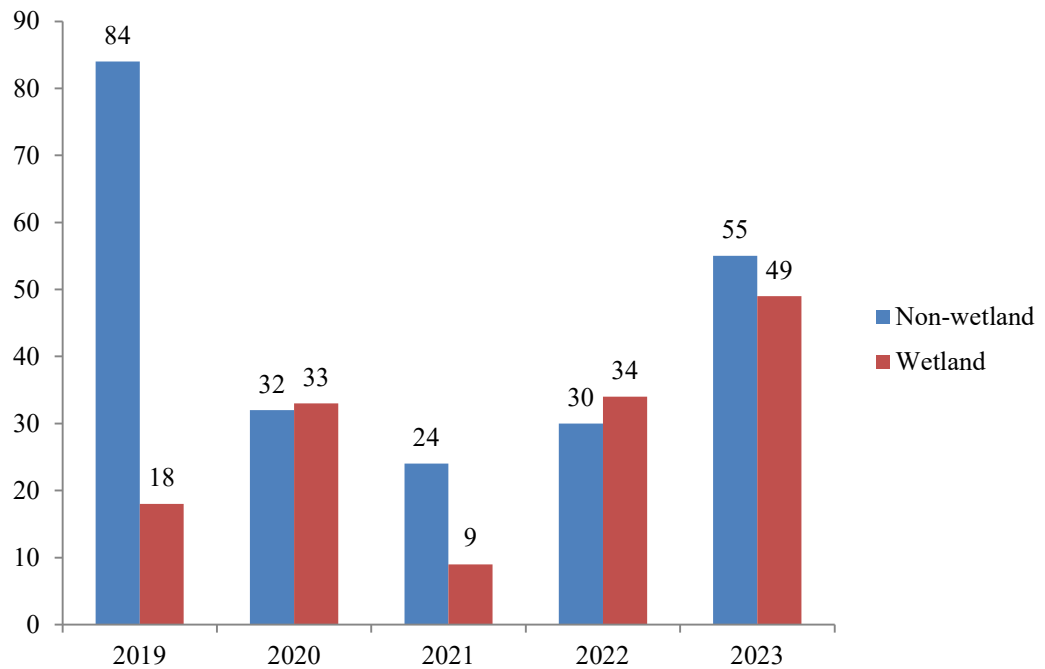
Figure 5: Bar chart showing the abundance based on habitat type from 2019 to 2023
(Actual quantity annotated at the top of each bar)

5.4 After analysing survey results in September from 2019 to 2023, stable number of species richness and a significant increase in the abundance for Wetland and Non-wetland habitat are recorded in September 2023. This could be benefited by some positive factors such as the major construction works were completed and most of the PME has been removed from site. Besides, compensation planting works have been conducted in early Jan 2023. Therefore, disturbance to fauna species from construction works have been largely minimised. In addition, woodland compensation and grassland reinstatement would be implemented in the second and third quarter of 2023. Hence, the habitat of fauna species would be gradually recovered and expectation of increase in the species richness and abundance for wetland habitat is high.

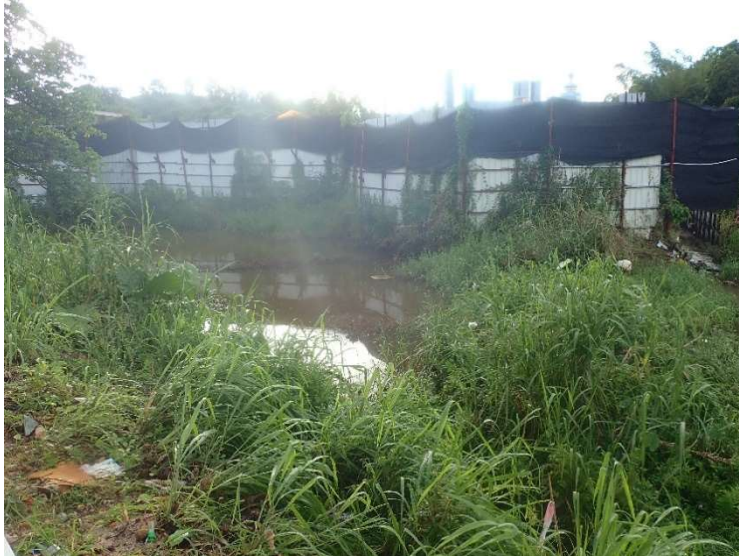
Picture 1

Watercourse in monitoring area.

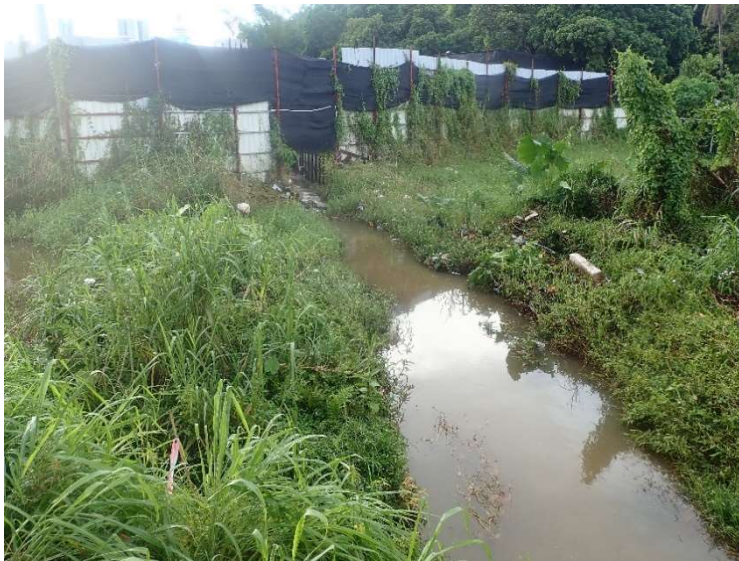
Picture 2

Watercourse in monitoring area.

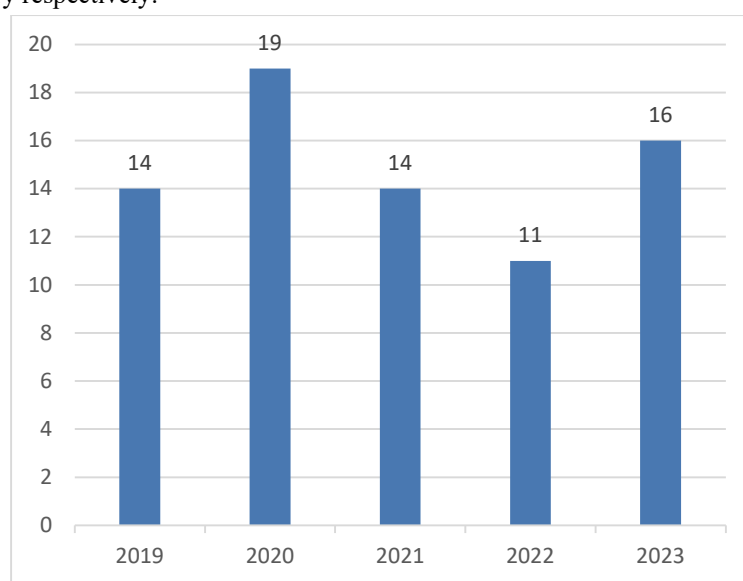
Figure 1: Bar chart showing the total species richness within site boundary from 2019 to 2023 (Actual quantity annotated at the top of each bar)

5.1 Total abundance and species richness in September over years were compared to show the trends. Figures 1 and 2 indicate total species richness and total abundance within the site boundary respectively.

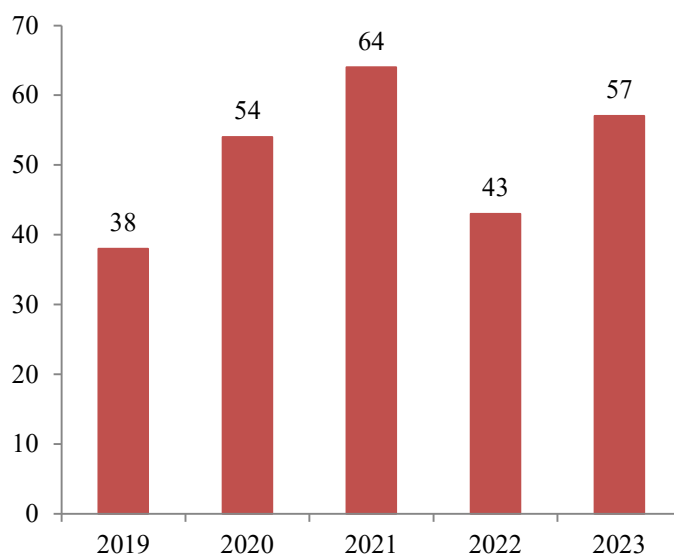
Figure 2: Bar chart showing the total abundance within site boundary from 2019 to 2023 (Actual quantity annotated at the top of each bar)

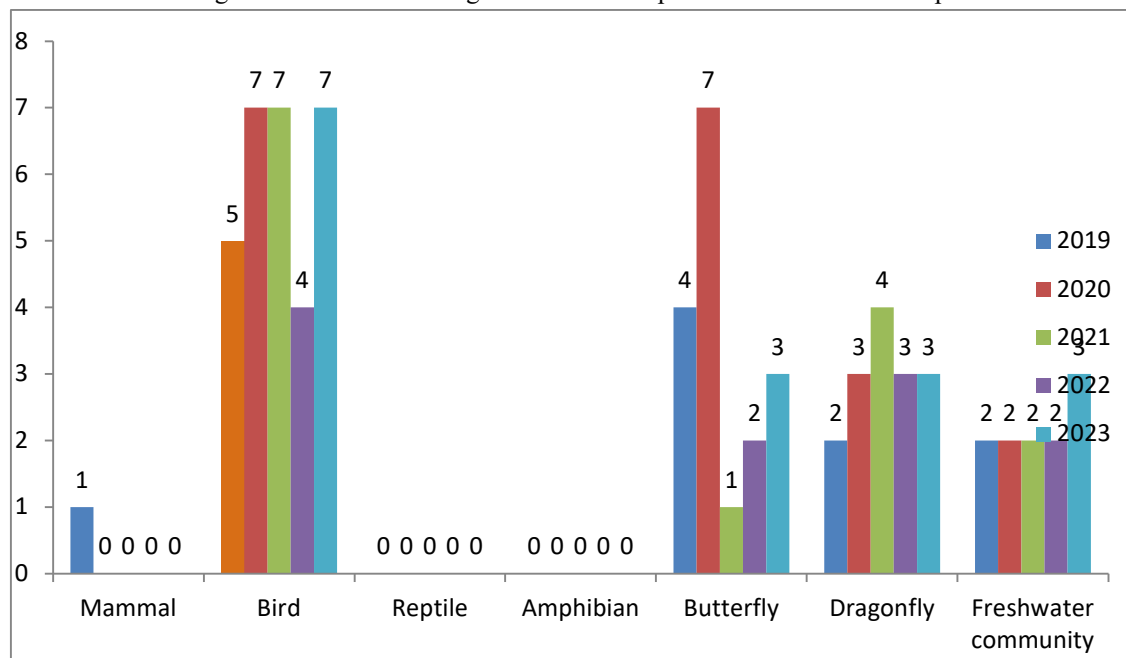
Figure 3: Bar chart showing the species richness within site boundary by taxa from 2019 to 2023
 (Actual quantity annotated at the top of each bar)

5.2 As results in section 4 were categorized by taxa, a detailed breakdown of each taxon is shown in figure 3 to further investigate the trend of specific taxa over contract period.

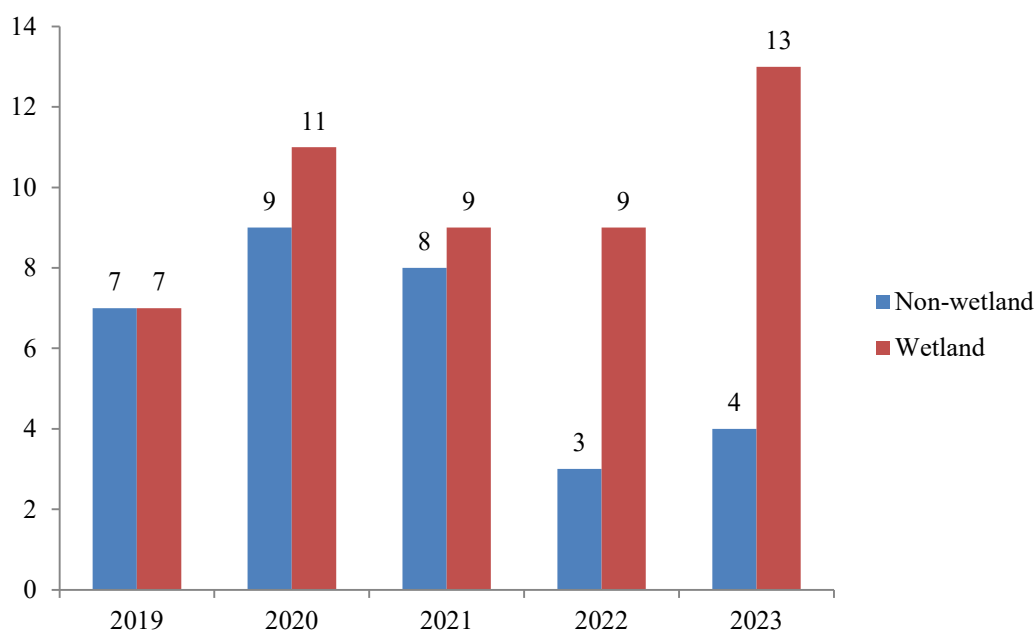
Figure 4: bar chart showing the species richness based on habitat type from 2019 to 2023
 (Actual quantity annotated at the top of each bar)

5.3 According to EM&A Manual, monitoring measures was determined by the species diversity of types of sensitive habitats, i.e. non-wetland and wetland habitats. Abundance and species richness by habitat type in September over years were compared in figures 4 and 5.

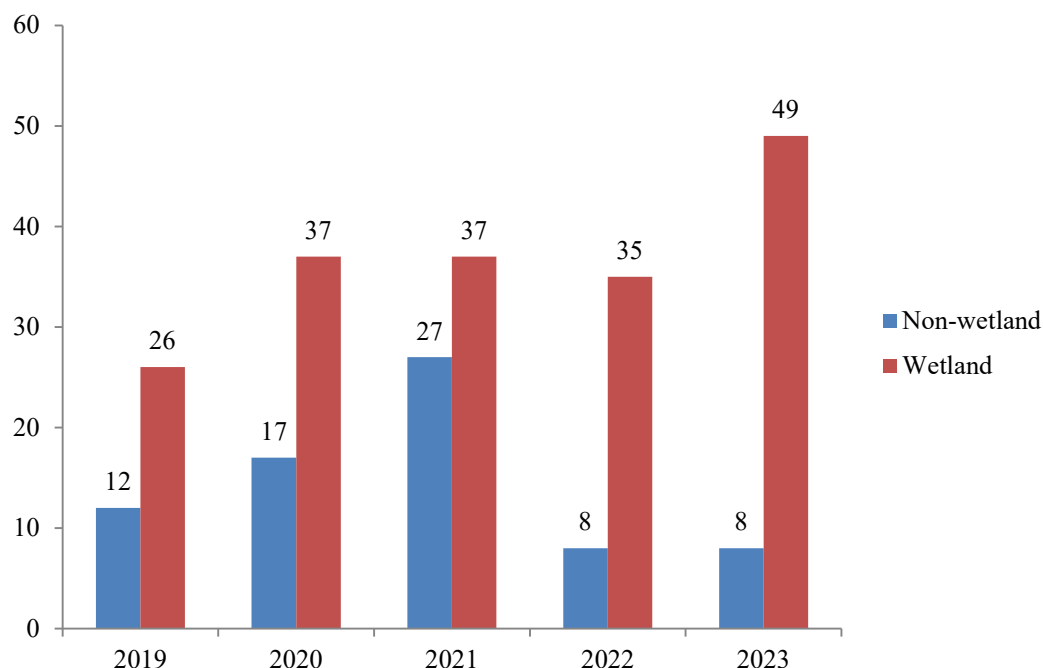
Figure 5: bar chart showing the abundance based on habitat type from 2019 to 2023
 (Actual quantity annotated at the top of each bar)

5.4 After analysing survey results in September from 2019 to 2023, records in species richness and abundance for wetland and non-wetland habitats are unstable, this may due to natural fluctuation. According to the recent on-site observation, there are new built workshops by others situated on both sides of Lin Ma Hang Road so the disturbance to fauna species from construction works could be increased. Due to the cause was not related to this project, remedial action to remove or reduce source of disturbance is limited.

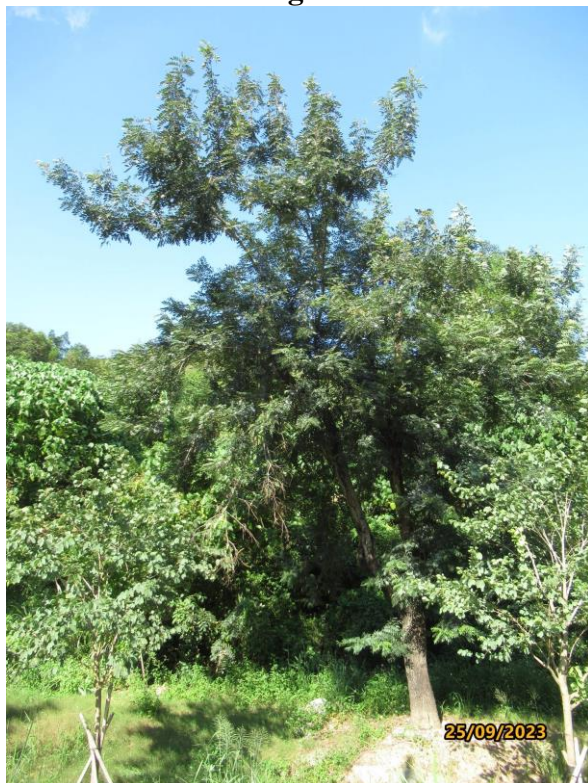
Fig E.

Transplanted tree (T-2465)

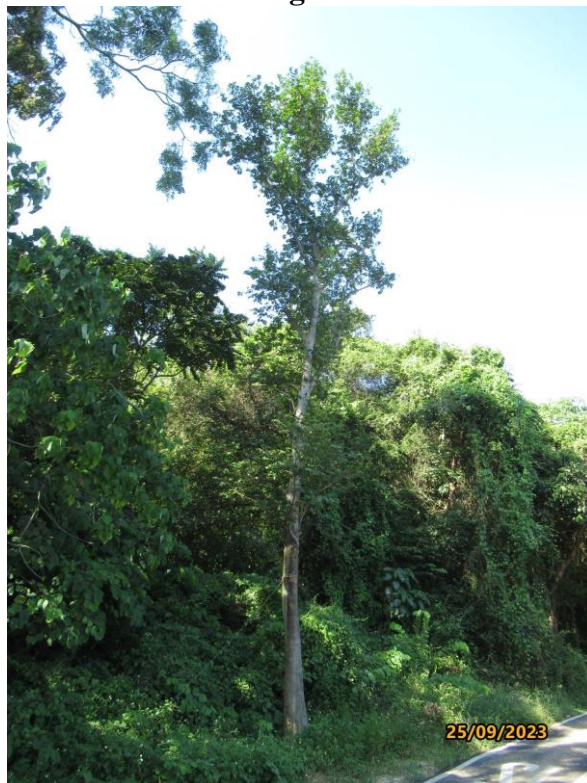
Fig F.

Transplanted tree (T-2928)
