JOB NO.: TCS00881/18 & TCS00944/18

SITE FORMATION AND ASSOCIATED INFRASTRUCTURAL WORKS FOR DEVELOPMENT OF COLUMBARIUM, CREMATORIUM AND RELATED FACILITIES AT SANDY RIDGE CEMETERY

MONTHLY ENVIRONMENTAL MONITORING AND AUDIT REPORT (NO.16) – NOVEMBER 2019

PREPARED FOR
HSIN CHONG TSUN YIP JOINT VENTURE &
SANG HING CIVIL CONTRACTORS CO., LTD

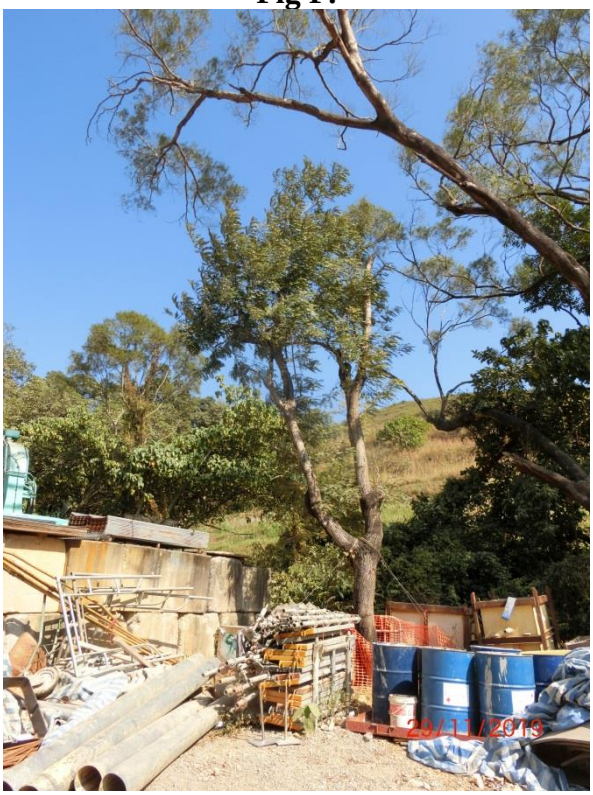
Fig F.

Date	Findings and Reminder	Follow-Up Status
29th Nov 2019	1. Transplanted trees T2465, T2468 and T2928 were in fair health condition with normal foliage color and density.	• The Contractor keep closely monitor on the health condition of T2928.
	2. Some Tree protection zone (TPZ) was damaged/missing.	• The damaged/missing TPZ was repaired by the Contractor.
	3. The Contractor was reminded to prevent the construction material pile within Tree Protection Zone (TPZ) and ensure no works is allowed within the TPZ.	• Reminder was noted by the Contractor.
	4. The Contractor was reminded to provide proper maintenance for transplanted tree (T2465, T2468 and T2928) according to the approved method statement.	• Reminder was noted by the Contractor.

Transplanted tree (T-2465)
